Annual Inspection

North Warwickshire Borough Council

Openfield Croft

Inspection Ref: 1715258

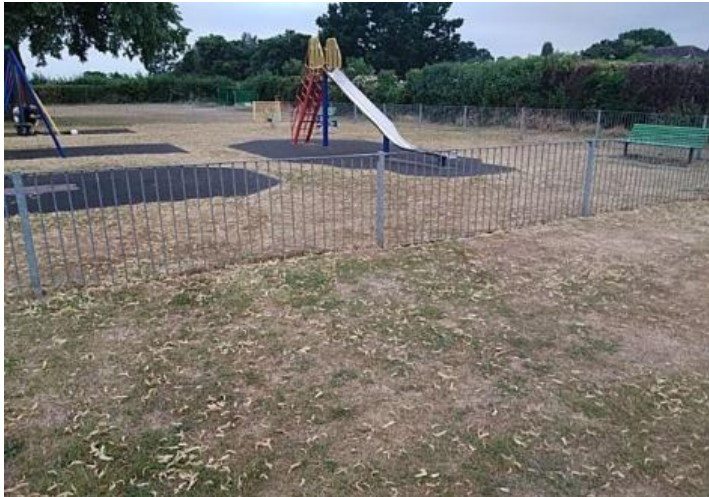
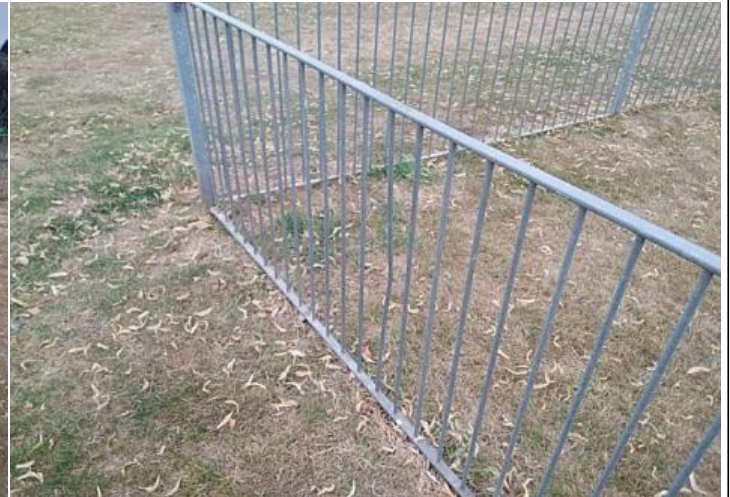
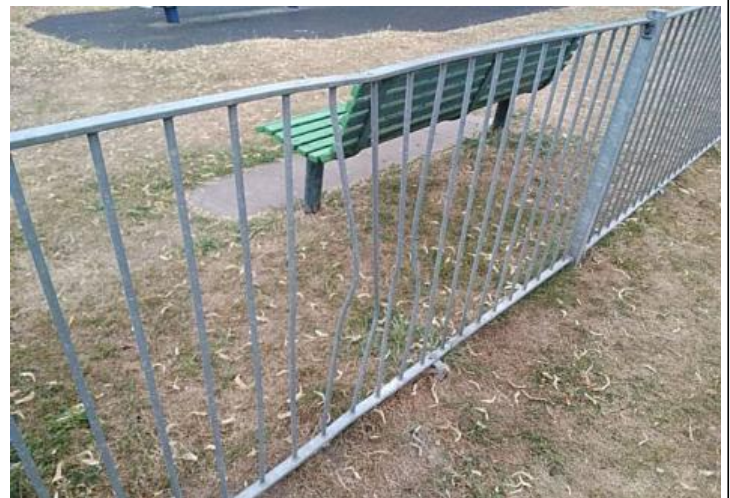
Finding: There is some damage to the fence sections

Action: Monitor for any further deterioration and repair as required

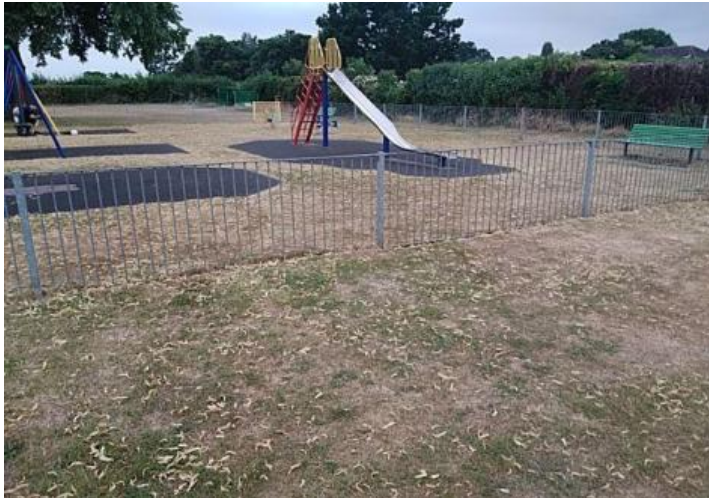
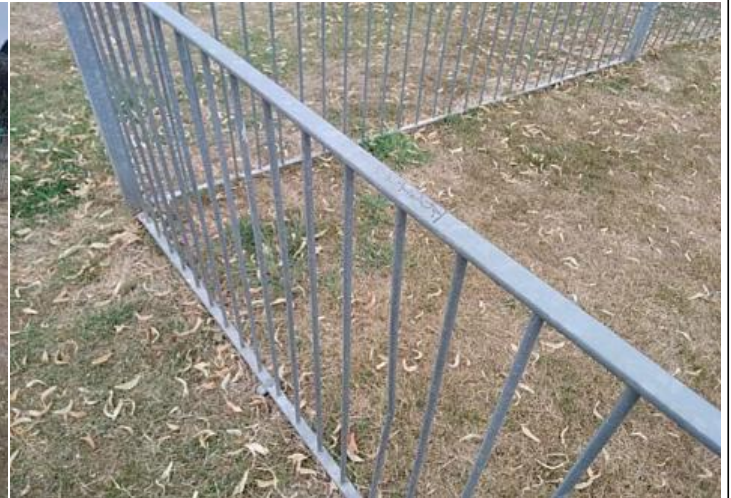
Finding: There is some graffiti present

Action: Remove the graffiti

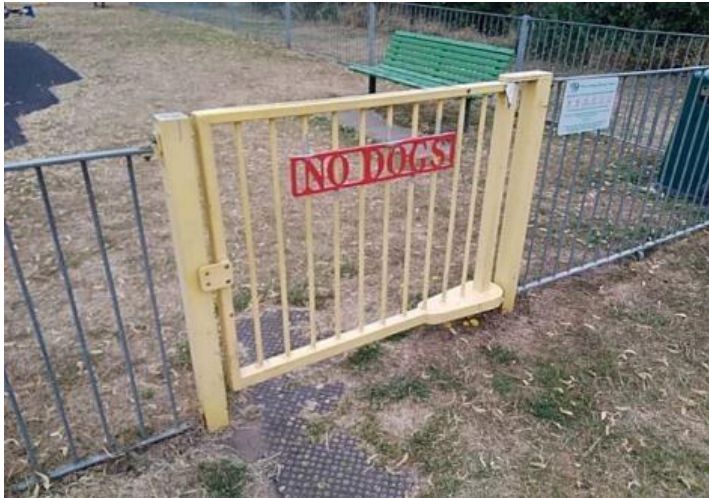
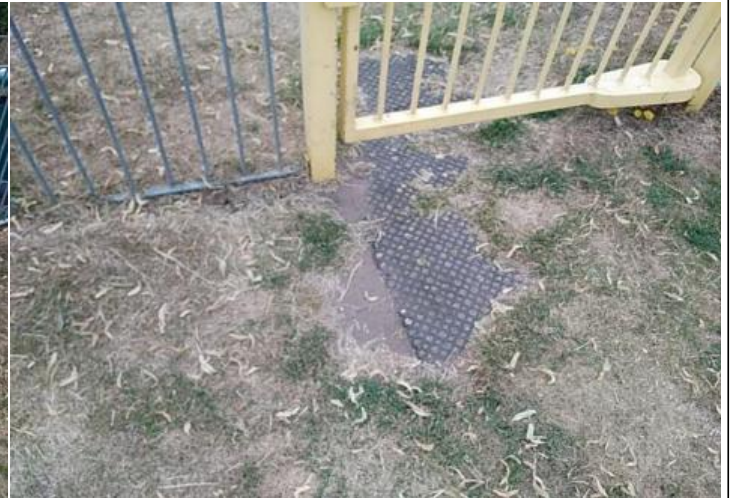
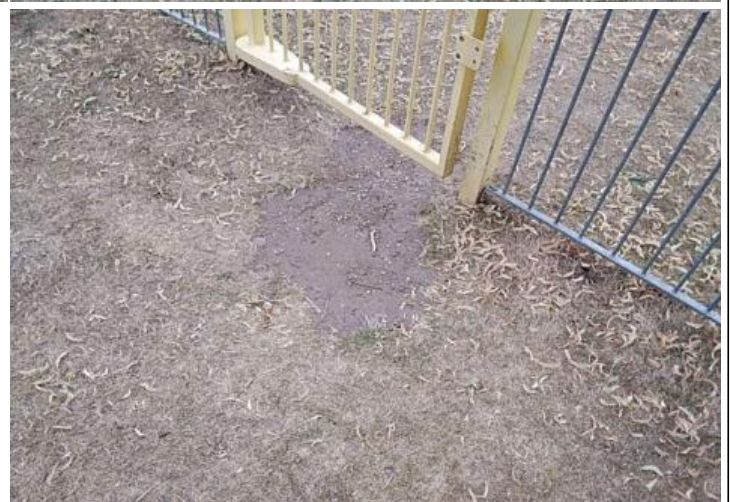
Finding: The area around the item has eroded and may become slippery

Action: Reinststate eroded area

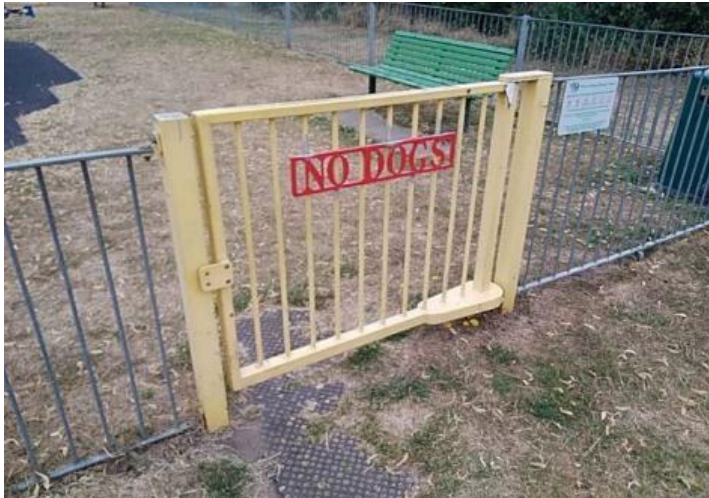
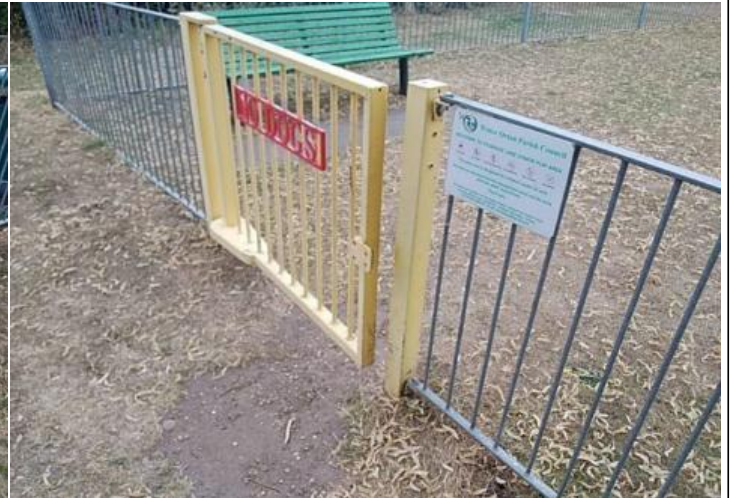
Finding: The gate is not operating correctly

Action: Take effective action to ensure the gate closes between 4 and 8 seconds

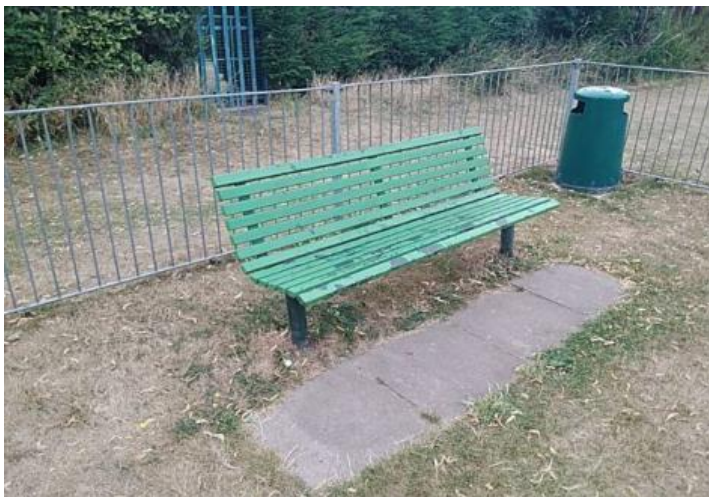
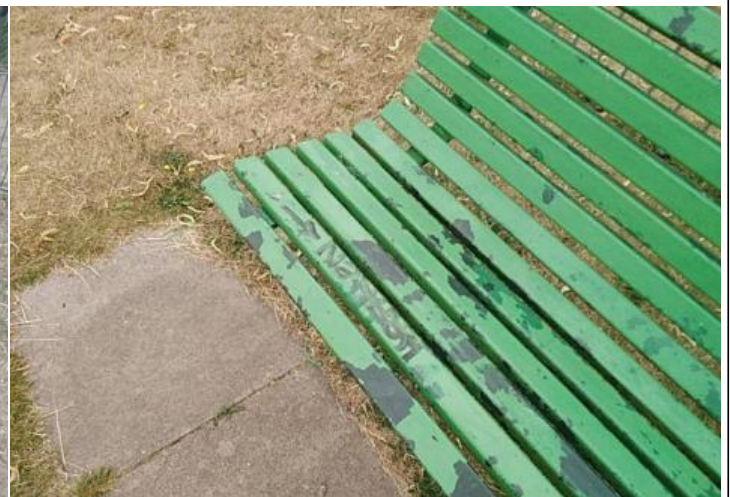
Finding: There is some graffiti present

Action: Remove the graffiti

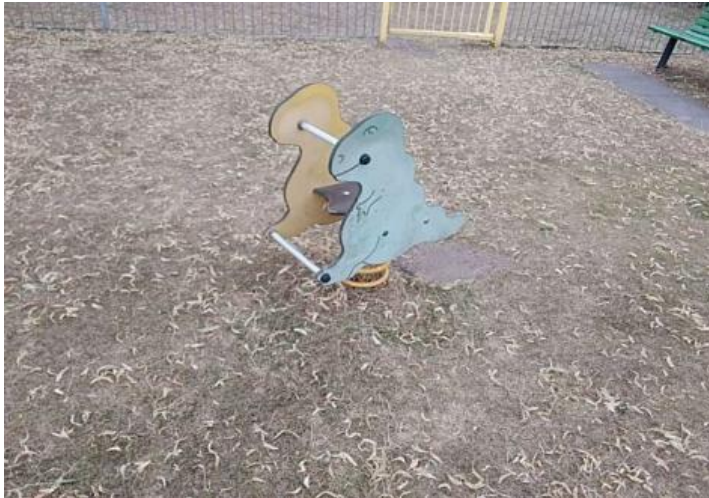
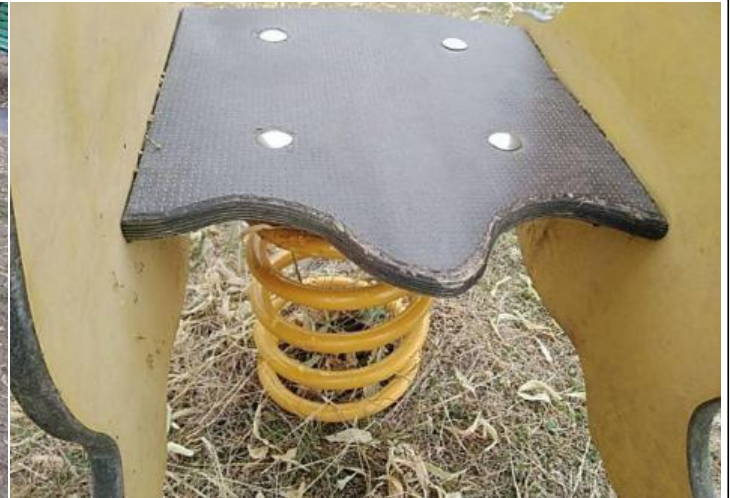
Finding: Parts of the timber are rough or splintered

Action: Remove all rough or sharp edges

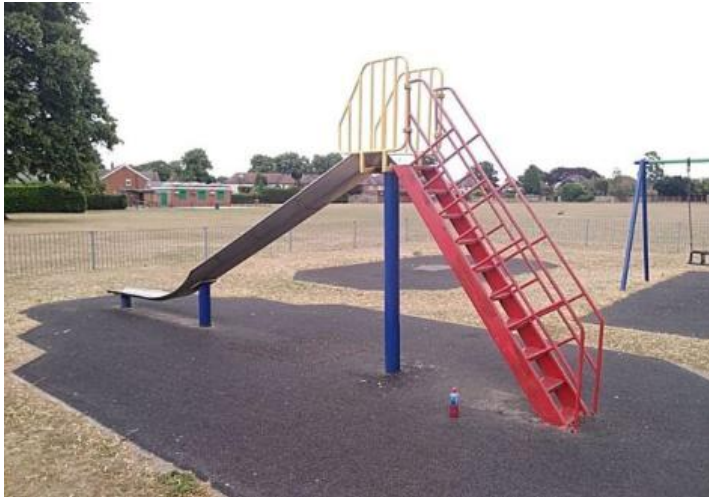
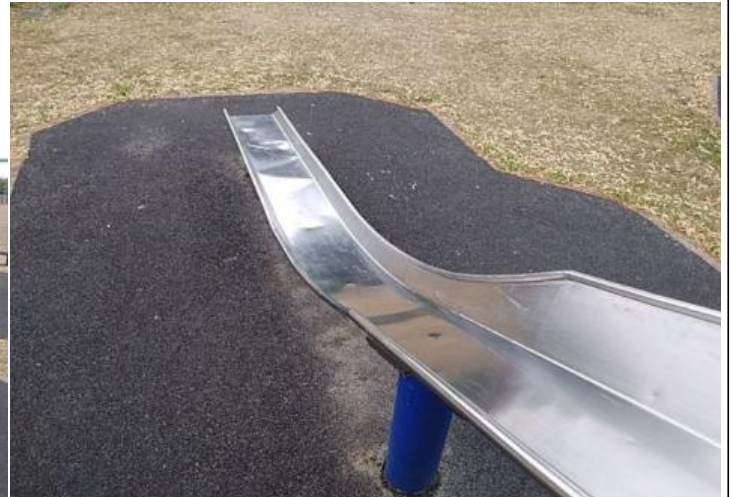
Finding: There are a number of dents in the slide surface

Action: Monitor for any further deterioration and repair as required

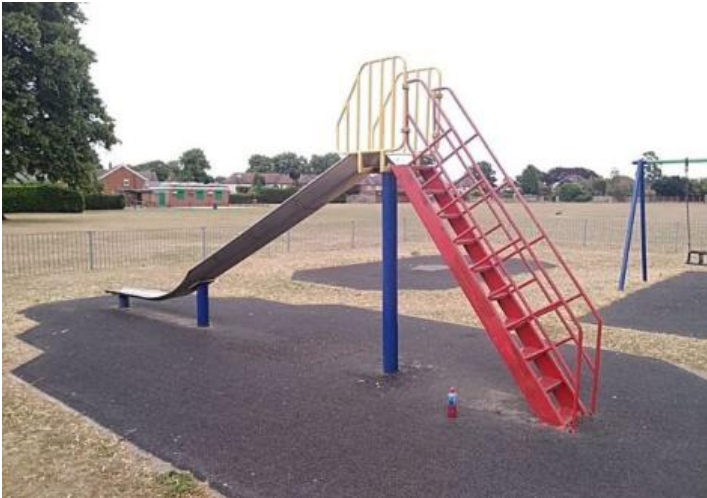
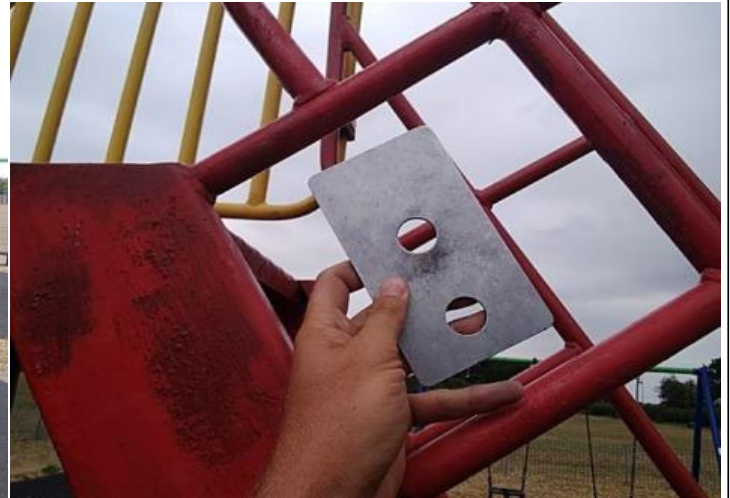
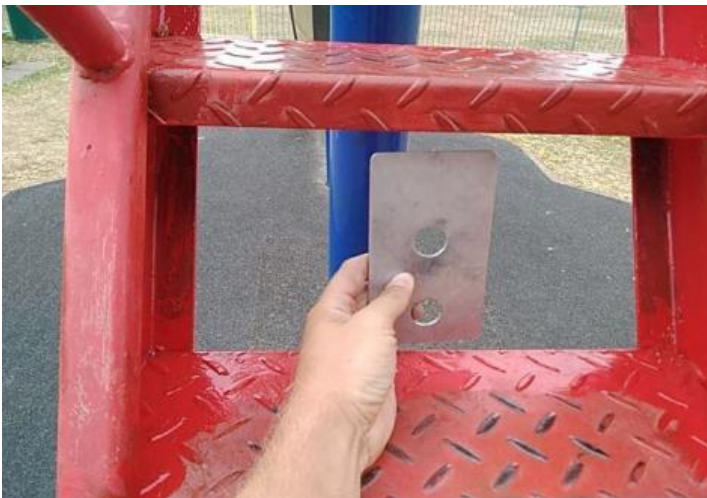
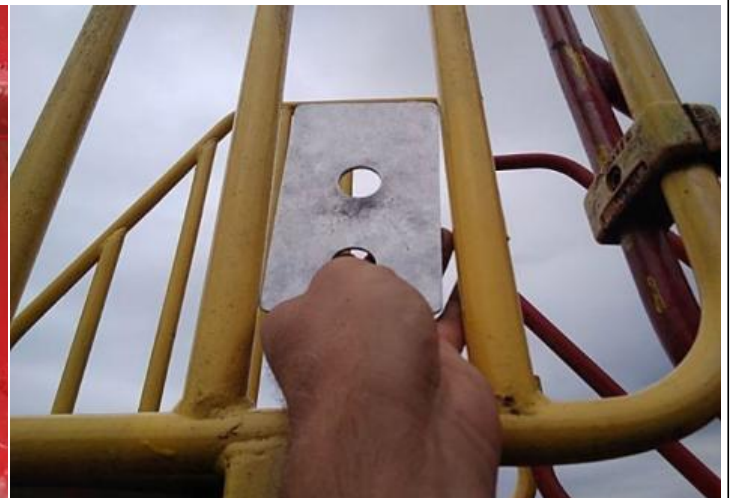
Finding: The item fails to meet the requirements of BS EN 1176 Part 1 4.2.7.2 head and neck entrapment in the barriers and/or steps

Action: Monitor - No remedial work recommended

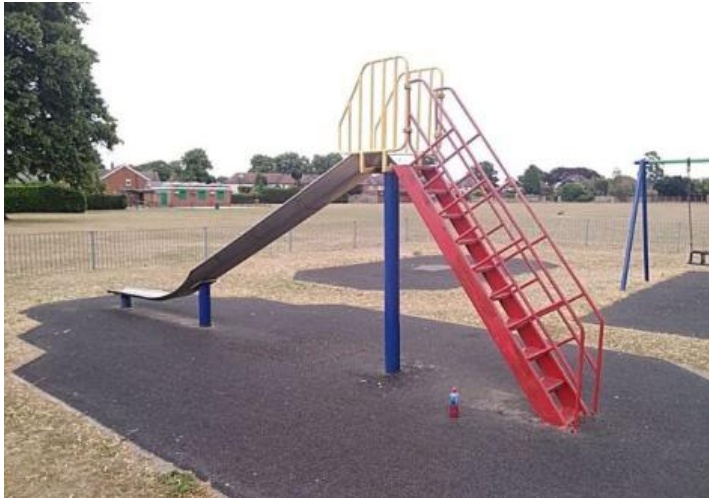
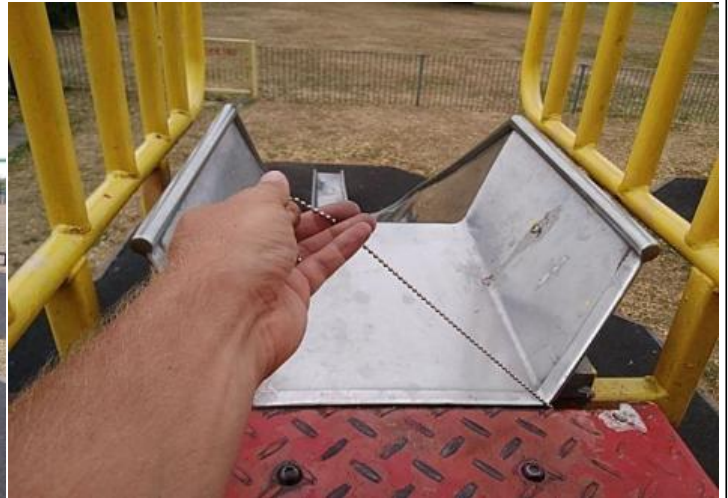
Finding: There is / are toggle entrapment/s present in contravention of the recommendations set out in BS EN 1176 Part 3

Action: Monitor - no remedial work recommended

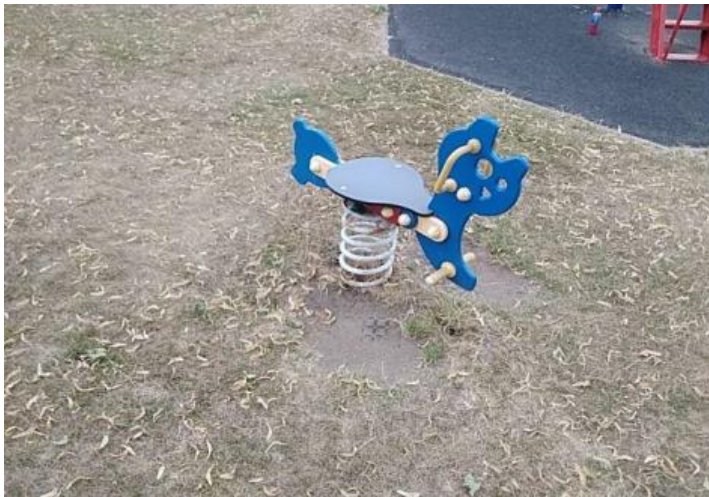
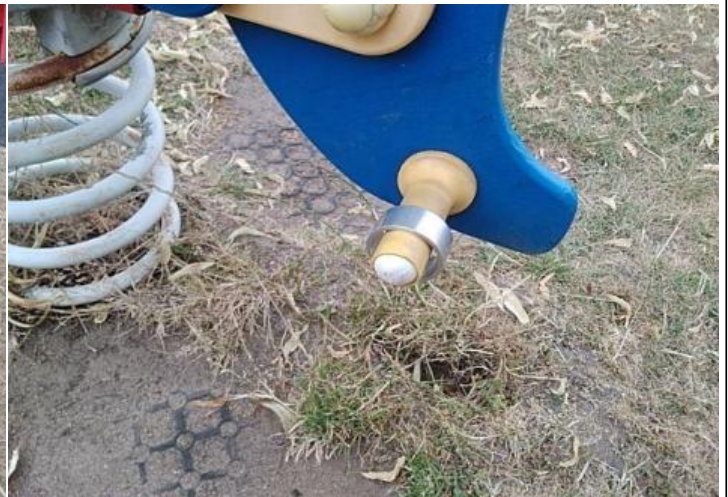
Finding: The end of handgrips and/or footrests have a cross section of less than 15cm² and fail to meet the requirements of BS EN 1176 Part 6

Action: Monitor - No remedial work recommended

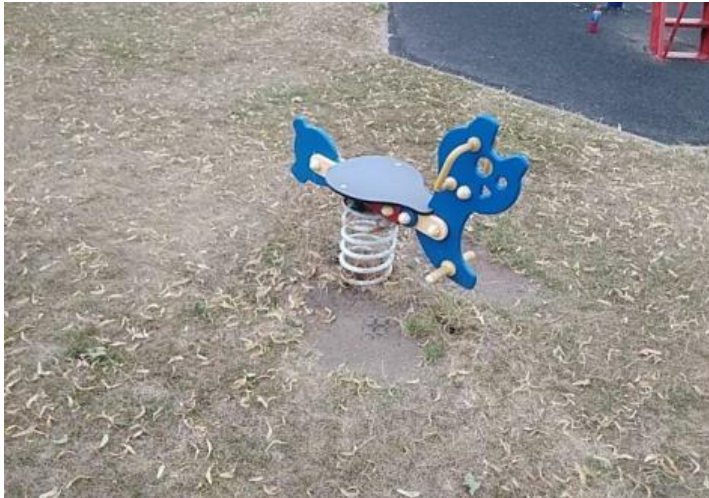
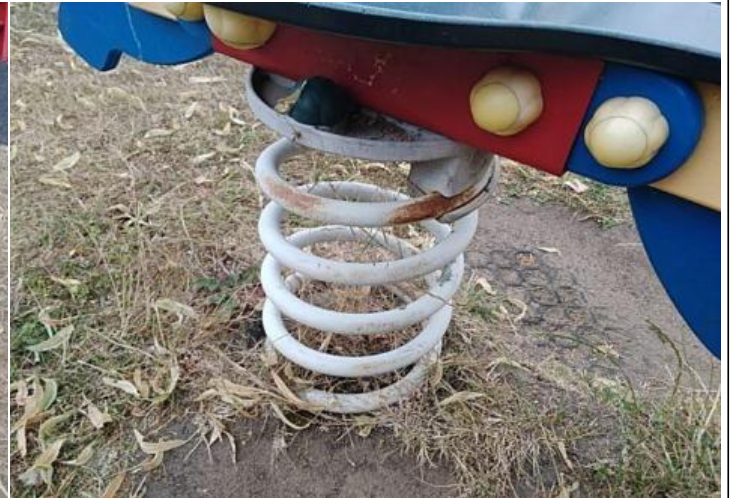
Finding: The paintwork on the spring has been damaged or worn exposing the metal underneath which is rusting
Action: Treat any rusting components and repaint

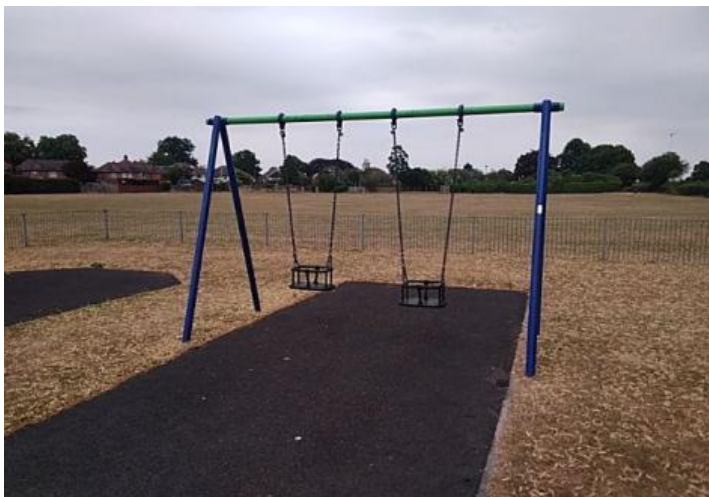
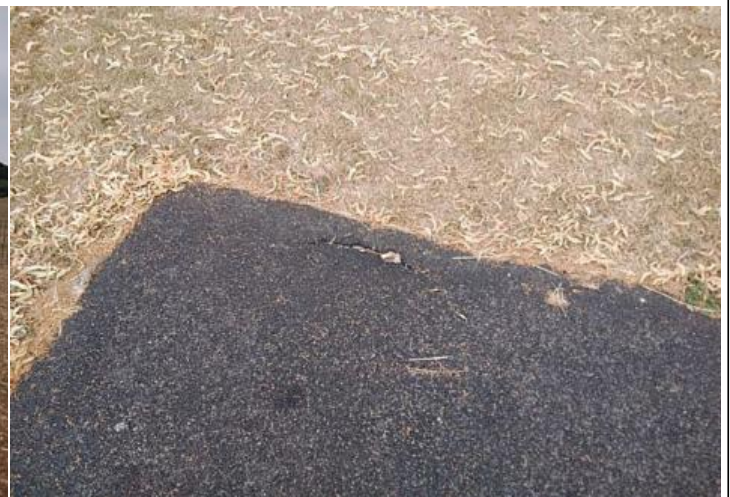
Finding: There is some minor damage to the surface
Action: Monitor for any further deterioration and repair as required

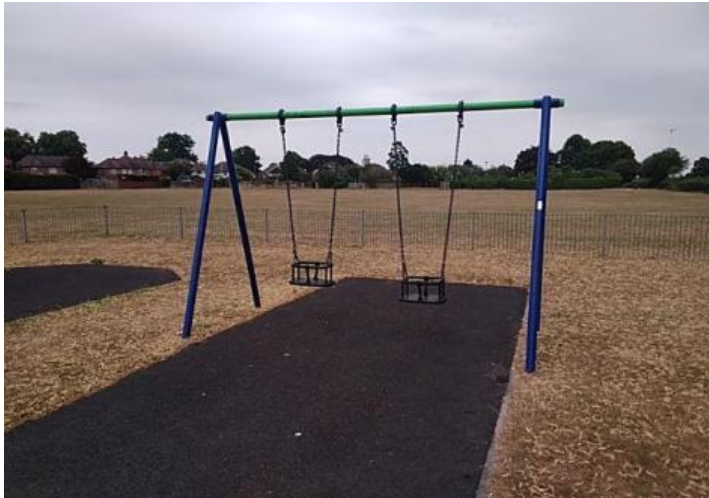
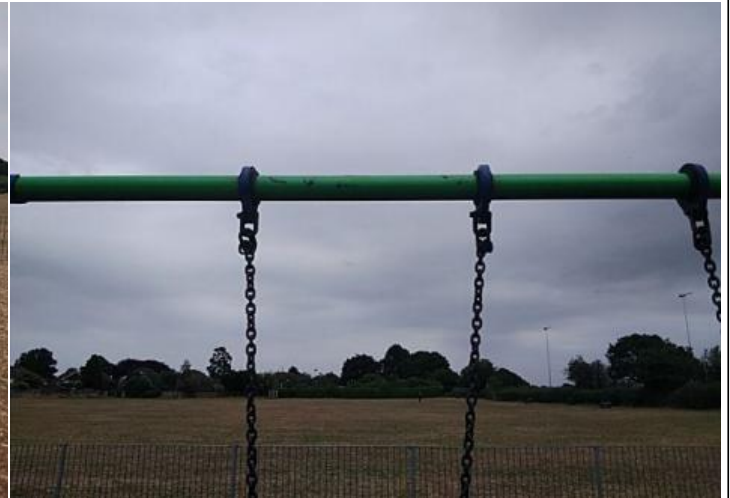
Finding: The bushes are showing signs of wear

Action: Monitor for any further deterioration and replace as required

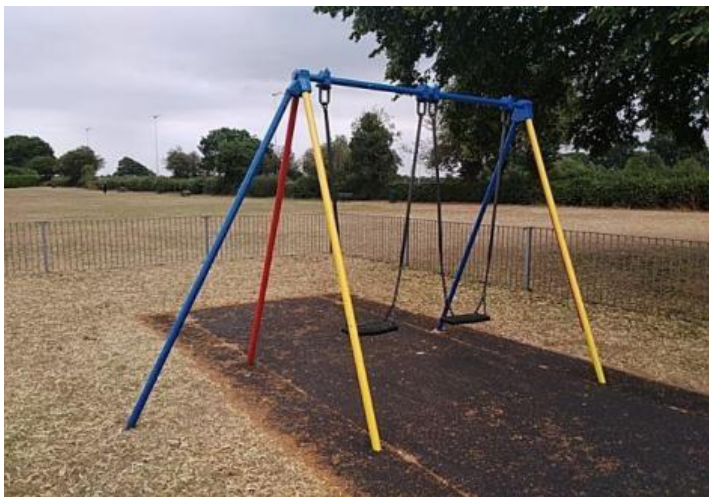
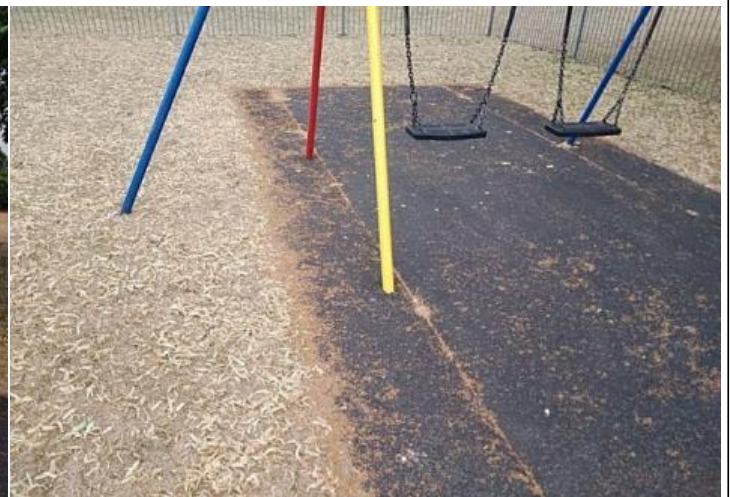
Finding: There is some tree debris on the surfacing

Action: Remove and maintain

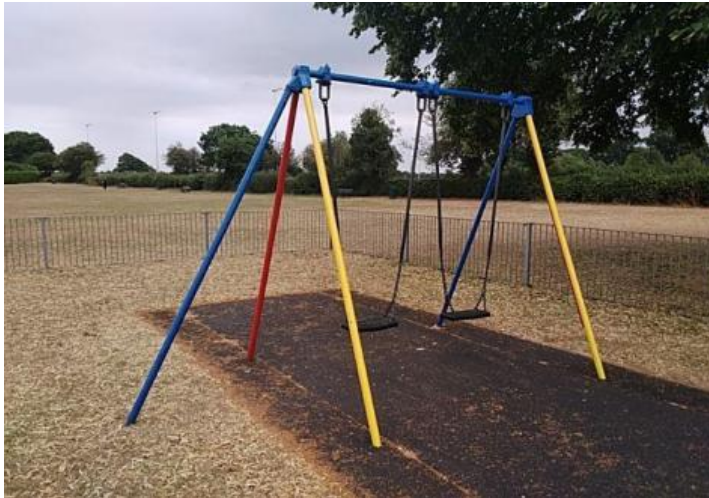
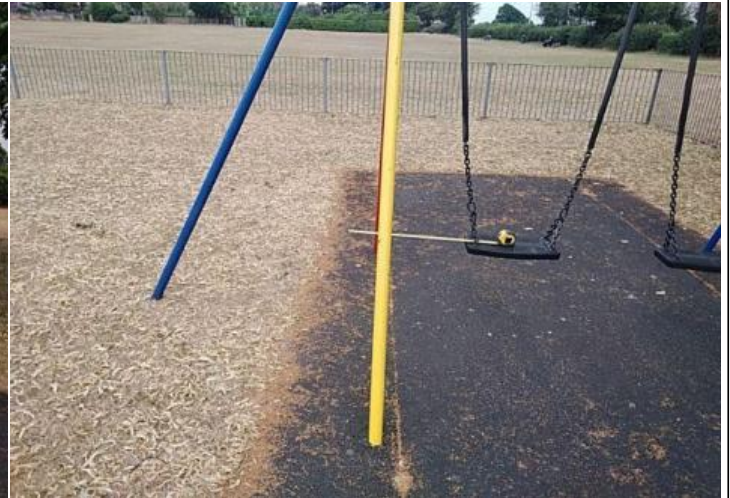
Finding: The seats are too close to the frame as defined in BS EN 1176 Part 2; this is a low risk failure and no remedial action is required

Action: Monitor - No remedial work recommended

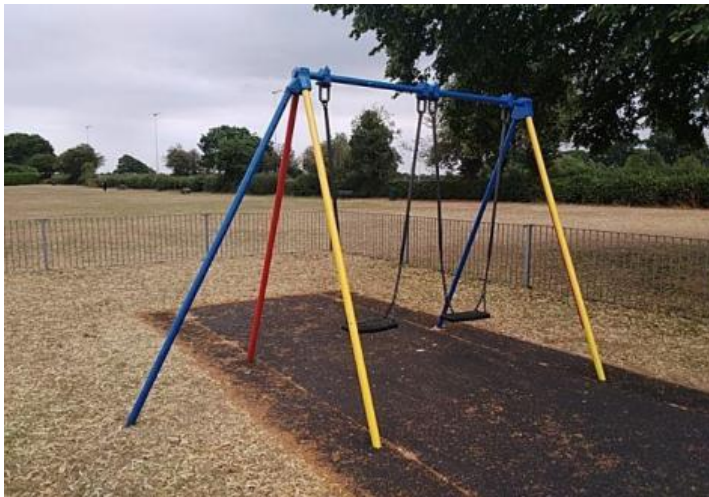
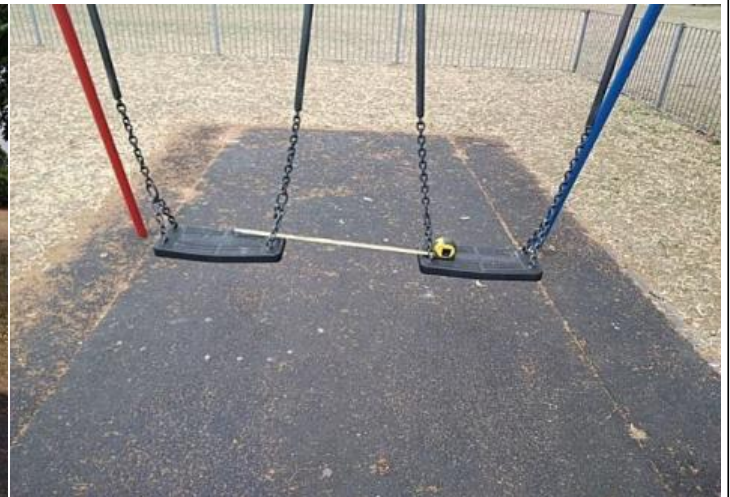
Finding: The seats are too close to each other as defined in BS EN 1176 Part 2; this is a low risk failure and no remedial action is required

Action: Monitor - No remedial work recommended

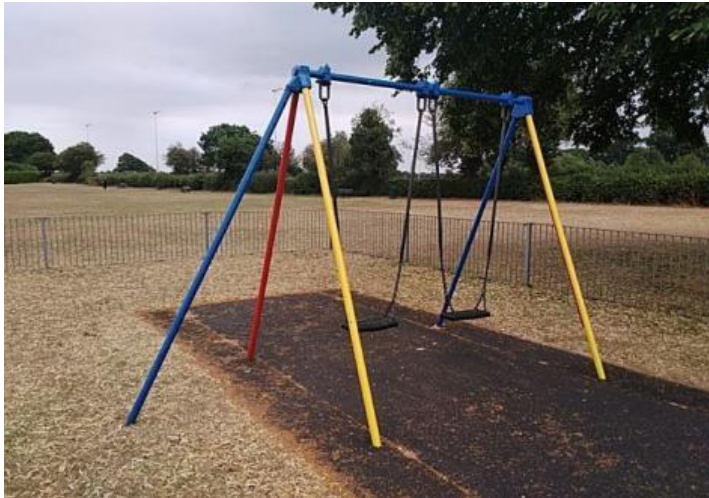
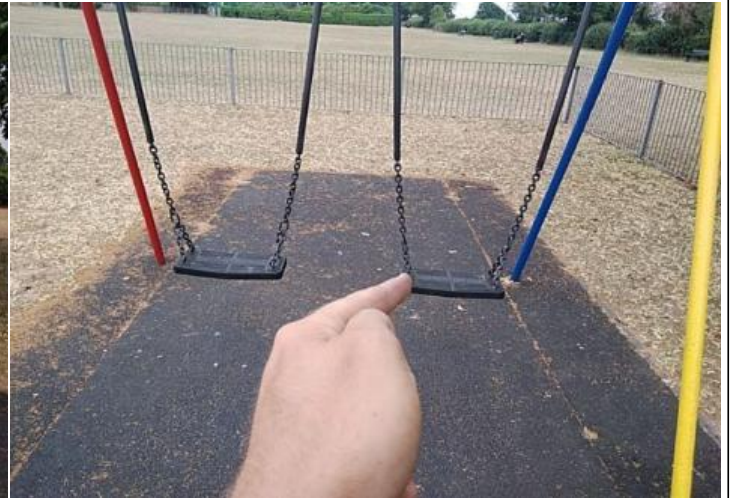
Finding: The swing seat connectors are loose

Action: Tighten to secure

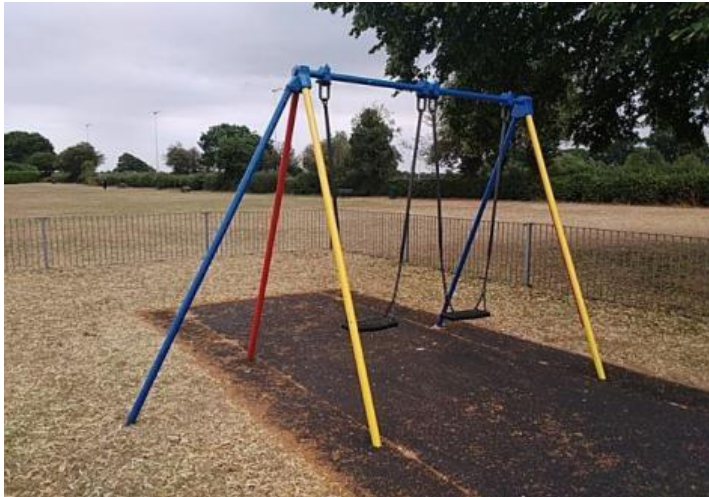
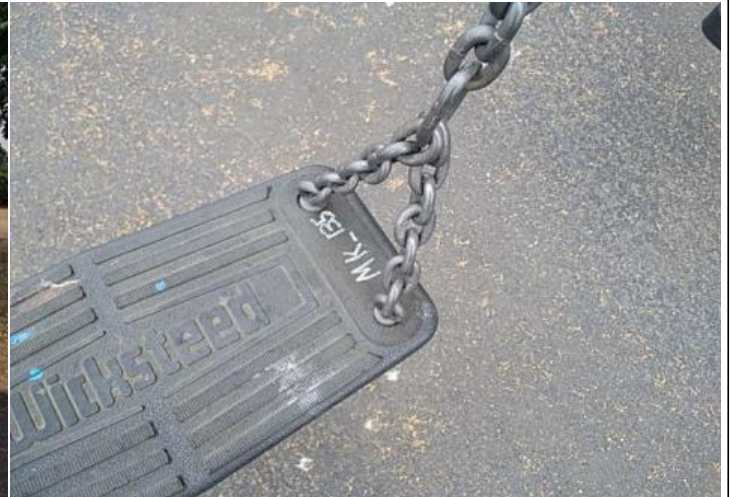
Finding: There is some graffiti present

Action: Remove the graffiti

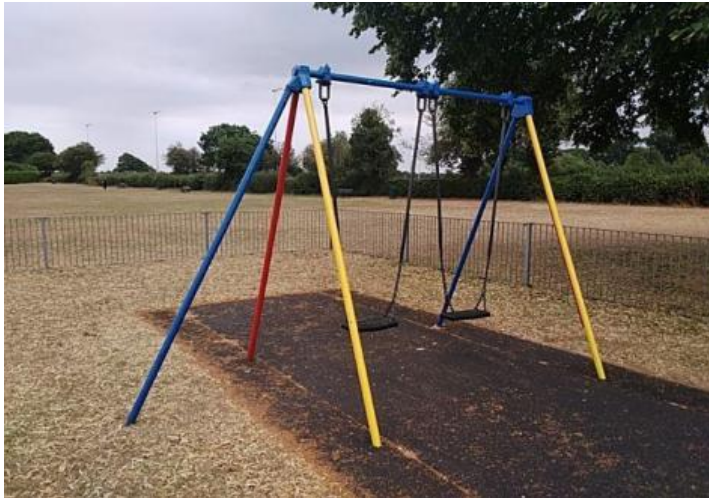
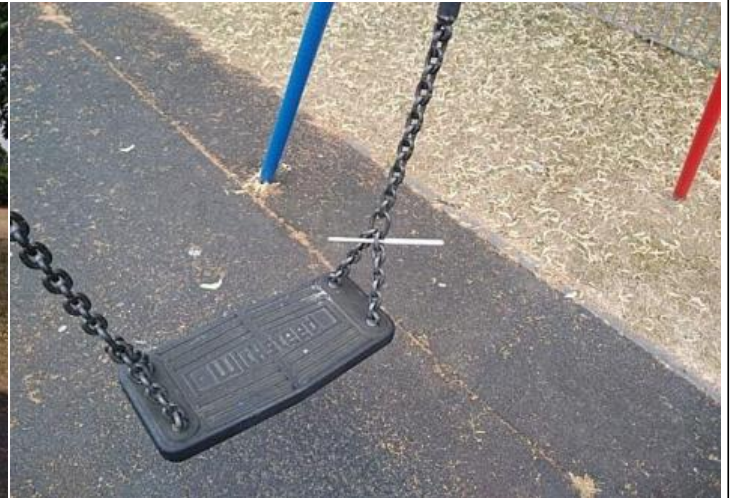
Finding: The chain openings are in excess of 8.6mm and do not meet the recommendations of BS EN 1176 Part 1

Action: Monitor - No remedial work recommended

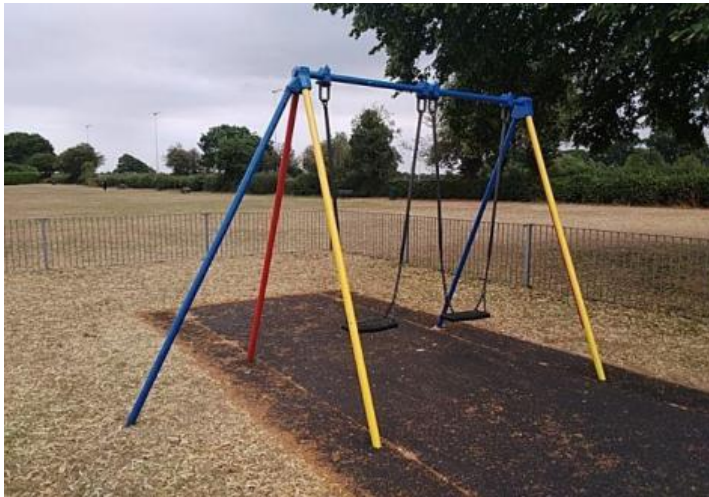
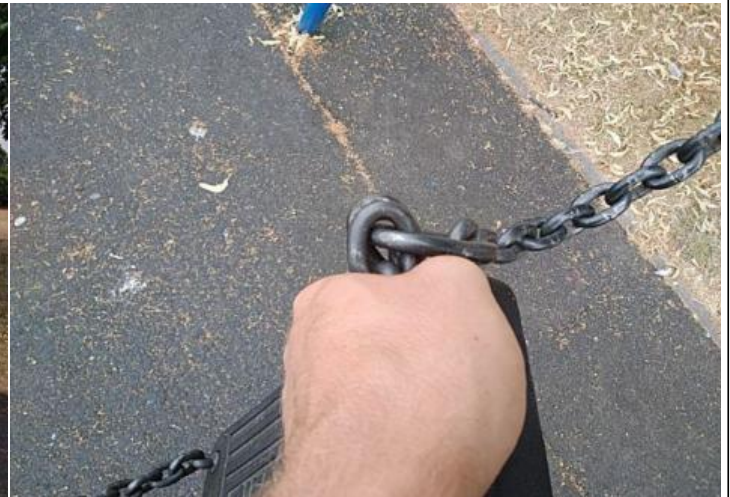
Finding: There is some notable evidence of chain wear

Action: Monitor for any further deterioration and replace when 40% worn

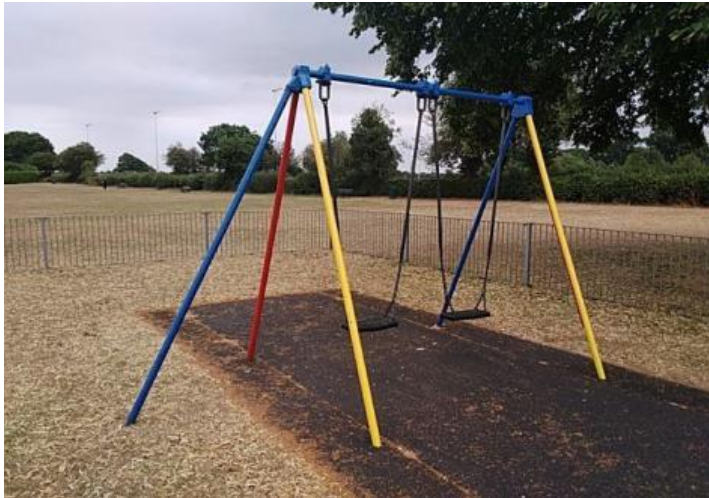
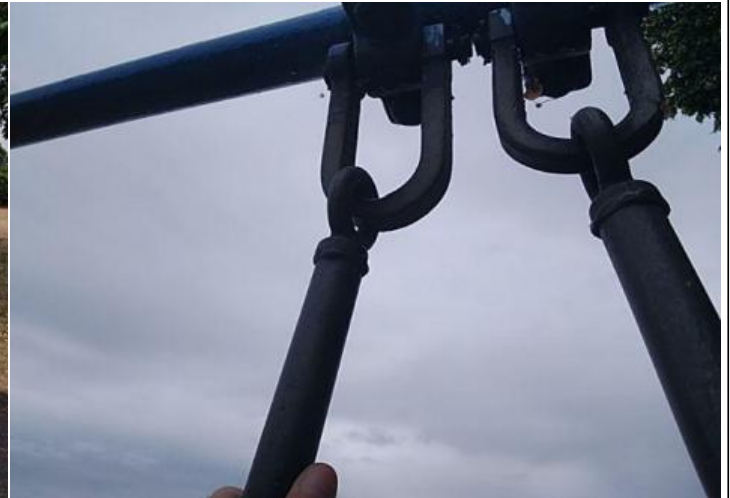
Finding: There is some wear to the shackles

Action: Monitor for any further deterioration and replace when 40% worn

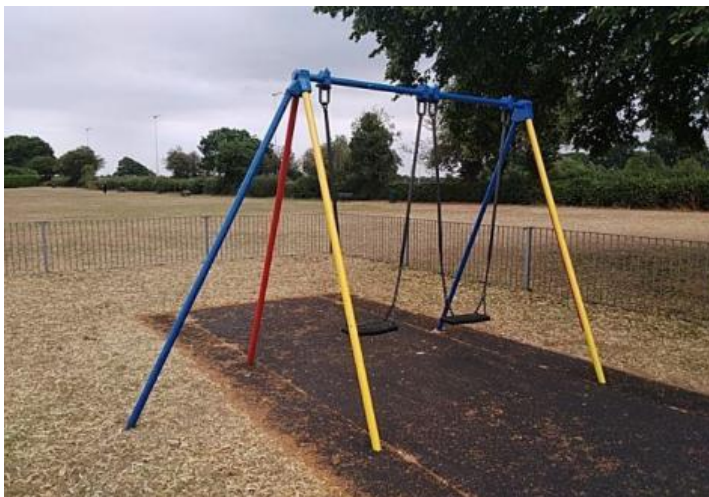
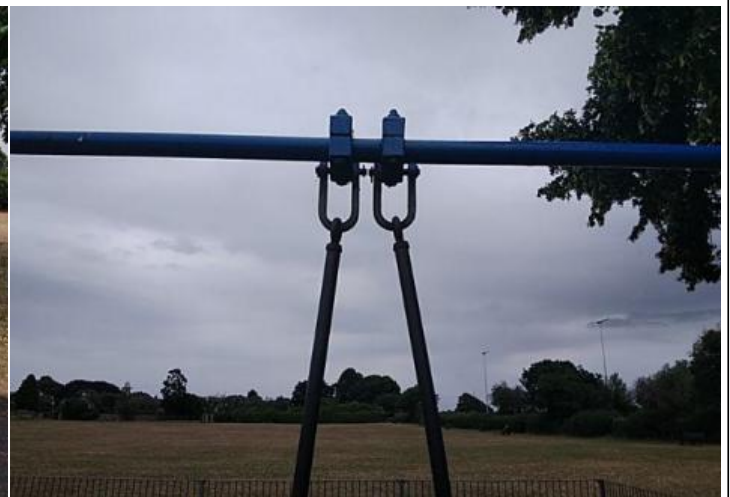
Finding: The bushes are showing signs of wear

Action: Monitor for any further deterioration and replace as required

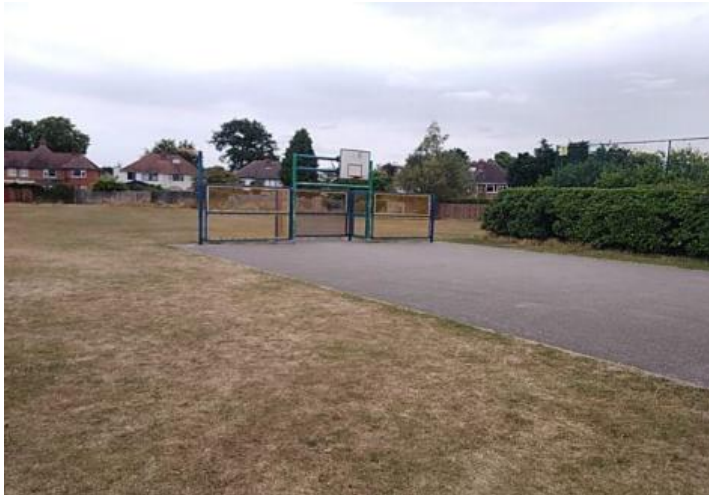
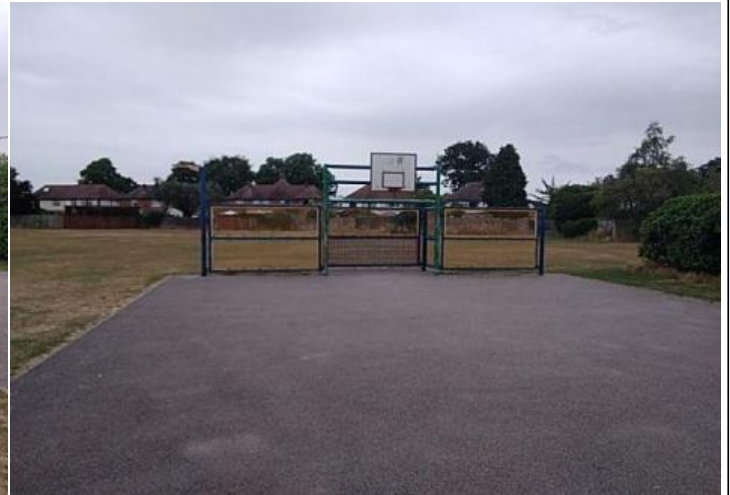
Finding: A clearly visible facility sign should be provided in a prominent position with the wording as detailed BS EN 15312- the equipment is not intended for children less than 3 years old- the warning - Do not climb on the framework or nets- the warning - Do not hang on the ring (if provided)- the warning - Do not wear rings or other jewellery- name and telephone number of the administrator- number to call in case of accident

Action: Provide signage to BS EN 15312

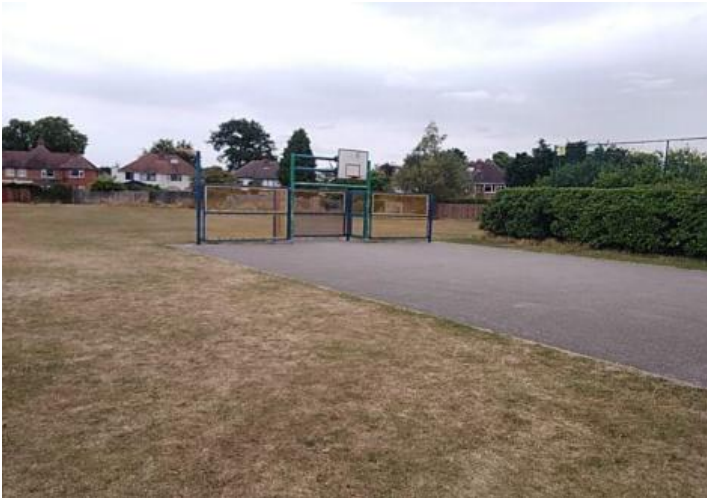
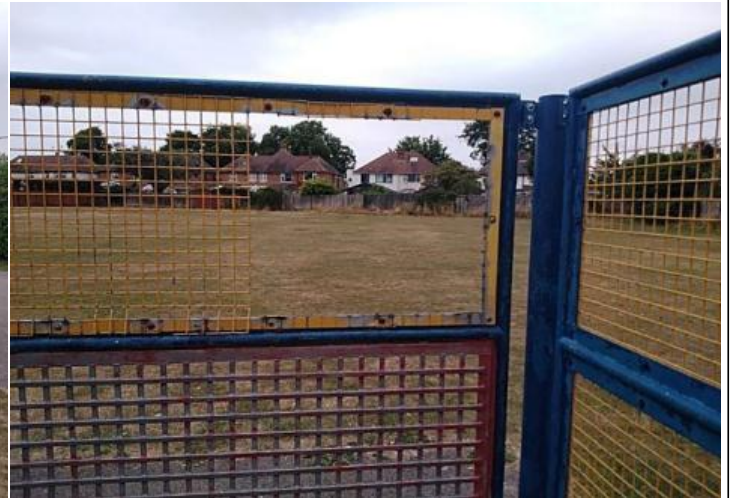
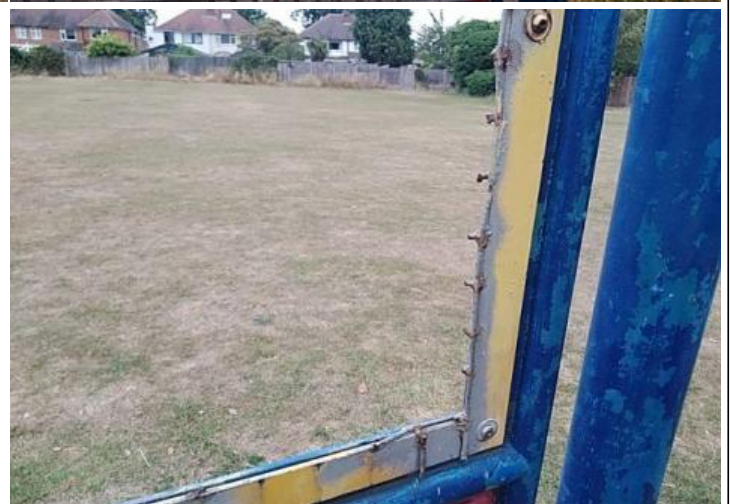
Finding: The item has missing panels exposing sharp edges

Action: Replace missing components

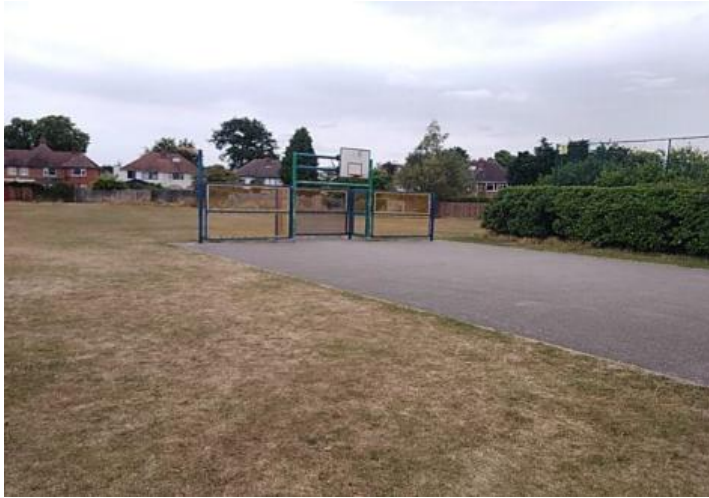
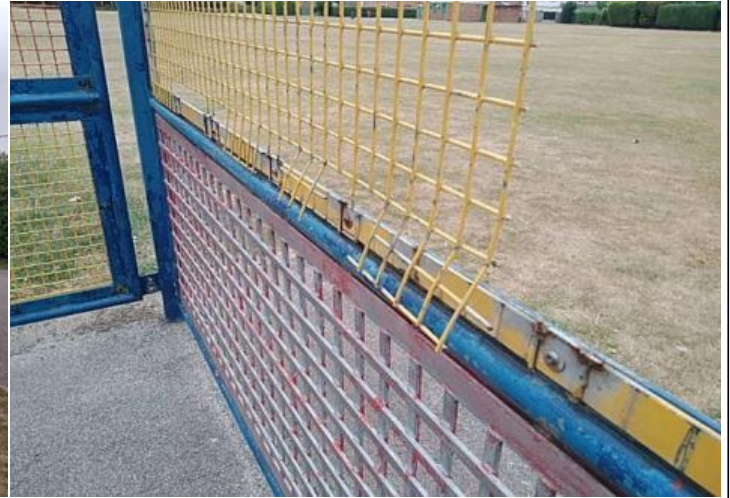
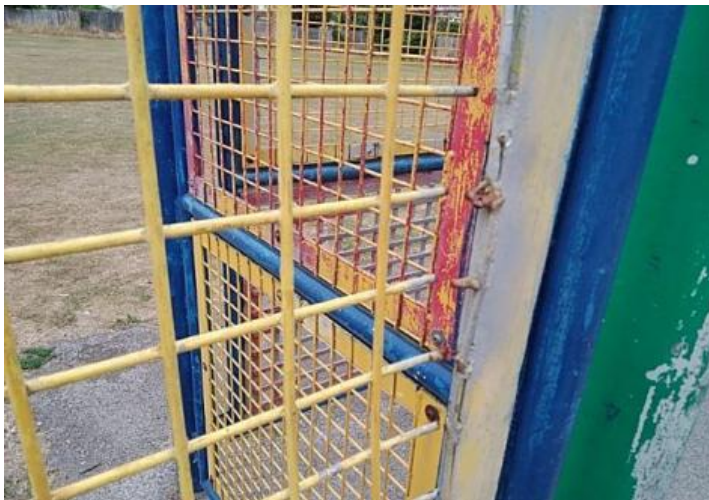
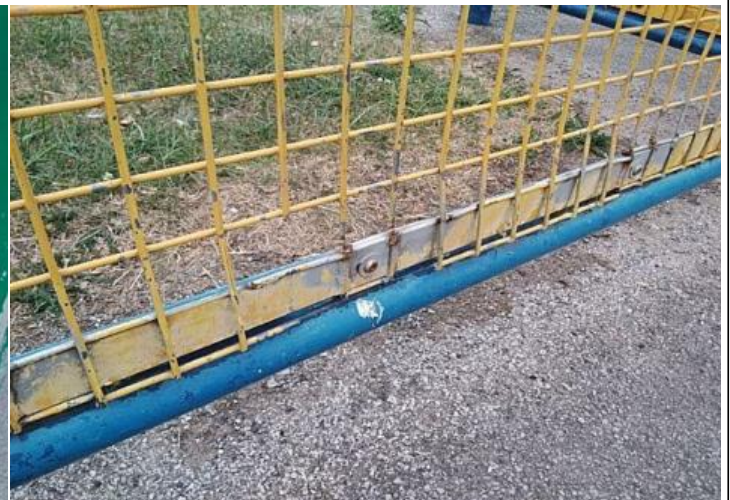
Finding: The weld(s) on this item have failed

Action: Repair item

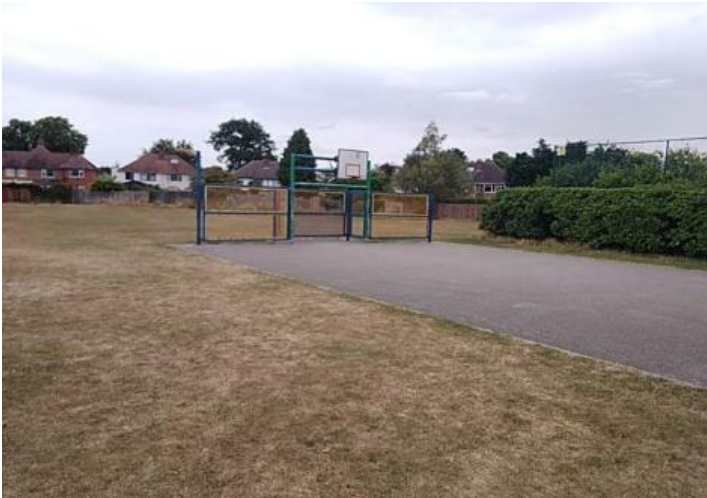
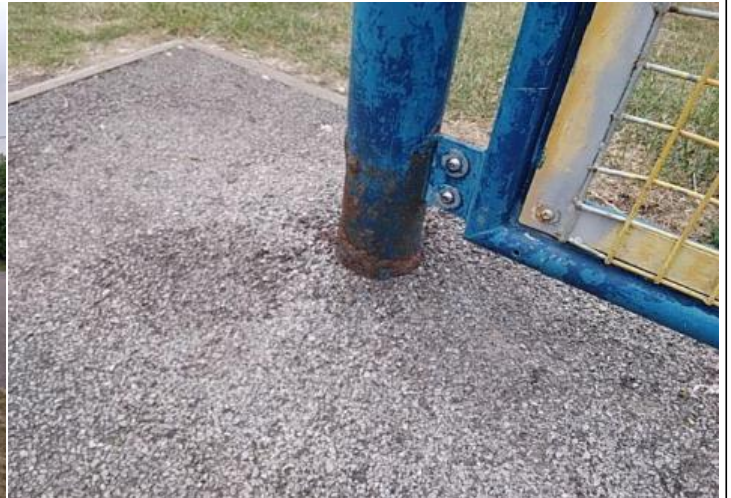
Finding: The paintwork on this item has been damaged or worn exposing the metal underneath which is rusting

Action: Treat any rusting components and repaint

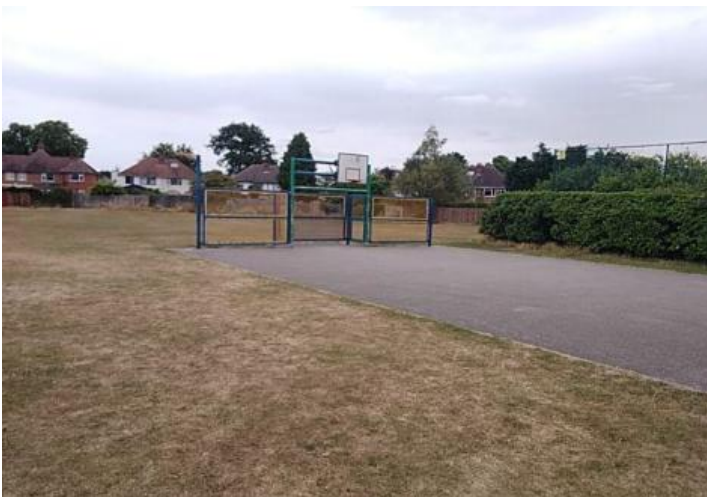
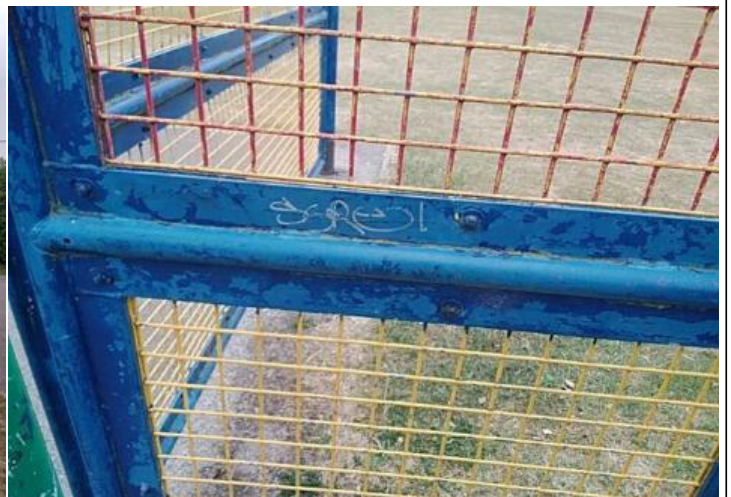
Finding: There is some graffiti present

Action: Remove the graffiti
