Annual Inspection

North Warwickshire Borough Council

Openfield Croft

Inspection Ref: 1715258

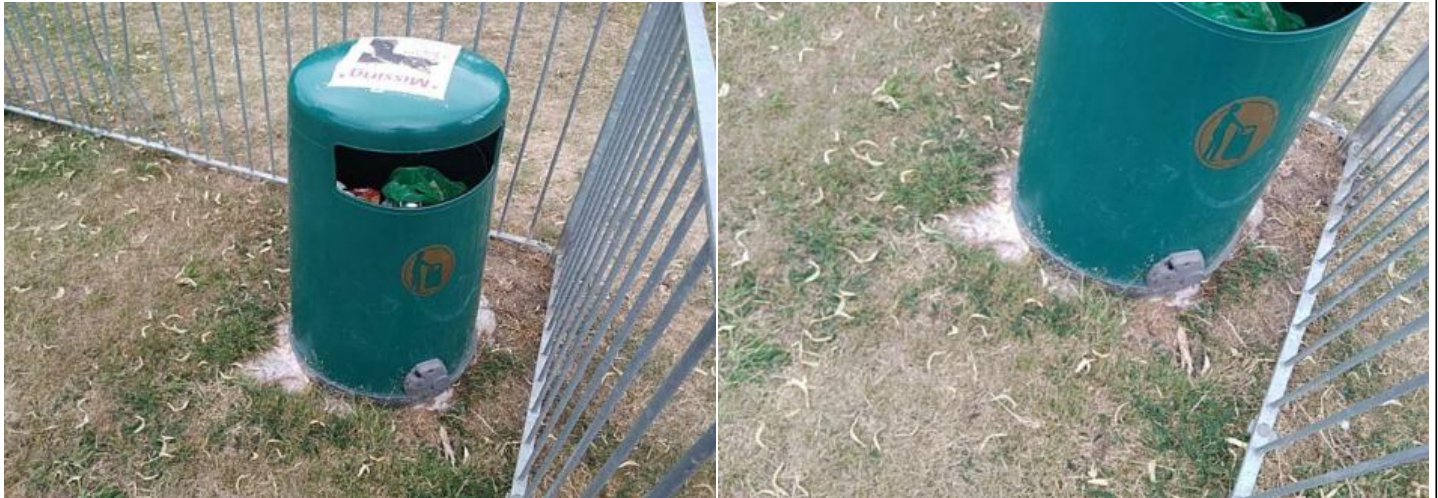
Finding: The bin is not securely fixed to the surface and there is some possibility of the item tipping or rolling over

Action: Secure the bin to the ground
