the **play inspection** company

Annual Inspection

North Warwickshire Borough Council

Openfield Croft

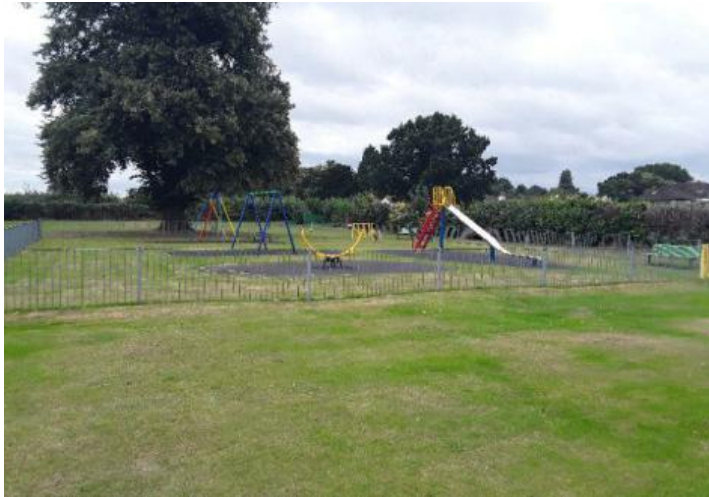
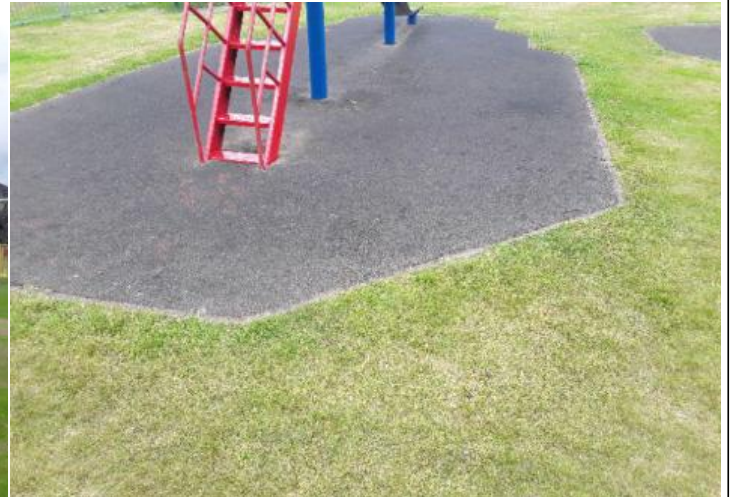
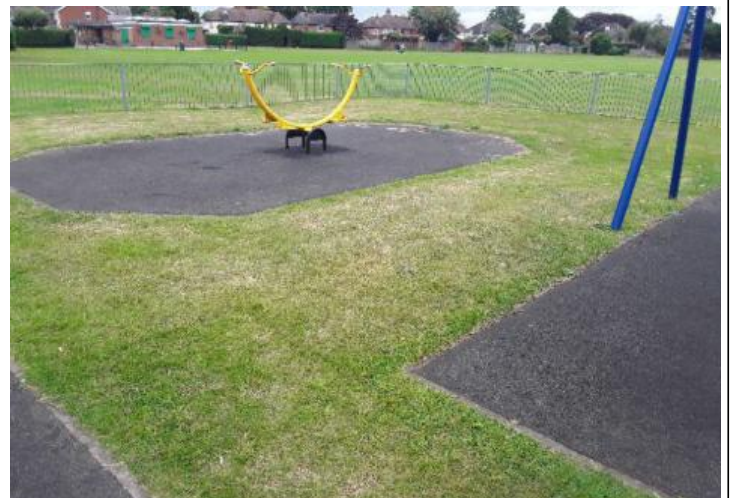
Finding: There are trip hazards at the edges of the surface **Action:** Remove trip hazard

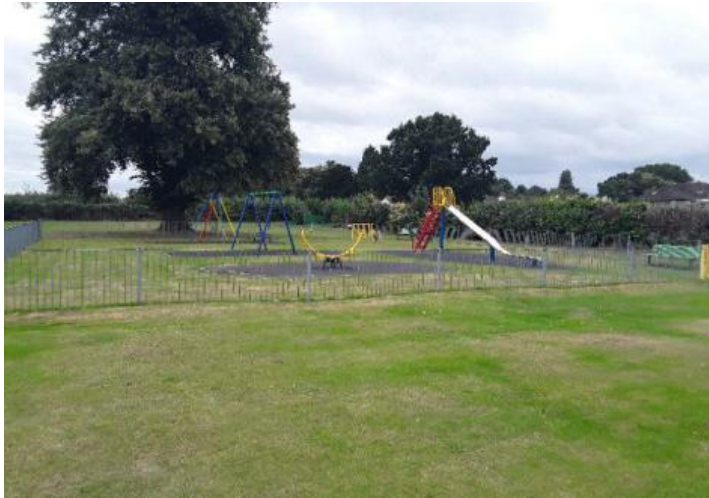
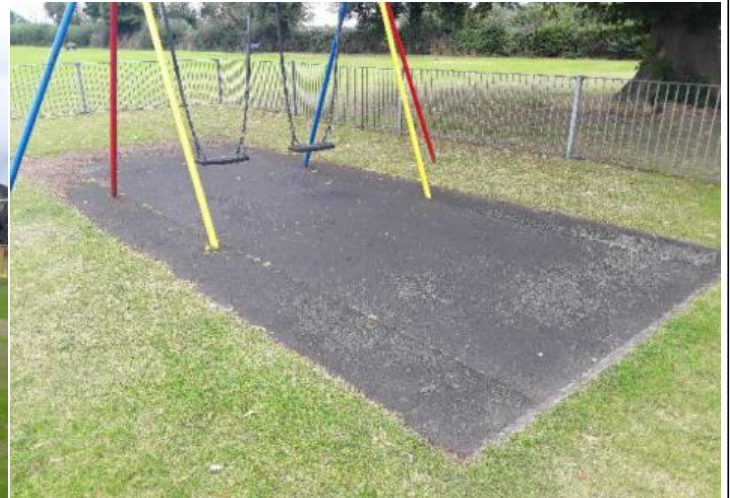
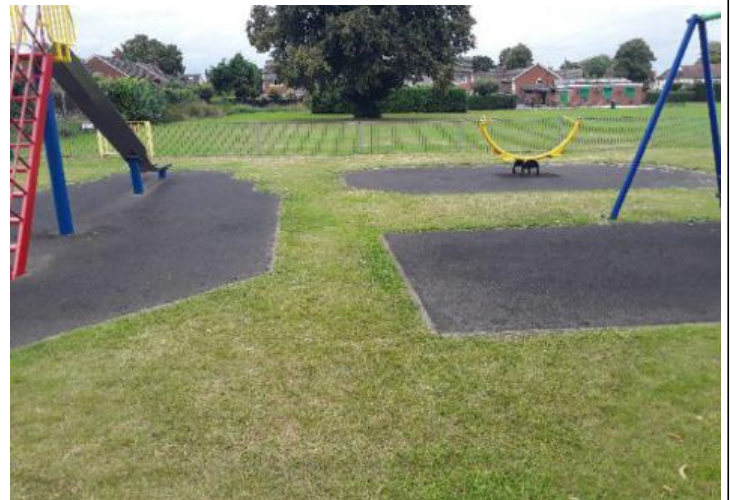
Finding: There is algae, silt or moss growth on the surface resulting in slippery conditions

Action: Clean and treat appropriately

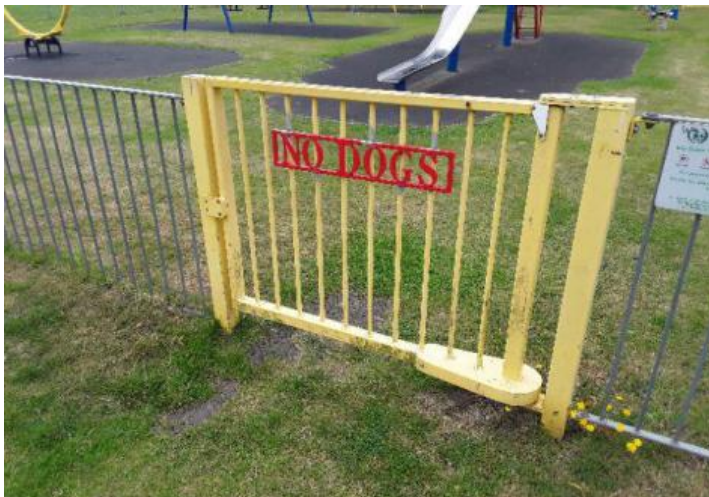
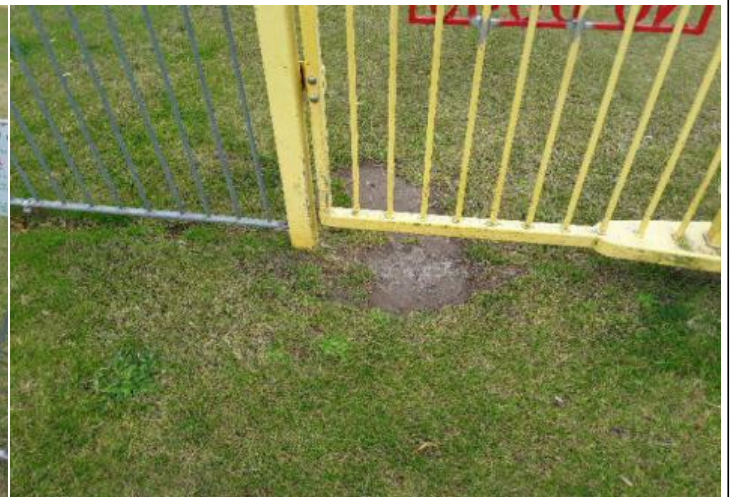
Finding: The area under the gate has eroded leaving uneven areas, or the concrete foundations exposed, resulting in trip hazards at the entrance/exit to the playground

Action: Reinstate to level with surrounding surfaces

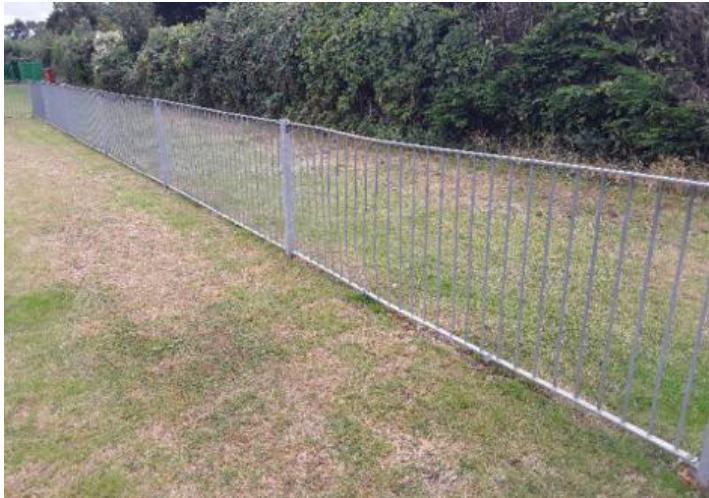
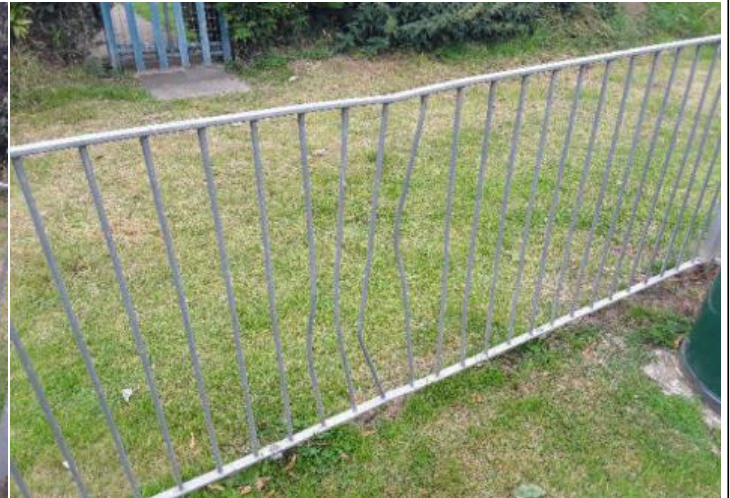
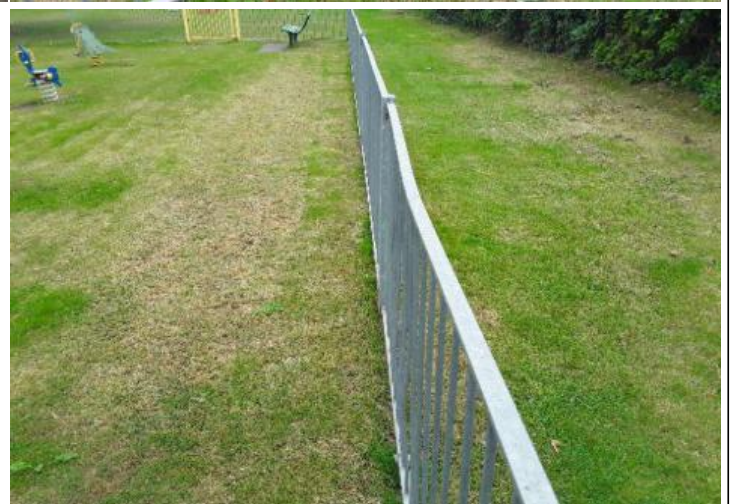
Finding: There is some damage to the fence sections

Action: Monitor for any further deterioration and repair as required

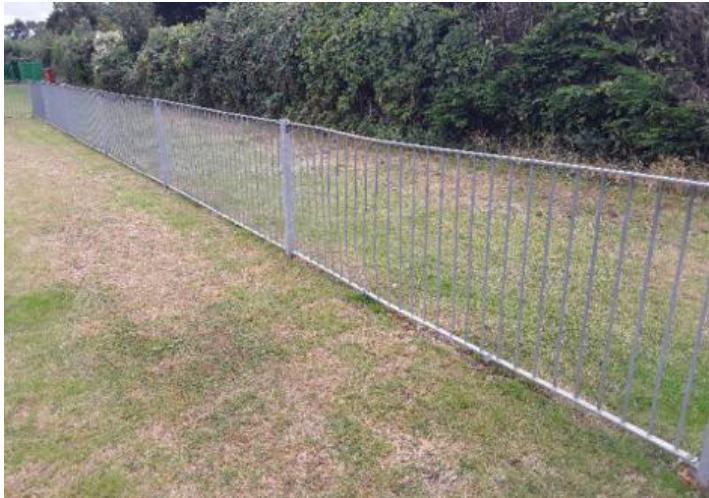
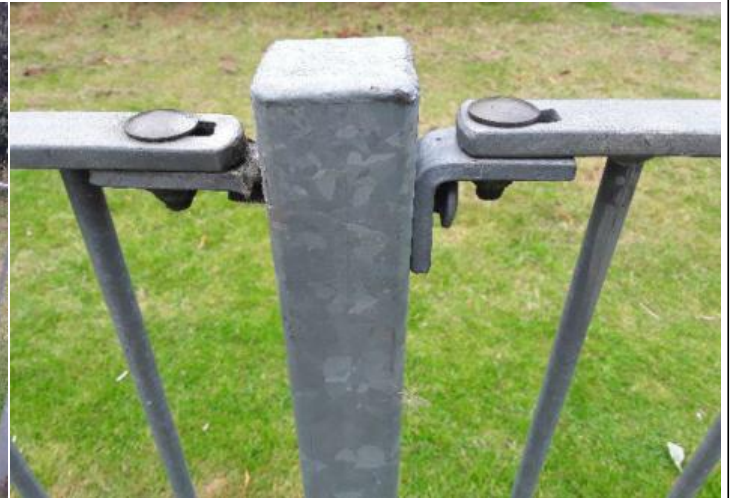
Finding: A number of fixings have worked loose around the fencing
Action: Secure all loose fixings

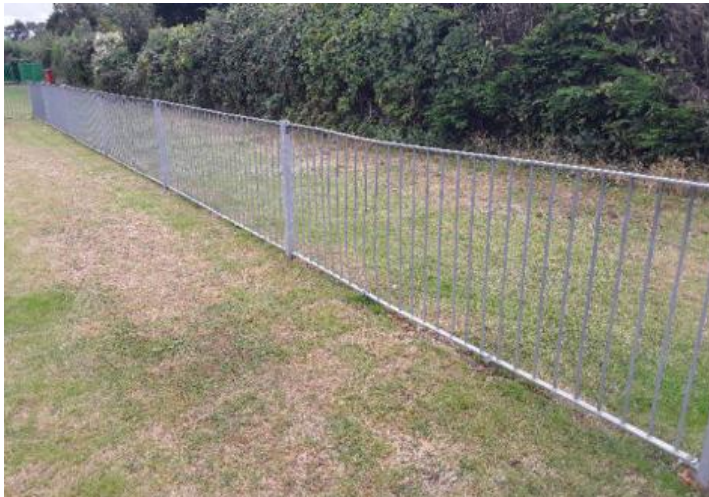
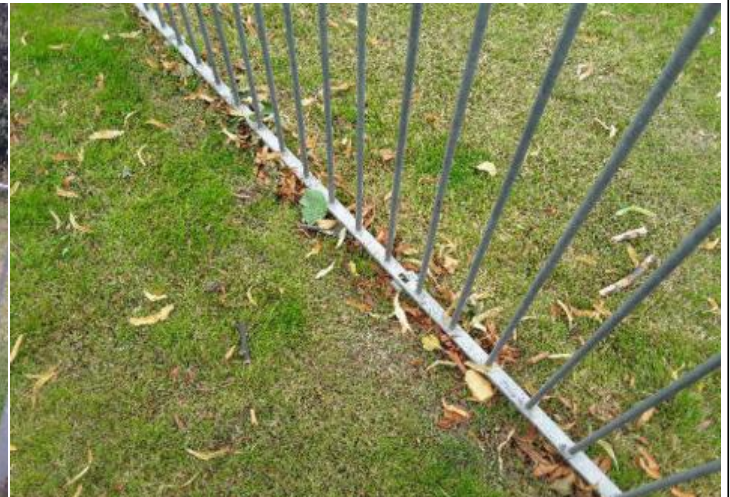
Finding: There are a number of fixings missing from the fence
Action: Replace missing fixings

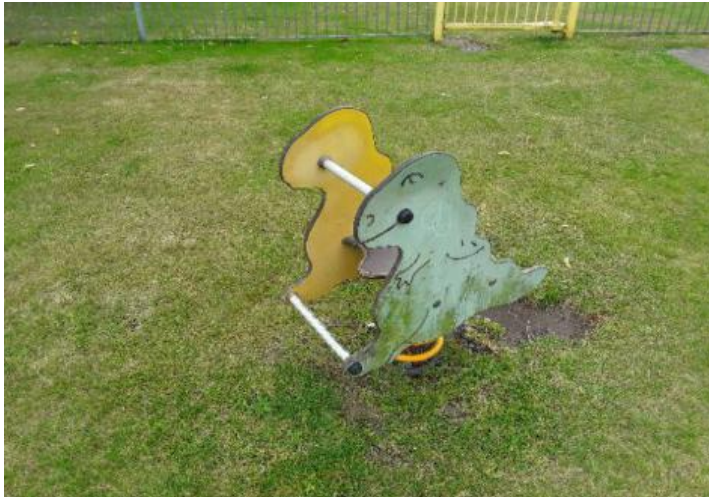
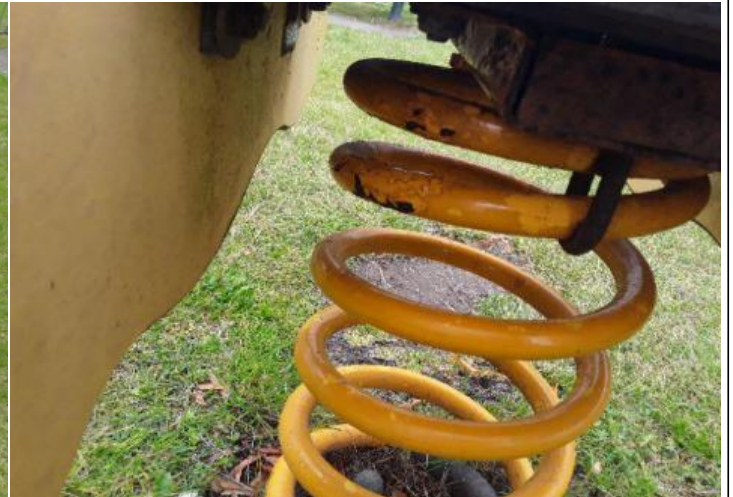
Finding: The paintwork on the spring has been damaged or worn exposing the metal underneath which is rusting

Action: Treat any rusting components and repaint

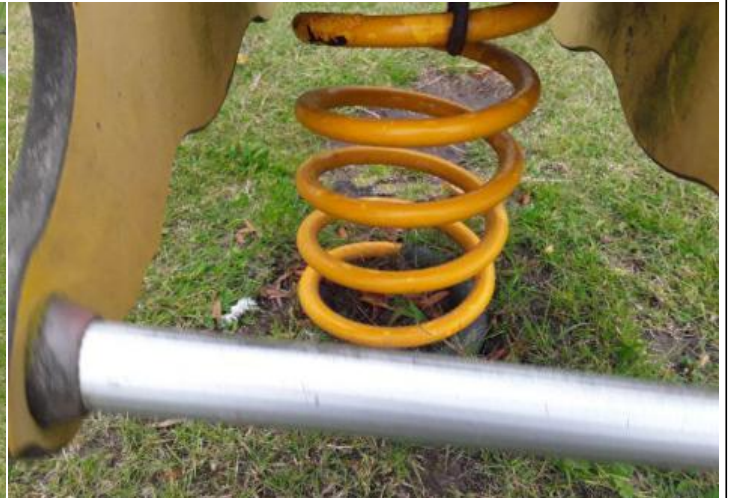
Finding: The item is slightly loose in its foundations

Action: Monitor for any further deterioration and repair as required

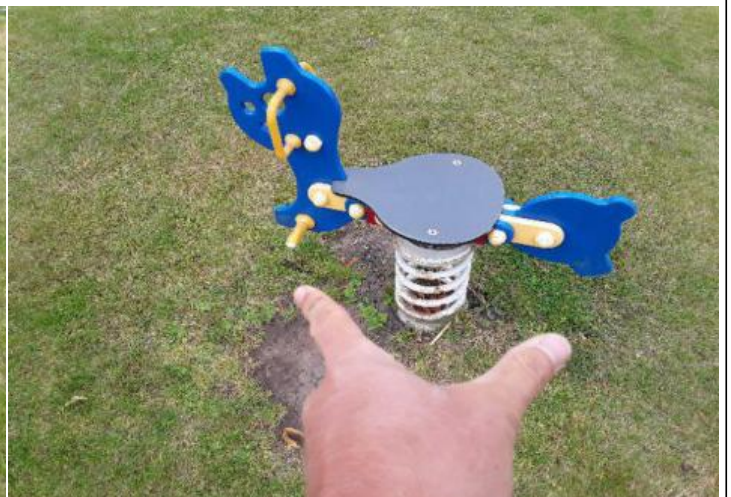
Finding: There is moderate damage to the surface

Action: Repair the damaged areas of surfacing

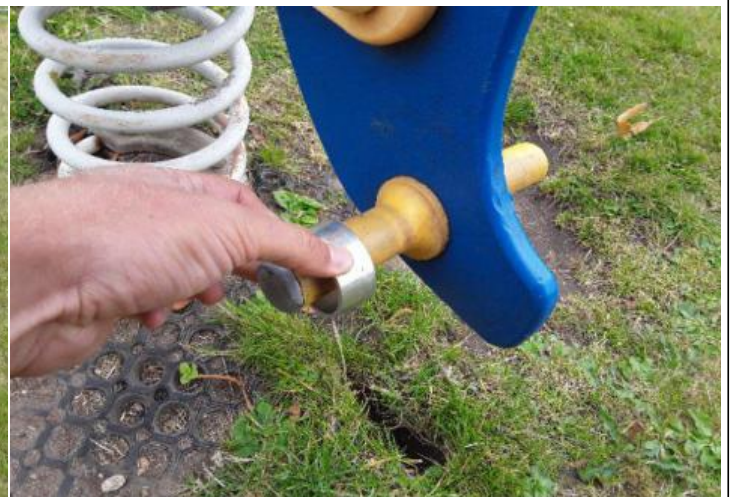
Finding: The end of handgrips and/or footrests have a cross section of less than 15cm² and fail to meet the requirements of BS EN 1176 Part 6 **Action:** Monitor - No remedial work recommended

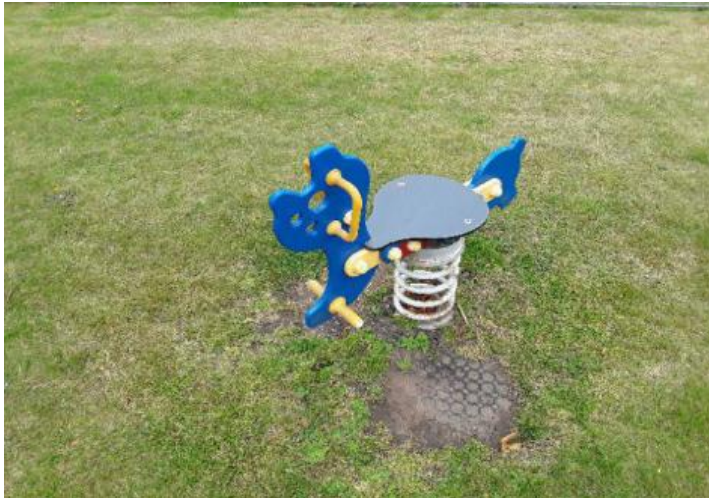
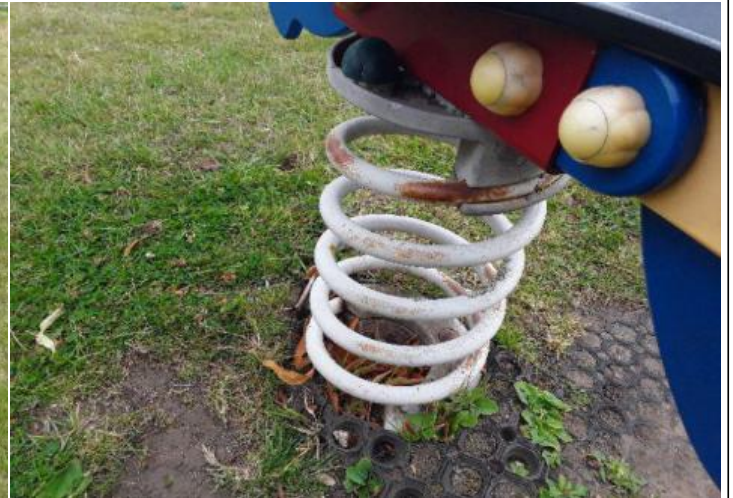
Finding: The paintwork on the spring has been damaged or worn exposing the metal underneath which is rusting
Action: Treat any rusting components and repaint

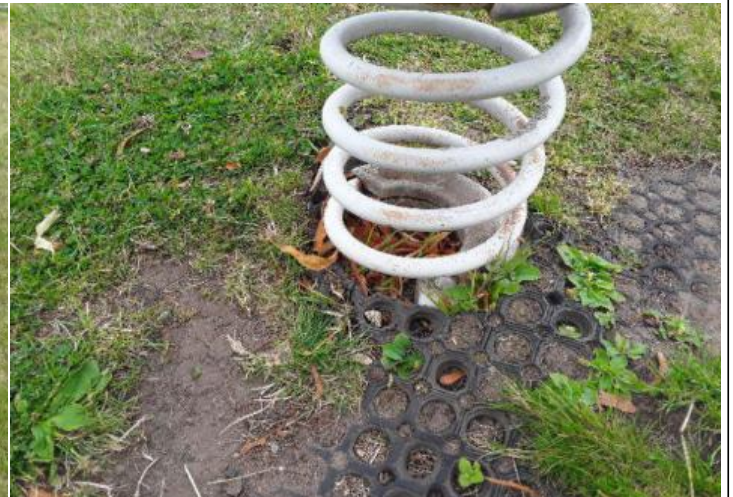
Finding: The item is slightly loose in its foundations
Action: Monitor for any further deterioration and repair as required

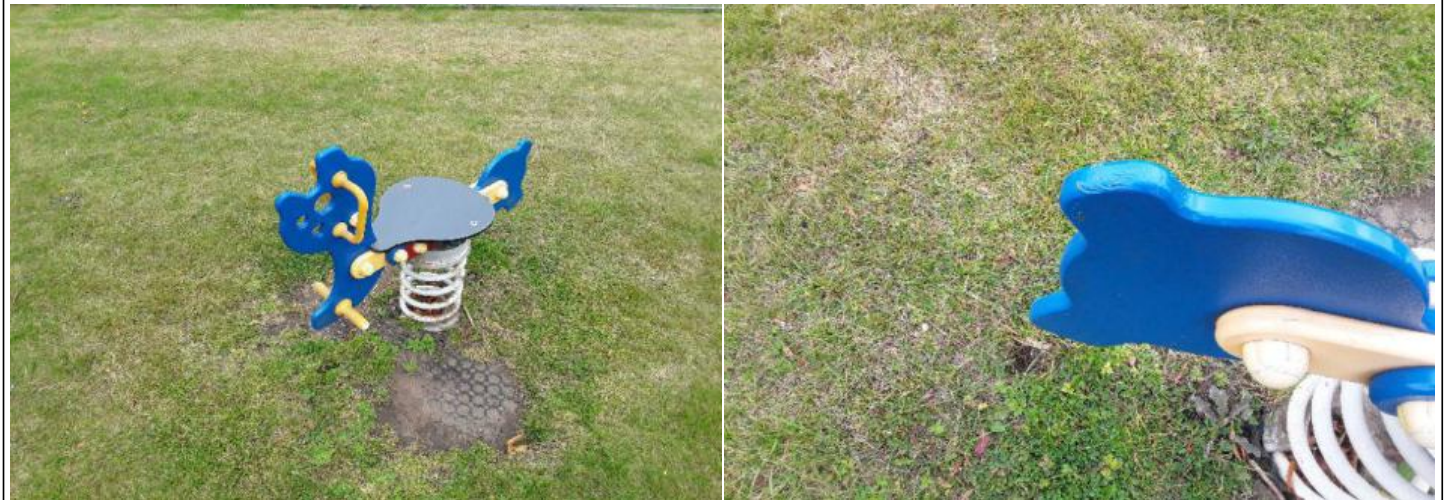
Finding: The item has been damaged
Action: Monitor for any further deterioration and replace as required

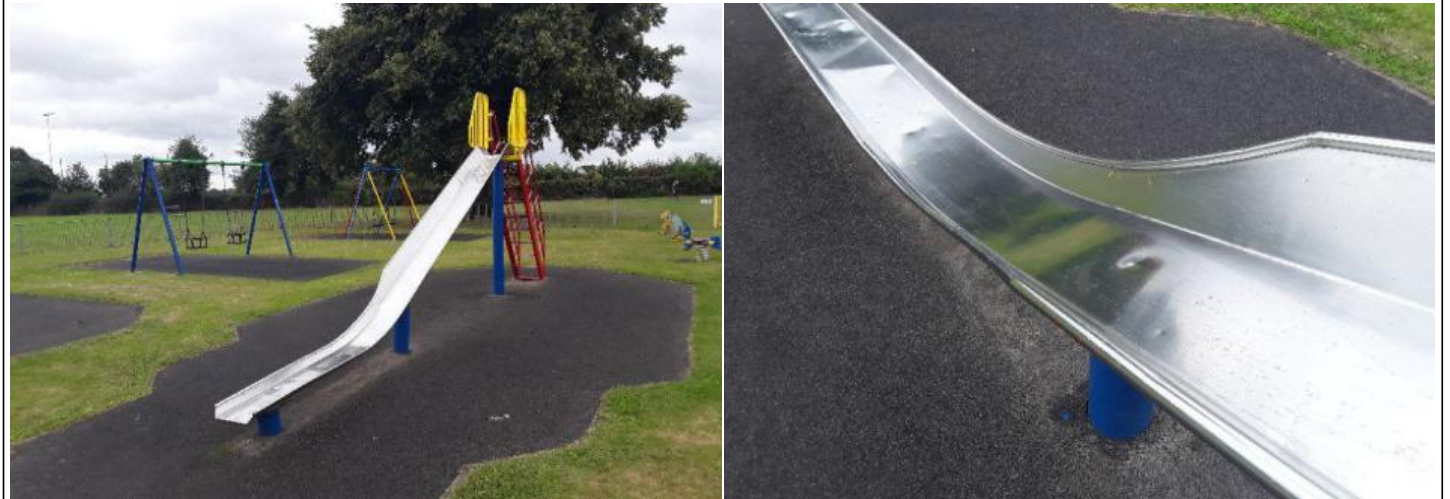
Finding: There are a number of dents in the slide surface
Action: Monitor for any further deterioration and repair as required

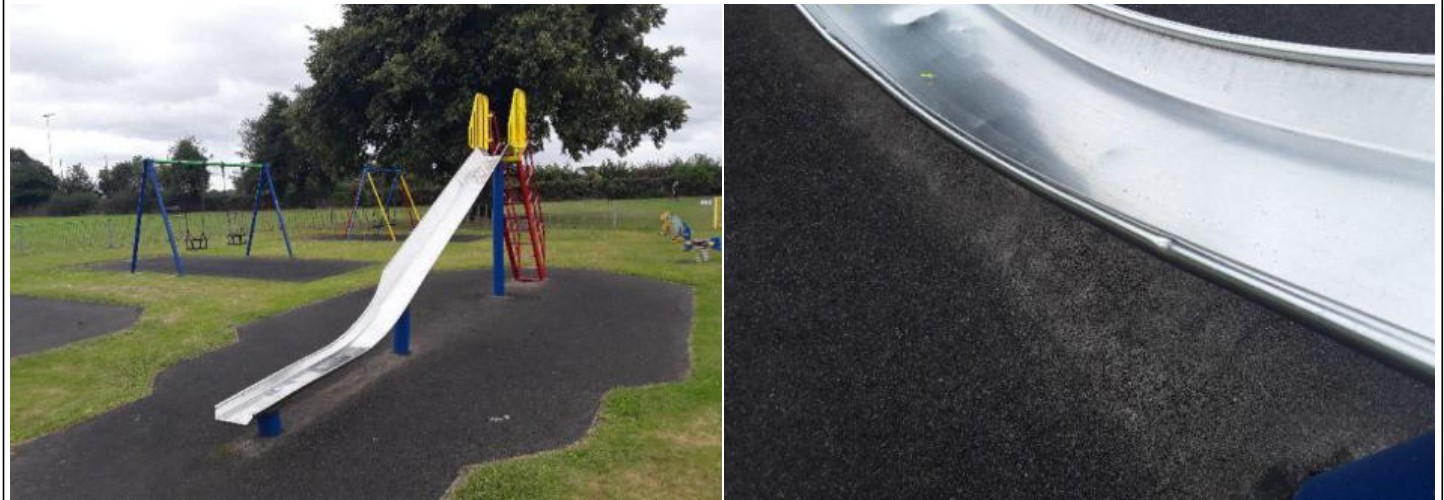
Finding:	The side of the slide is damaged	Action:	Monitor for any further deterioration and repair as required
-----------------	----------------------------------	----------------	--

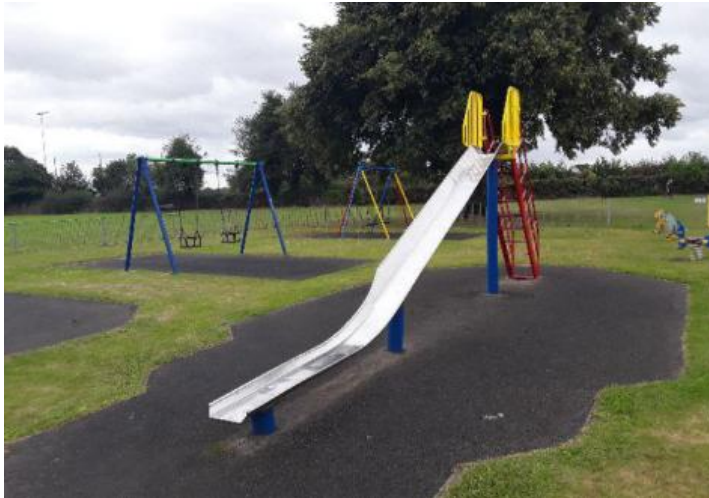
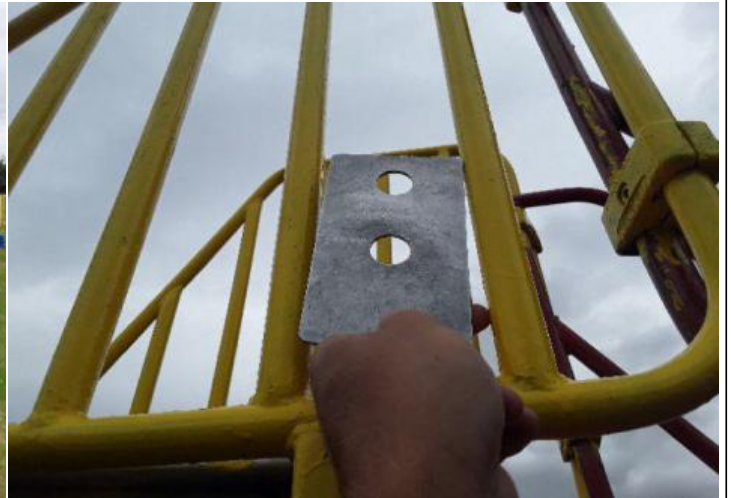
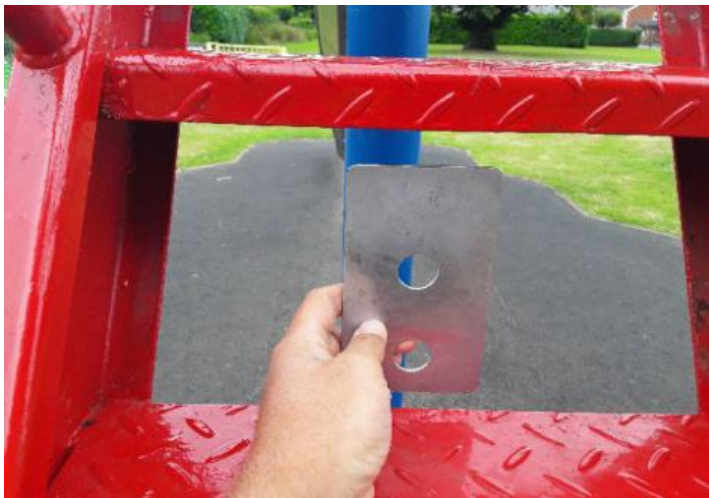
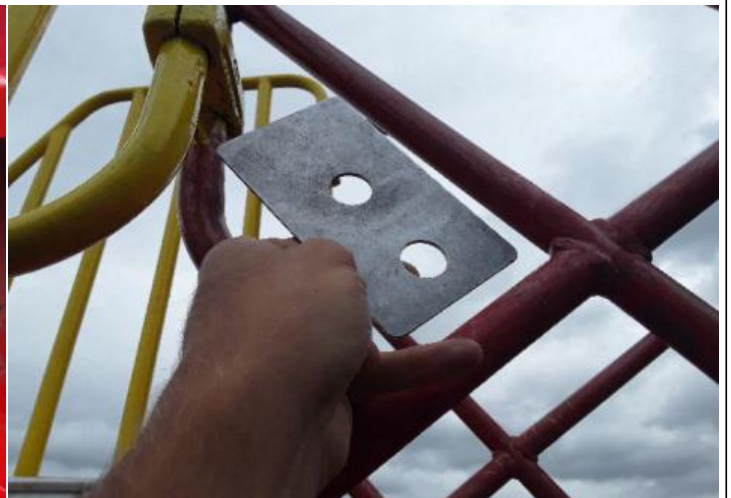
Finding: The item fails to meet the requirements of BS EN 1176 Part 1 4.2.7.2 head and neck entrapment in the barriers and/or steps

Action: Monitor - No remedial work recommended

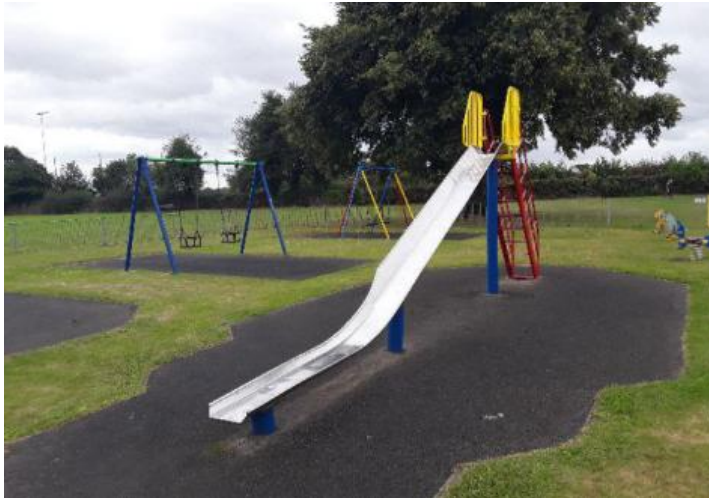
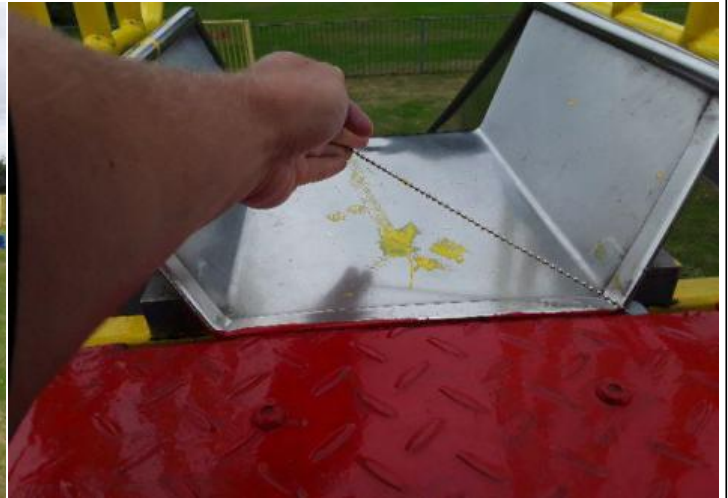
Finding: There is / are toggle entrapment/s present in contravention of the recommendations set out in BS EN 1176 Part 1

Action: Monitor - no remedial work recommended

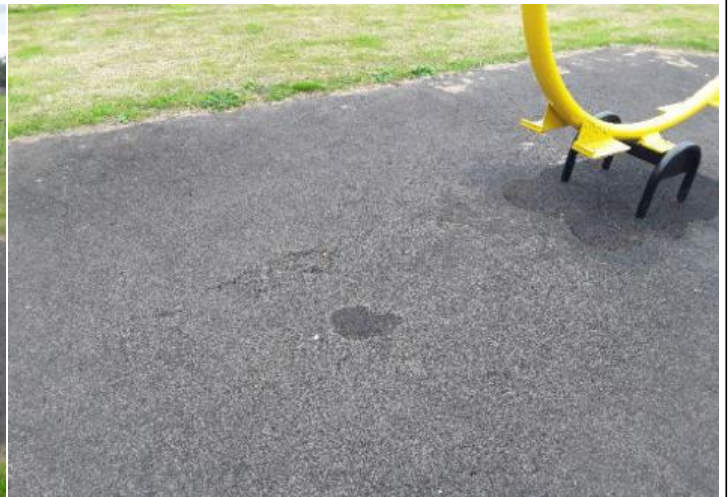
Finding: There is some minor damage to the surface

Action: Monitor for any further deterioration and repair as required

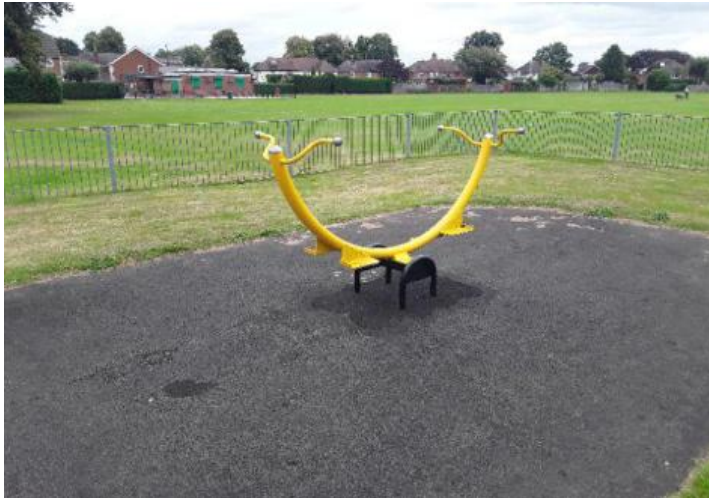
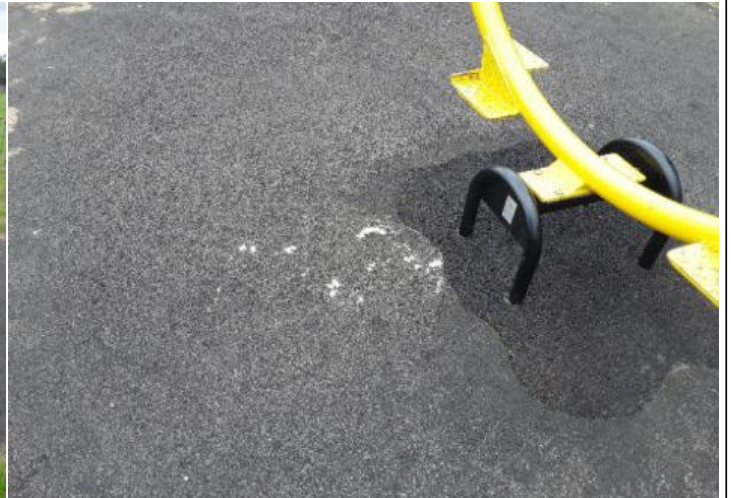
Finding: There is some evidence of fire damage to the surfacing

Action: Repair as required

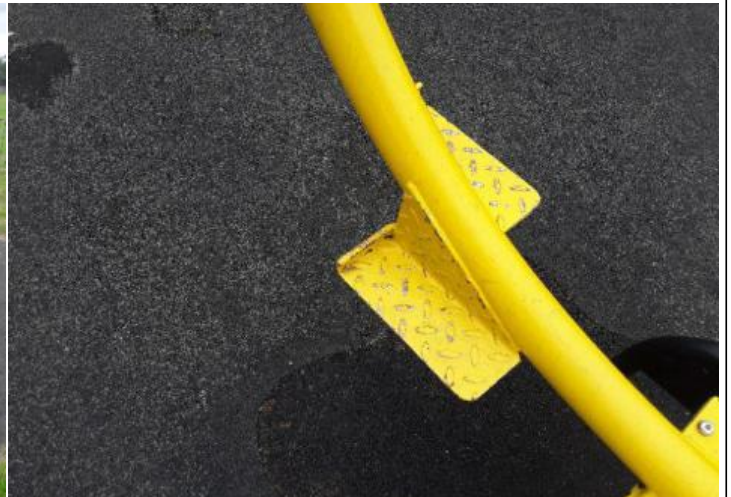
Finding: The paintwork on this item has been damaged or worn exposing the metal underneath which is rusting / corroding

Action: Treat affected areas and repaint

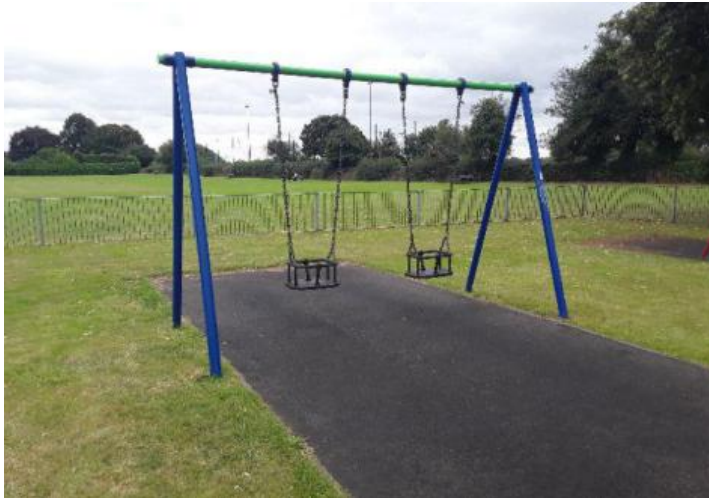
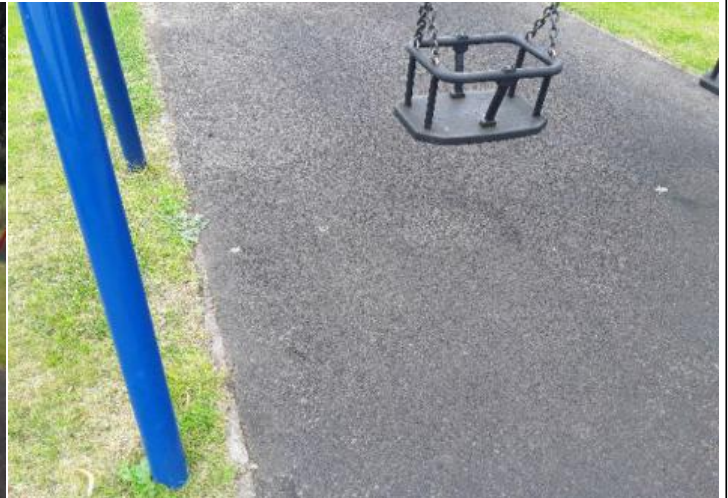
Finding: There is some minor damage to the surface

Action: Monitor for any further deterioration and repair as required

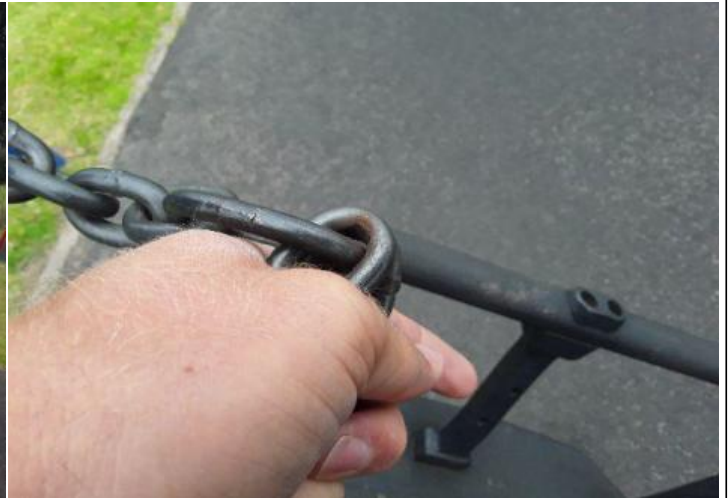
Finding: There is some notable evidence of chain wear

Action: Monitor for any further deterioration and replace when 40% worn

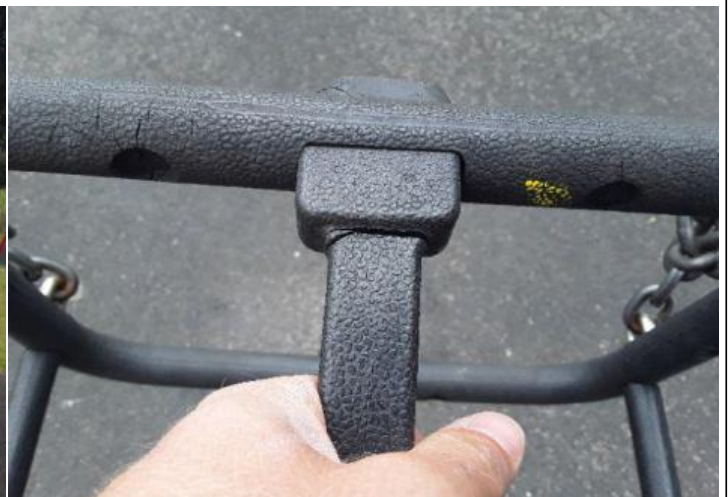
Finding: The seat has minor damage or wear

Action: Monitor for any further deterioration and replace as required

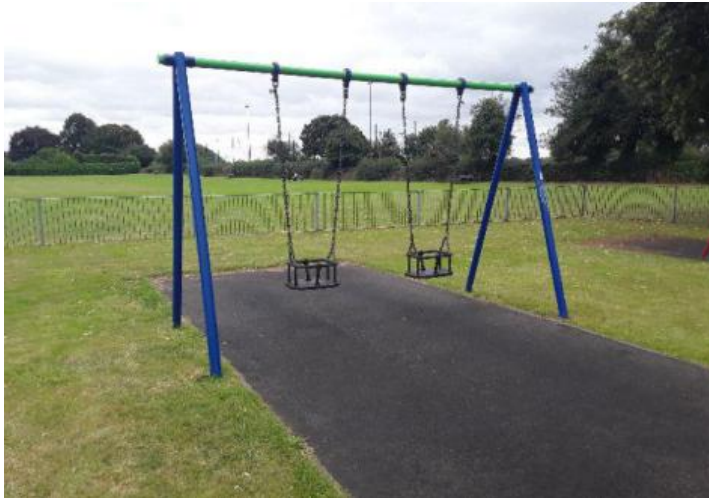
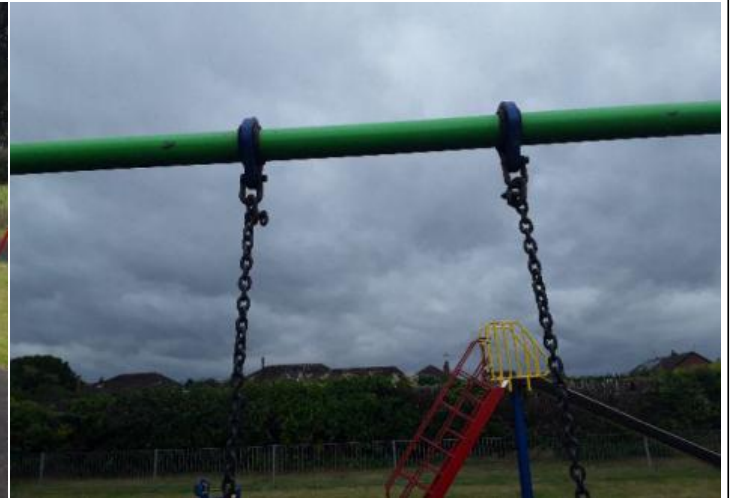
Finding: There is some wear to the shackles

Action: Monitor for any further deterioration and replace when 40% worn

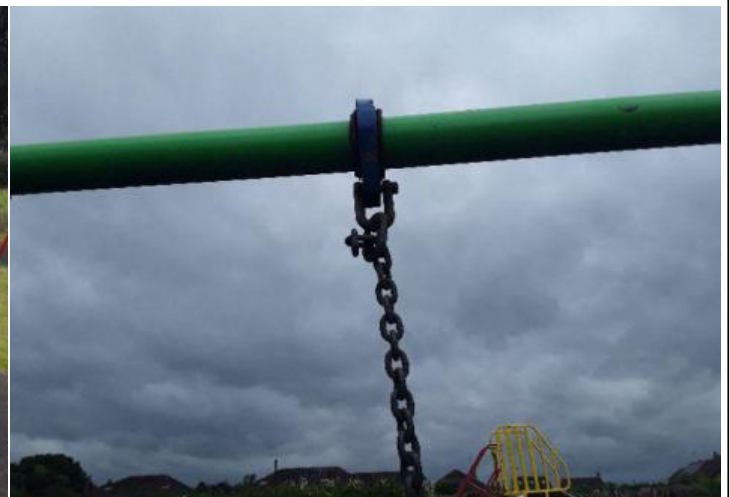
Finding: The bushes are showing signs of wear

Action: Monitor for any further deterioration and replace as required

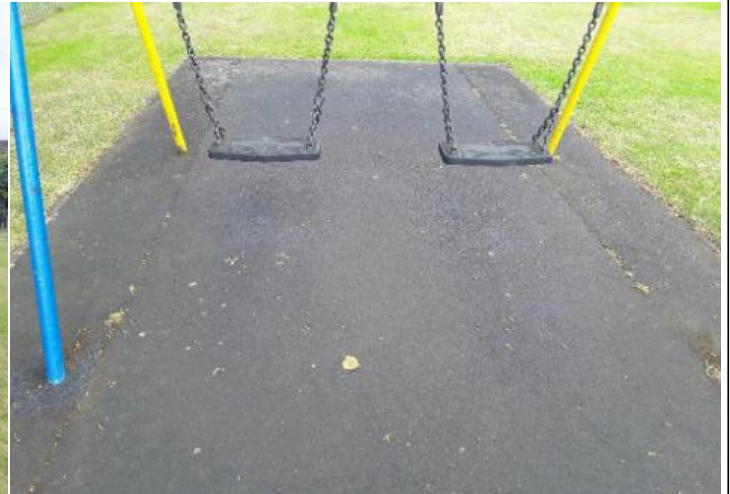
Finding: The safety surface around the area is beginning to wear

Action: Monitor for any further deterioration and repair as required

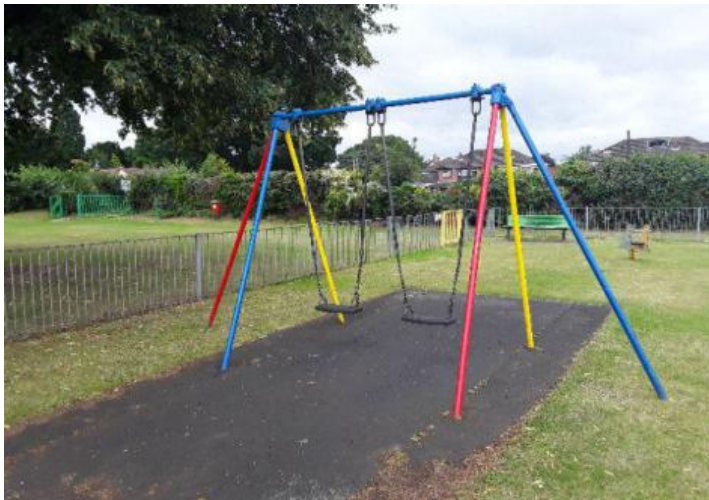
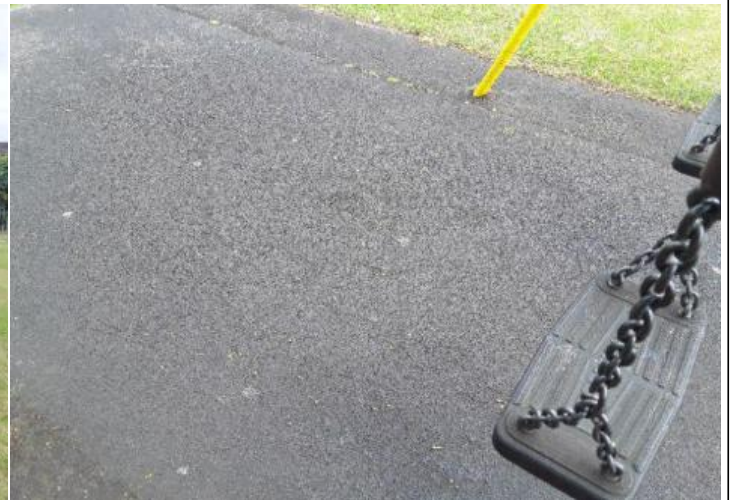
Finding: There is some minor damage to the surface
Action: Monitor for any further deterioration and repair as required

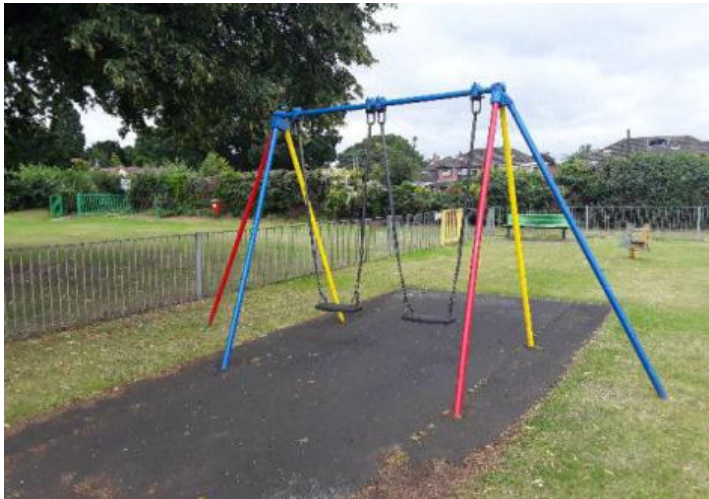
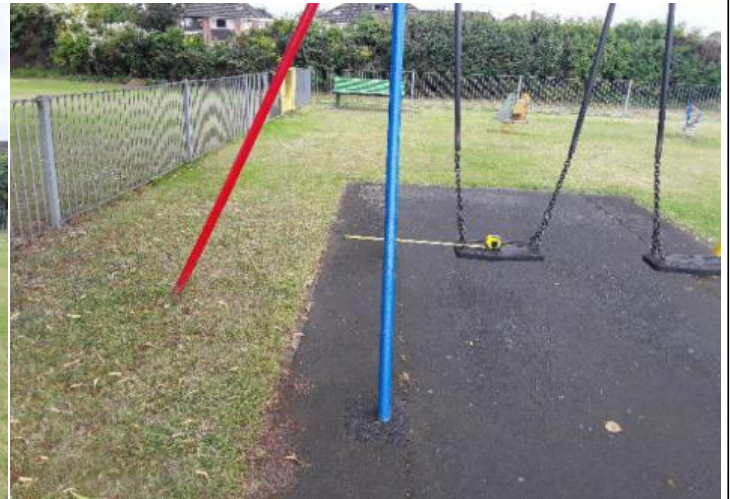
Finding: The seats are too close to the frame as defined in BS EN 1176 Part 2; this is a low risk failure and no remedial action is required
Action: Monitor - No remedial work recommended

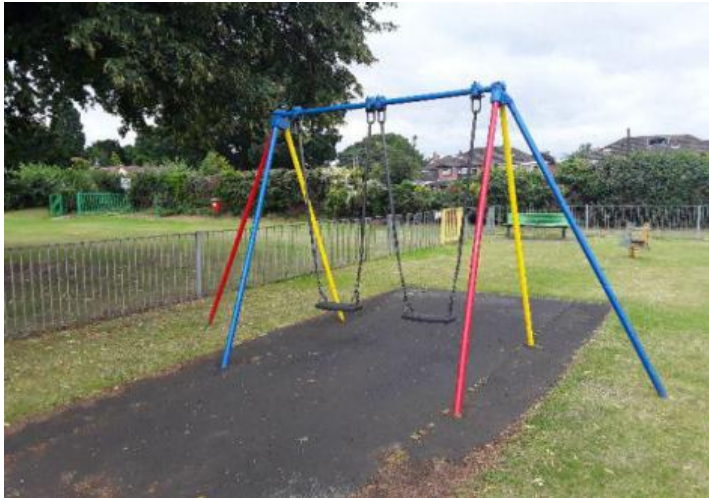
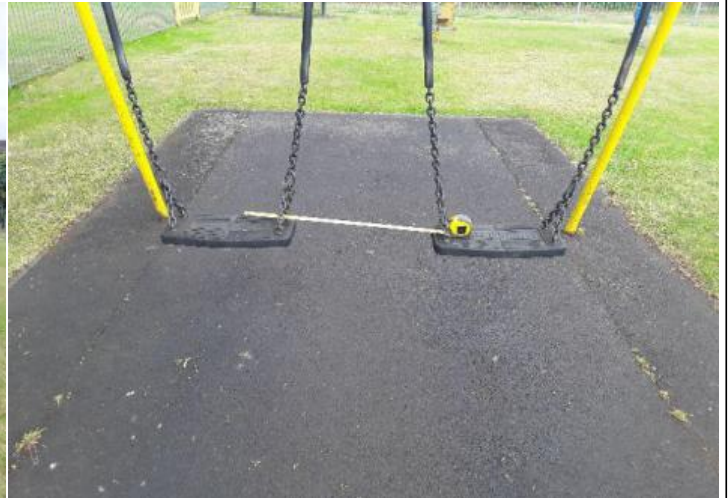
Finding: The seats are too close to each other as defined in BS EN 1176 Part 2; this is a low risk failure and no remedial action is required
Action: Monitor - No remedial work recommended

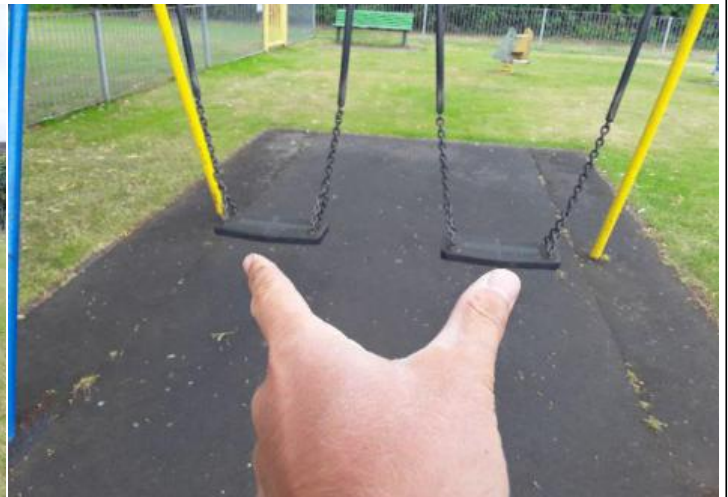
Finding: The swing seat connectors are loose
Action: Tighten to secure

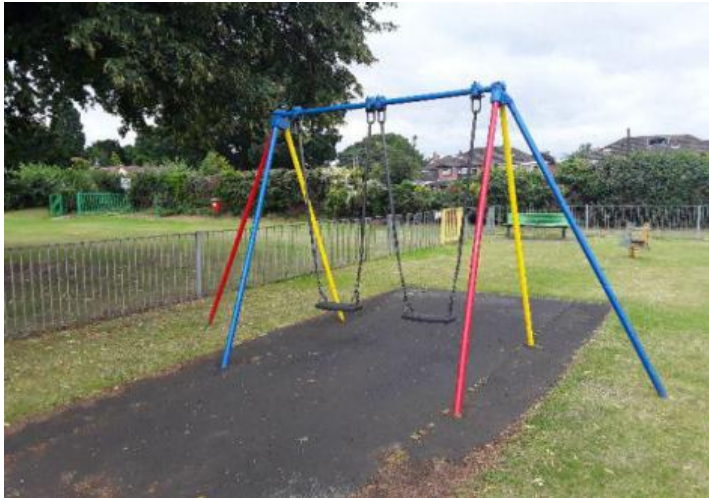
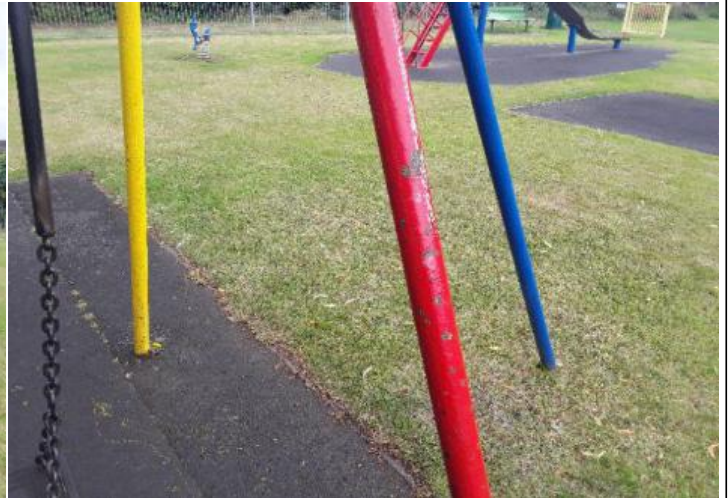
Finding: The paintwork on this item has been damaged or worn exposing the metal underneath which is rusting / corroding

Action: Treat affected areas and repaint

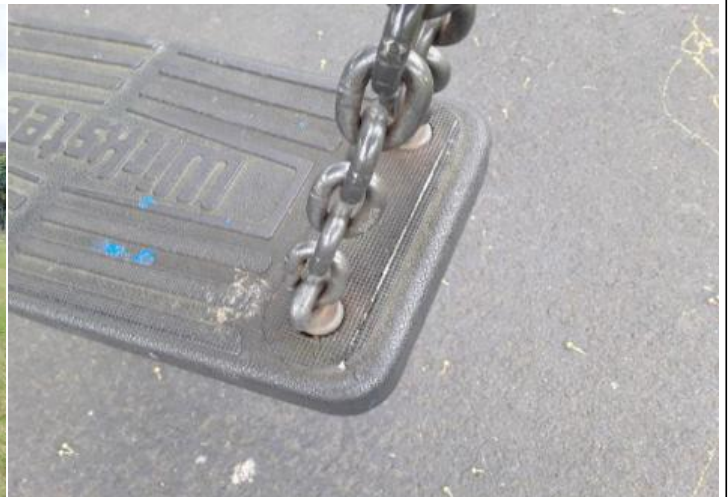
Finding: The seat has minor damage or wear

Action: Monitor for any further deterioration and replace as required

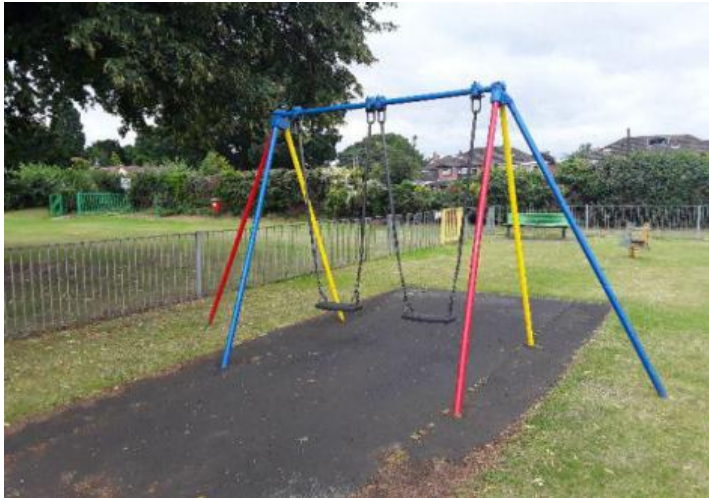
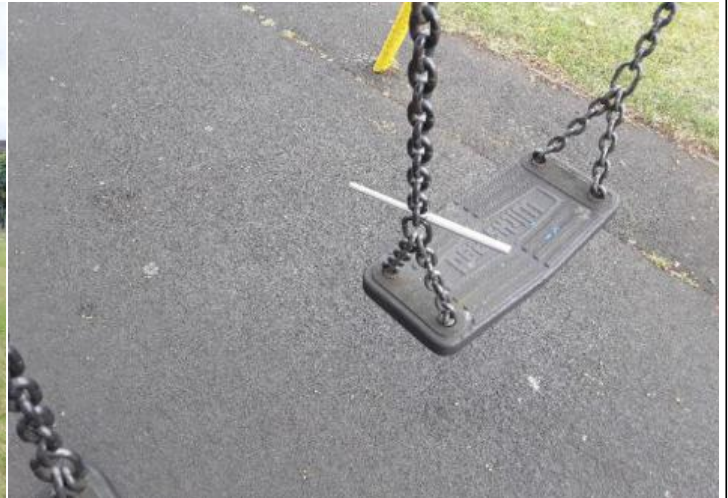
Finding: The chain openings are in excess of 8.6mm and do not meet the recommendations of BS EN 1176 Part 1

Action: Monitor - No remedial work recommended

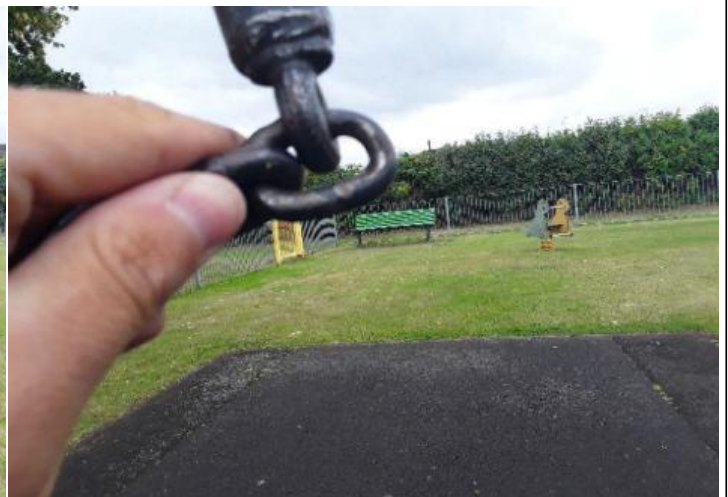
Finding: There is some notable evidence of chain wear

Action: Monitor for any further deterioration and replace when 40% worn
