the **play inspection** company

Annual Inspection

North Warwickshire Borough Council

Openfield Croft

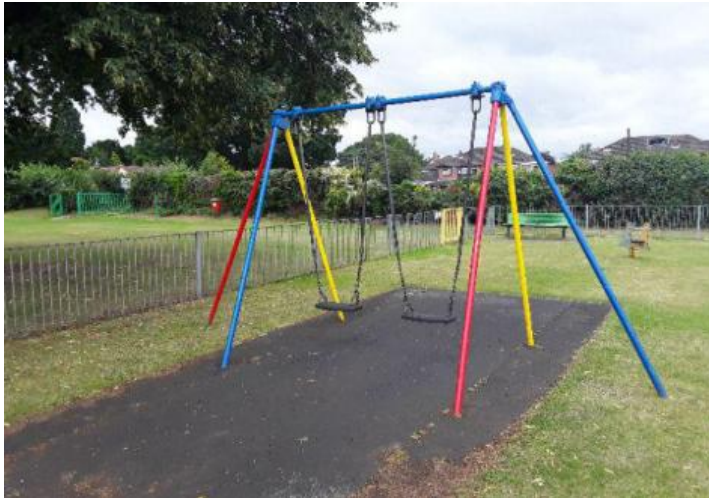
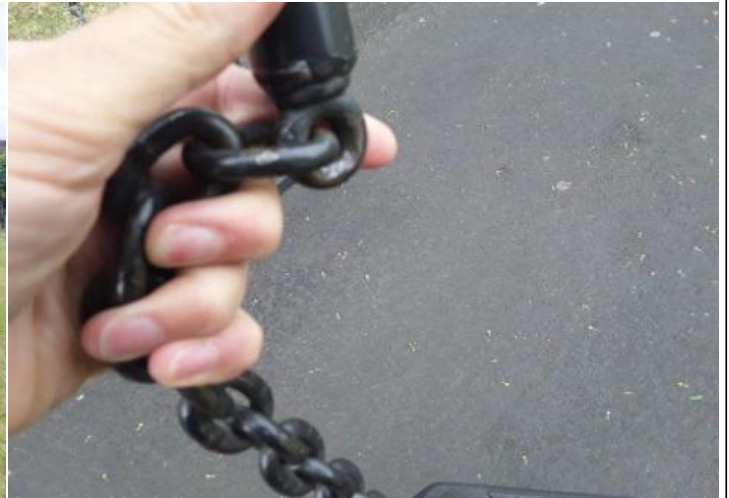
Finding: The connecting lugs are showing signs of wear

Action: Monitor for any further deterioration and repair as required

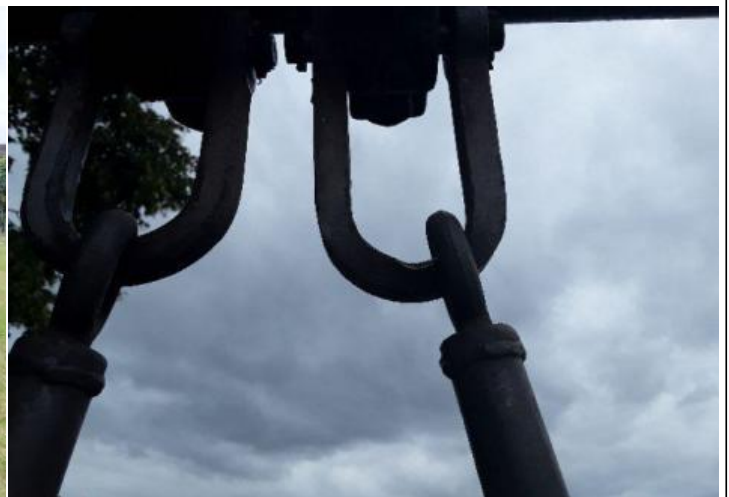
Finding: There is some wear to the shackles

Action: Monitor for any further deterioration and replace when 40% worn

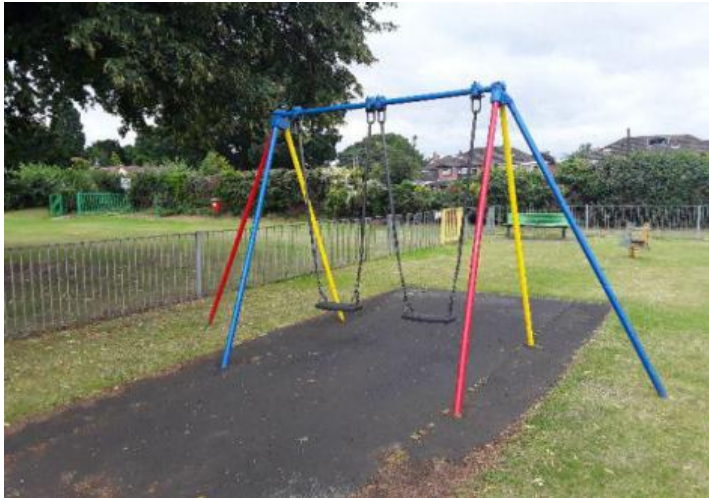
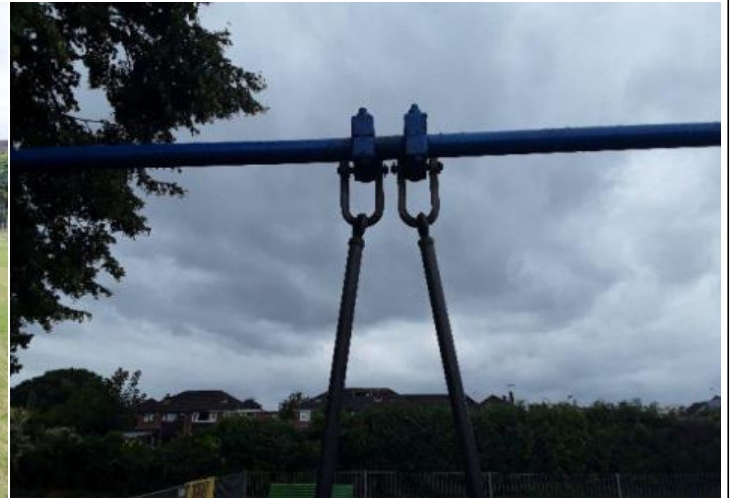
Finding: The bushes are worn or missing

Action: Replace worn or missing bushes

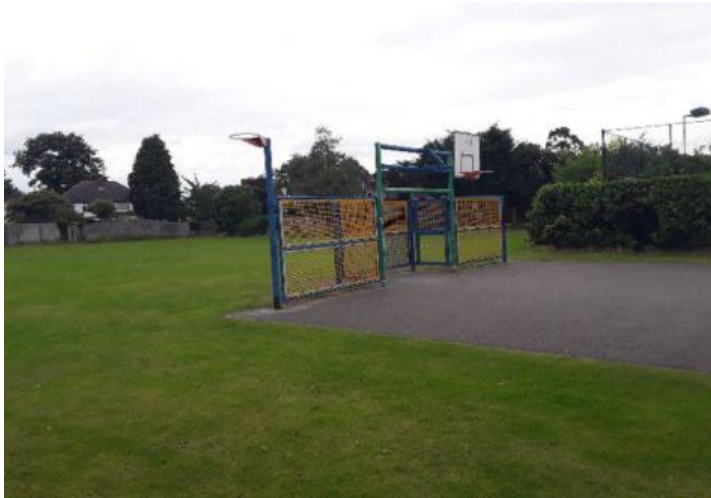
Finding: A clearly visible facility sign should be provided in a prominent position with the wording as detailed BS EN 15312- the equipment is not intended for children less than 3 years old- the warning - Do not climb on the framework or nets- the warning - Do not hang on the ring (if provided)- the warning - Do not wear rings or other jewellery- name and telephone number of the administrator- number to call in case of accident

Action: Provide signage to BS EN 15312

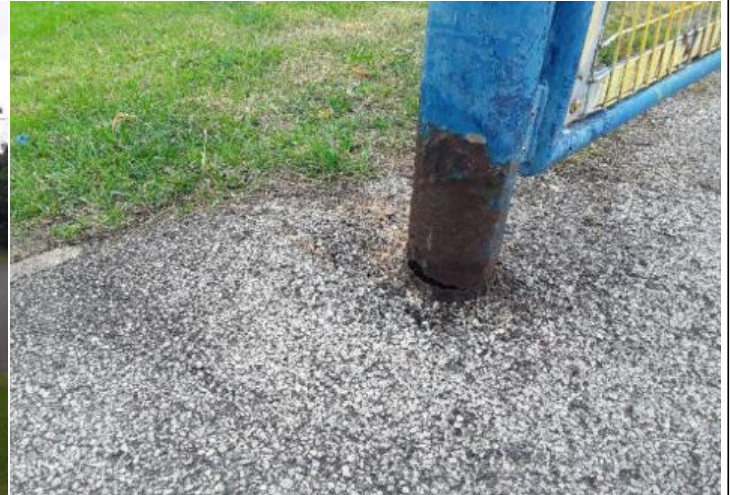
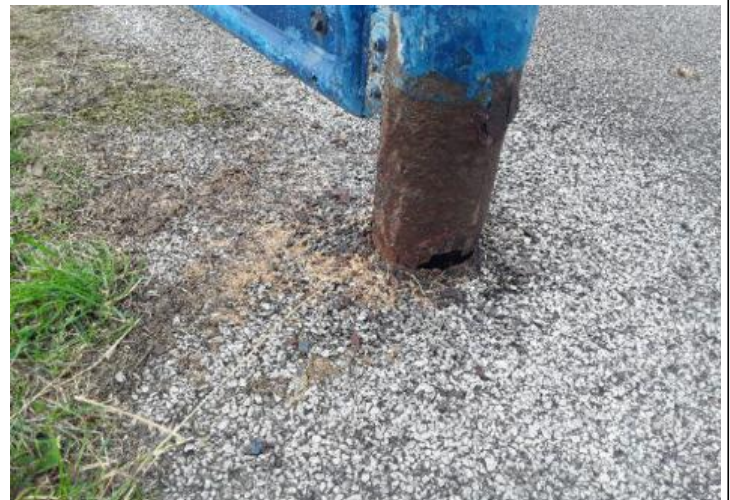
Finding: Parts of the steel on this item have corroded excessively and the metal has perforated in places

Action: Ensure all affected areas are treated and repaired

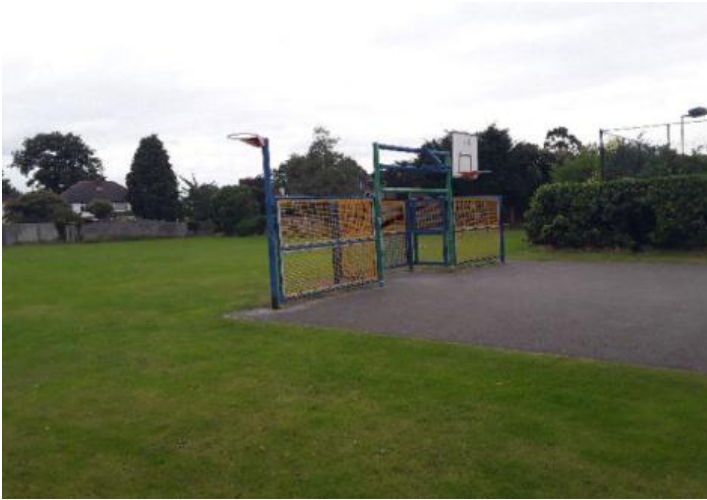
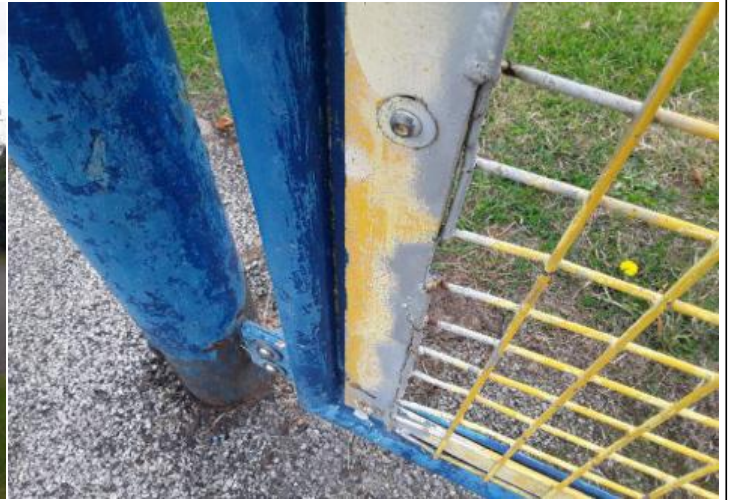
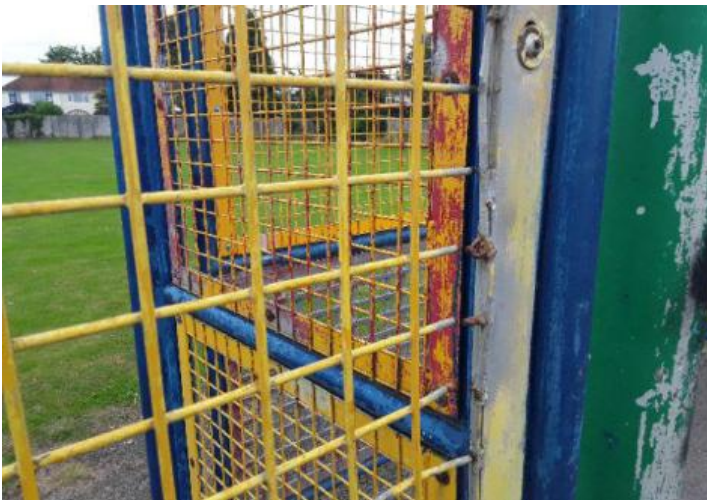
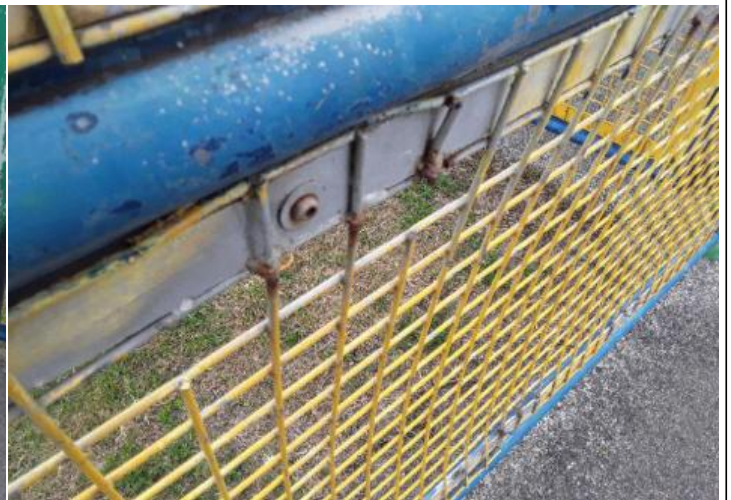
Finding: The weld(s) on this item have failed

Action: Repair item

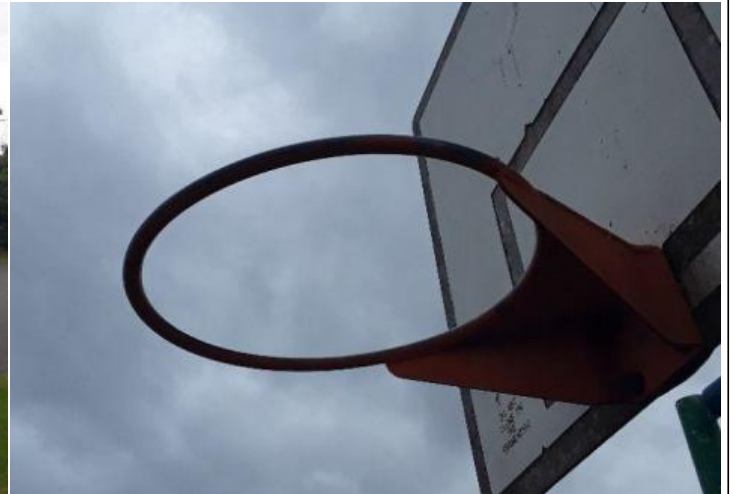
Finding: The paintwork on this item has been damaged or worn exposing the metal underneath which is rusting / corroding

Action: Treat affected areas and repaint
