the **play inspection** company

Annual Inspection

North Warwickshire Borough Council

Vicarage Lane

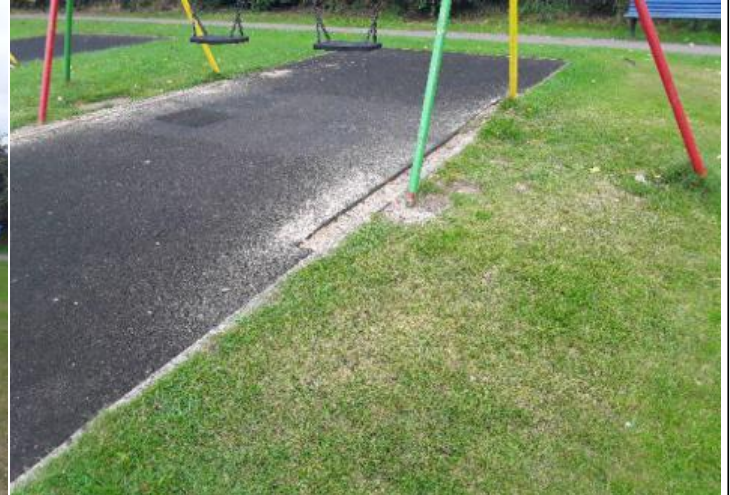
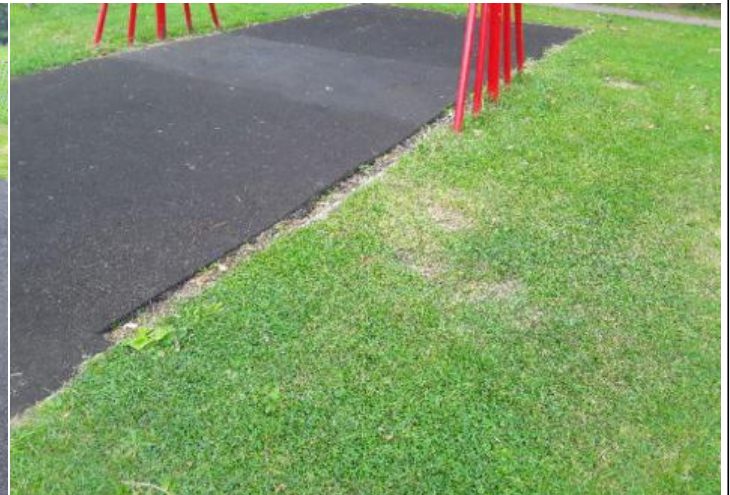
There are trip hazards at the edges of the surface - Remove trip hazard

Finding: There are trip hazards at the edges of the surface **Action:** Remove trip hazard

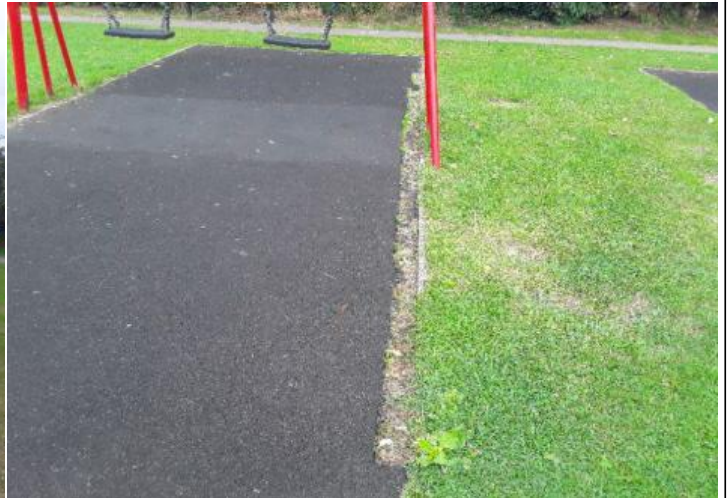
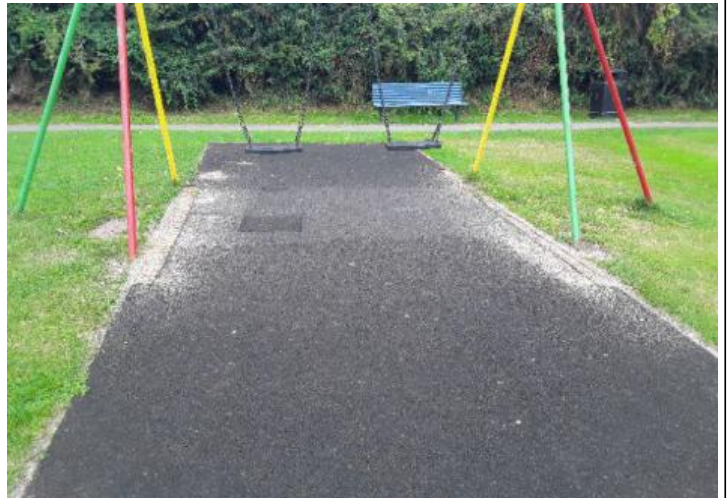
There are significant gaps (over 30mm) between the surface and the edging or between the joints in the surface; these are large enough for a small foot to enter - Repair surfacing

Finding: There are significant gaps (over 30mm) between the surface and the edging or between the joints in the surface; these are large enough for a small foot to enter

Action: Repair surfacing

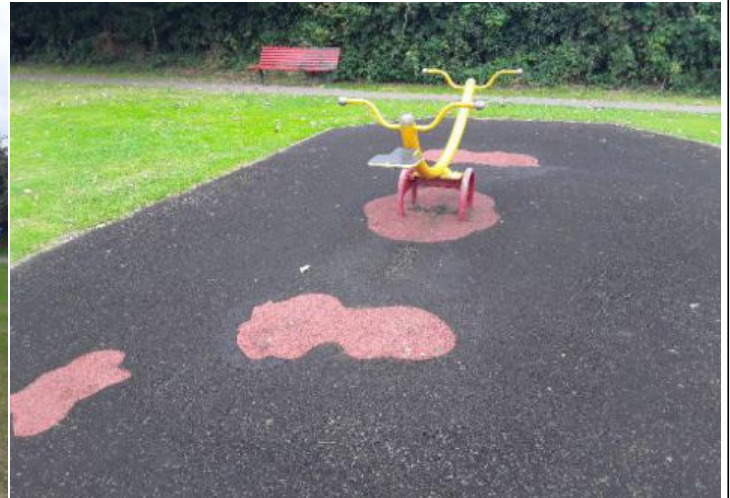
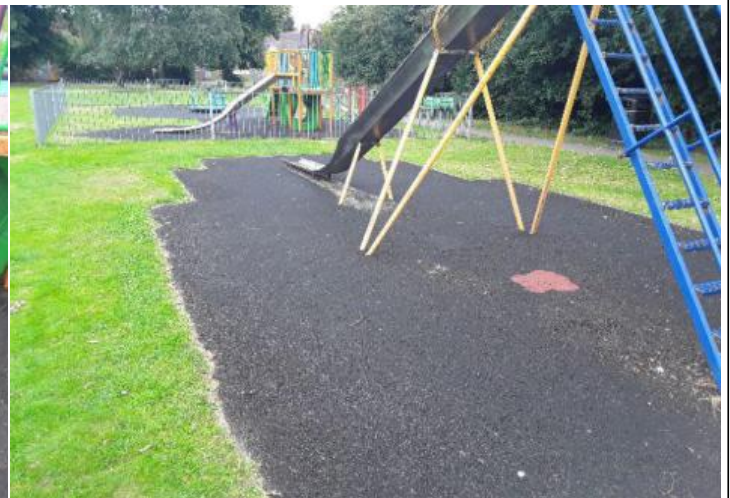
There is algae, silt or moss growth on the surface resulting in slippery conditions - Clean and treat appropriately

Finding: There is algae, silt or moss growth on the surface resulting in slippery conditions

Action: Clean and treat appropriately

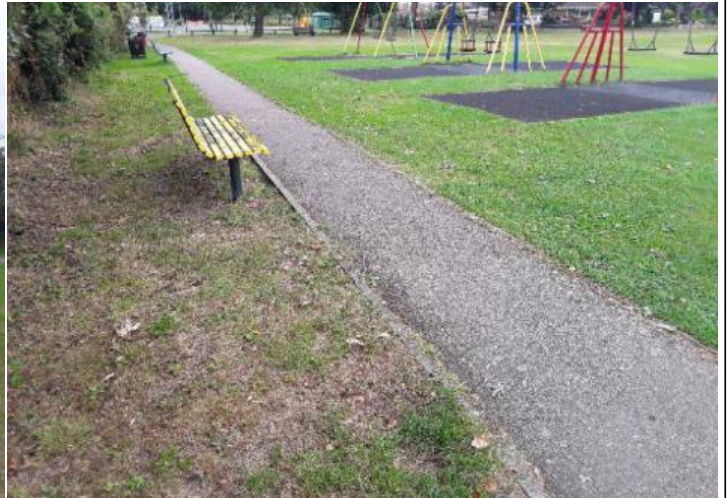
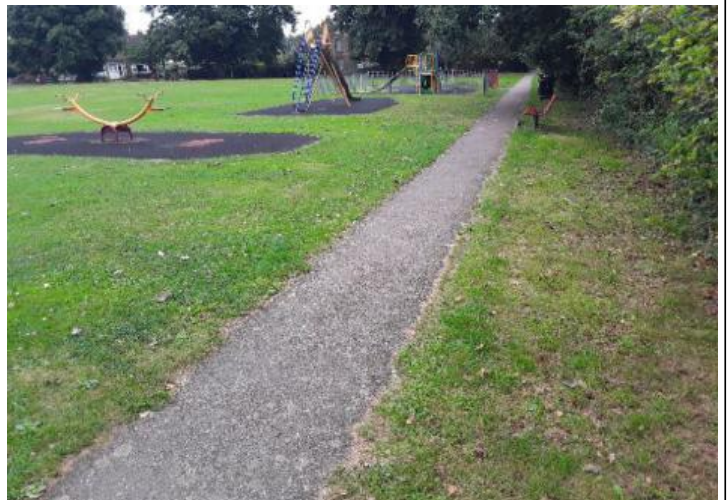
There are trip hazards present - Remove trip hazard

Finding: There are trip hazards present

Action: Remove trip hazard

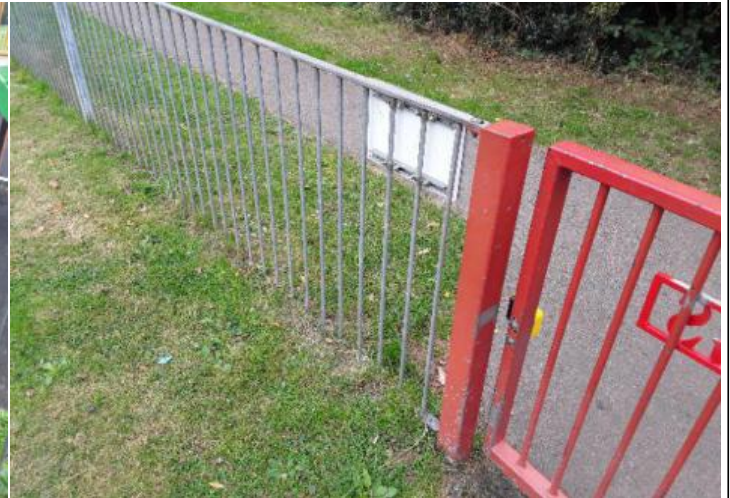
There are a number of loose posts around the fence - Monitor for any further deterioration and reset as required

Finding: There are a number of loose posts around the fence

Action: Monitor for any further deterioration and reset as required

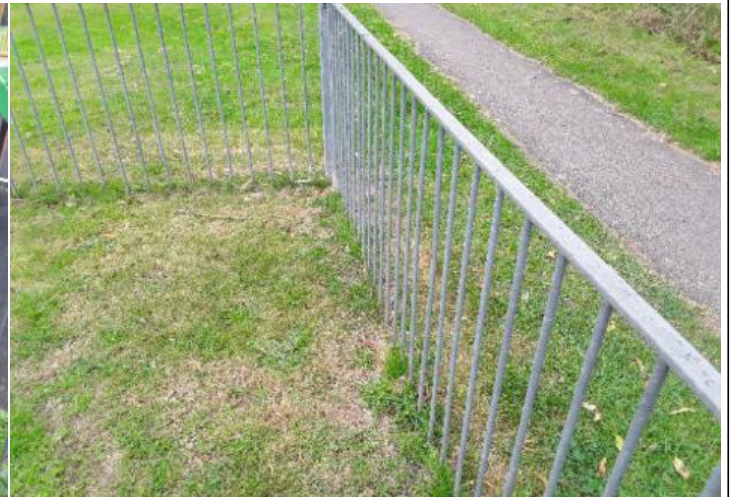
There is some damage to the fence sections - Monitor for any further deterioration and repair as required

Finding: There is some damage to the fence sections

Action: Monitor for any further deterioration and repair as required

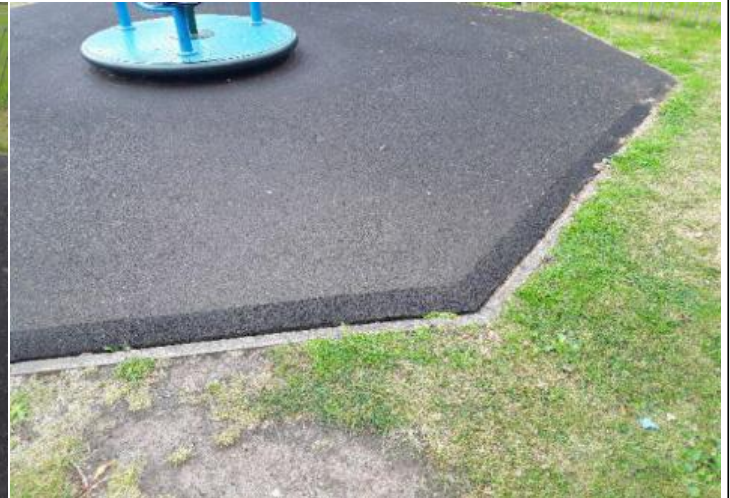
The surface is lifting at the edges and creating trip points -
Repair perimeter of surfacing to remove trip points

Finding: The surface is lifting at the edges and creating trip points
Action: Repair perimeter of surfacing to remove trip points

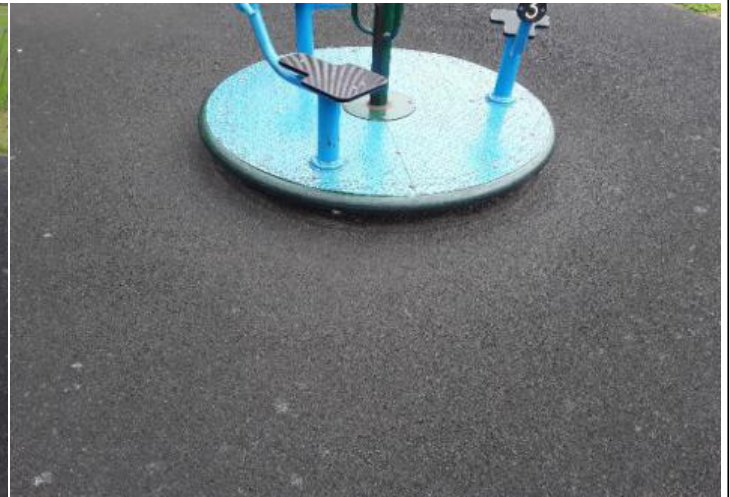
The safety surface around the area is beginning to wear -
Monitor for any further deterioration and repair as required

Finding: The safety surface around the area is beginning to wear
Action: Monitor for any further deterioration and repair as required

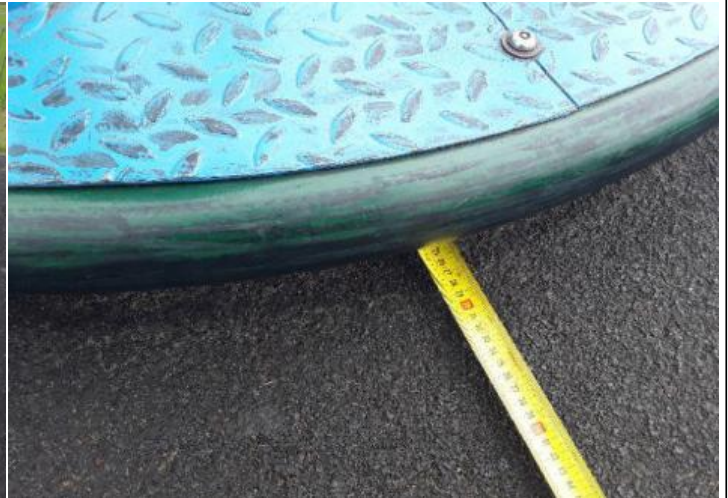
The ground clearance is not maintained under the
roundabout for 300mm without deviations as required by BS
EN 1176 Part 5 Clause 5.2.3 - Monitor - No remedial work
recommended

Finding: The ground clearance is not maintained under the roundabout for 300mm without deviations as required by BS EN 1176 Part 5 Clause 5.2.3
Action: Monitor - No remedial work recommended

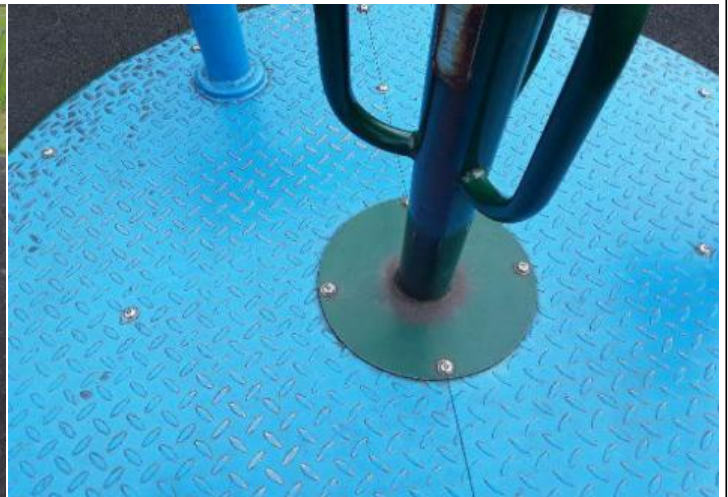
The paintwork on this item has been damaged or worn
exposing the metal underneath which is rusting / corroding -
Treat affected areas and repaint

Finding: The paintwork on this item has been damaged or worn exposing the metal underneath which is rusting / corroding
Action: Treat affected areas and repaint

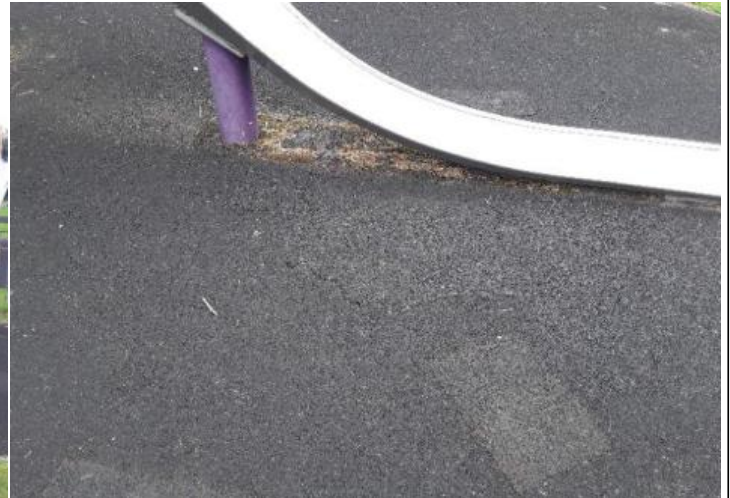
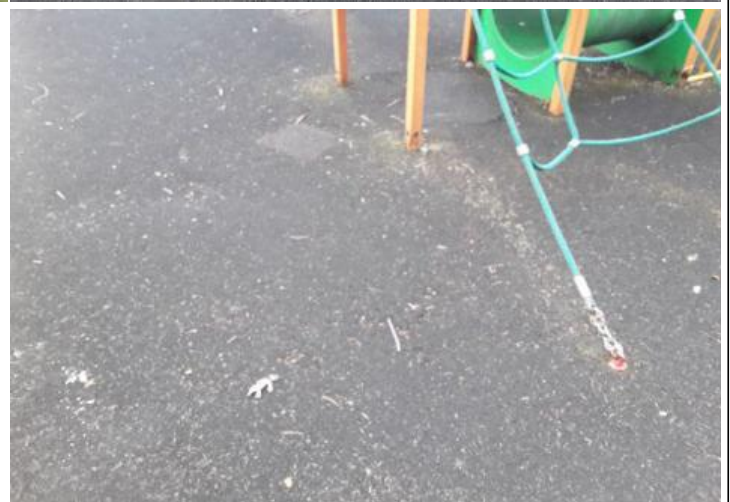
There is some minor damage to the surface - Monitor for any further deterioration and repair as required

Finding: There is some minor damage to the surface

Action: Monitor for any further deterioration and repair as required

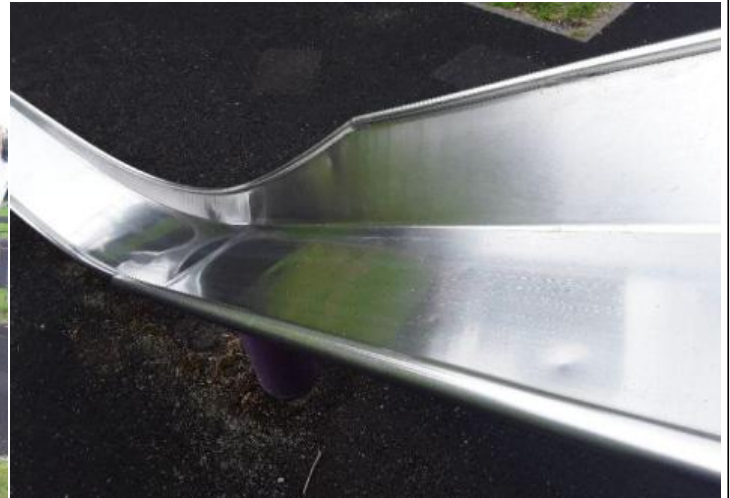
There are a number of dents in the slide surface - Monitor for any further deterioration and repair as required

Finding: There are a number of dents in the slide surface

Action: Monitor for any further deterioration and repair as required

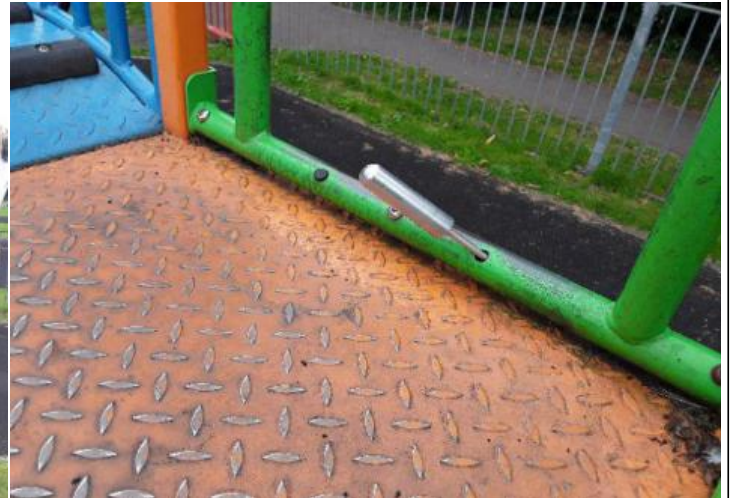
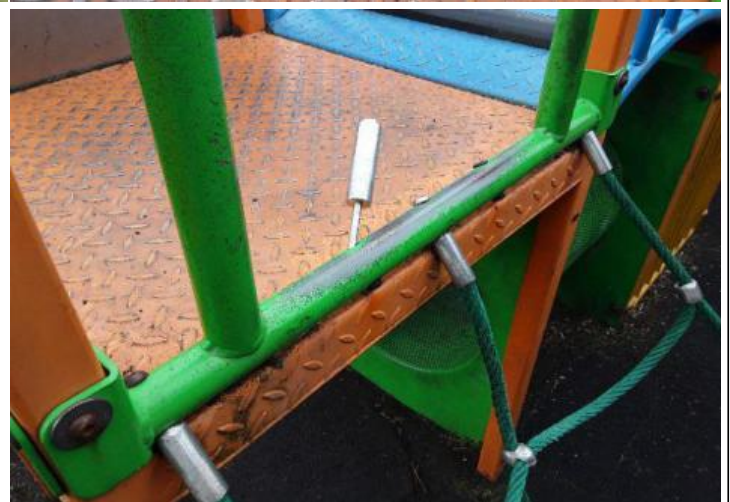
There is/are finger entrapment/s in the framework due to missing inserts and the item fails to meet the requirements of BS EN 1176 Part 1 4.2.7.6 Entrapment of fingers - Provide inserts to remove the entrapment

Finding: There is/are finger entrapment/s in the framework due to missing inserts and the item fails to meet the requirements of BS EN 1176 Part 1 4.2.7.6 Entrapment of fingers

Action: Provide inserts to remove the entrapment

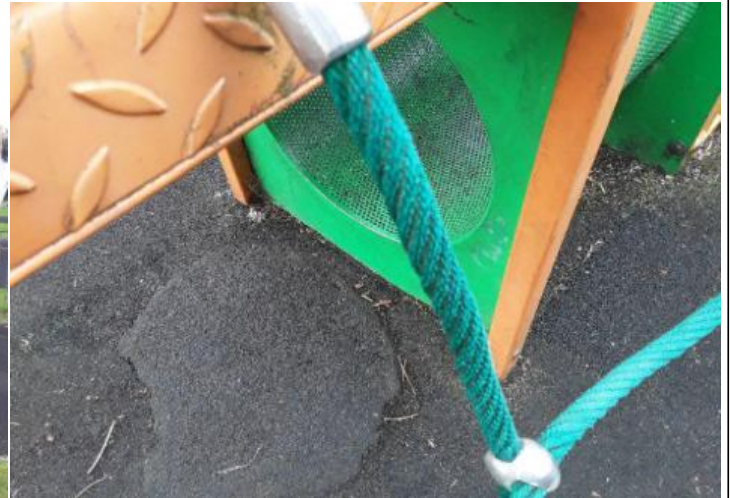
The ropes/nets are worn/damaged in places - Monitor for any further deterioration and repair or replace as required

Finding: The ropes/nets are worn/damaged in places

Action: Monitor for any further deterioration and repair or replace as required

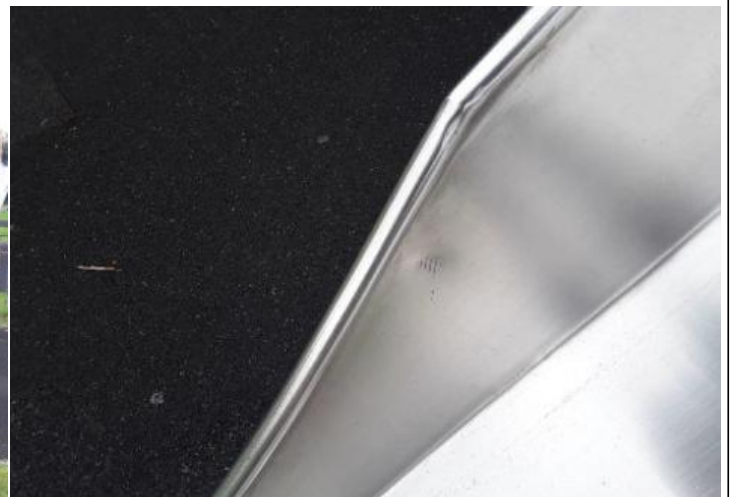
The side of the slide is damaged - Monitor for any further deterioration and repair as required

Finding: The side of the slide is damaged

Action: Monitor for any further deterioration and repair as required

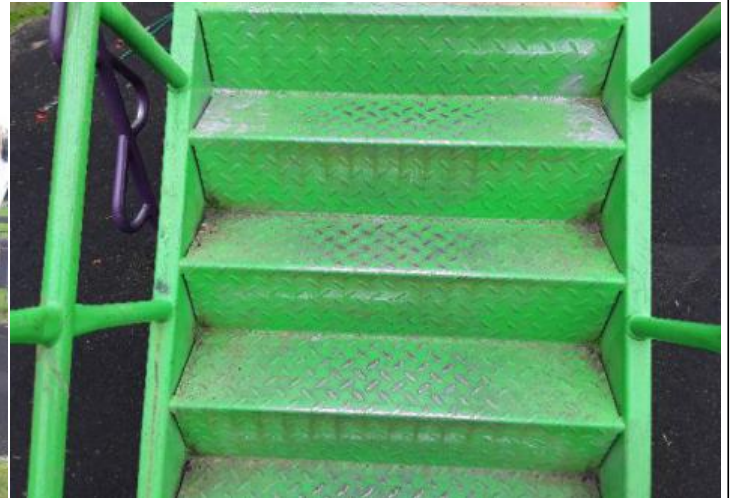
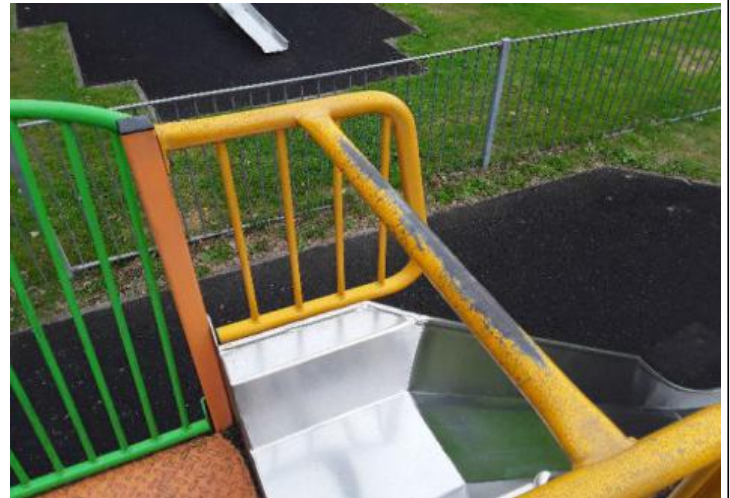
The paintwork on this item has been damaged or worn exposing the metal underneath which is rusting / corroding - Treat affected areas and repaint

Finding: The paintwork on this item has been damaged or worn exposing the metal underneath which is rusting / corroding

Action: Treat affected areas and repaint

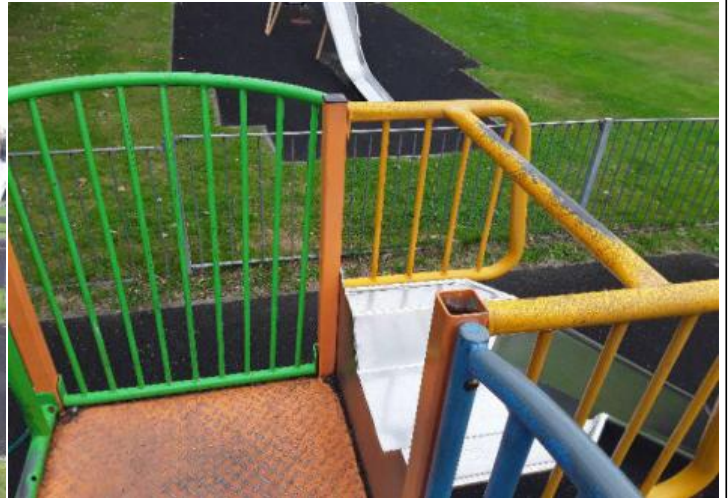
There is / are post or end caps missing / damaged on the item - Replace missing / damaged post or end caps

Finding: There is / are post or end caps missing / damaged on the item
Action: Replace missing / damaged post or end caps

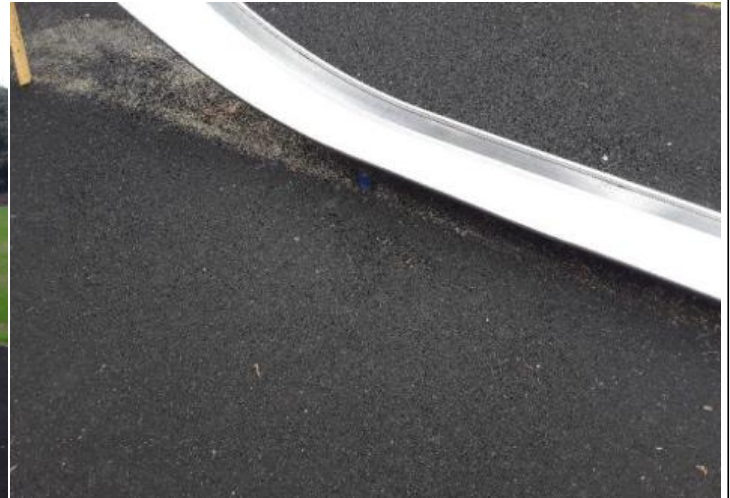
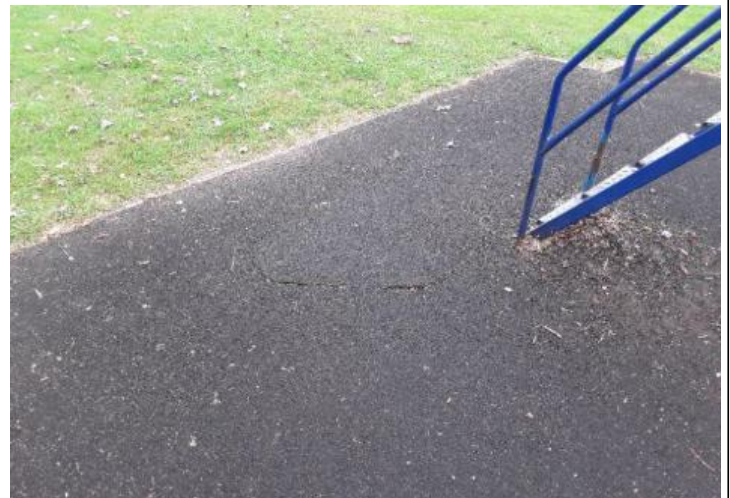
There is some minor damage to the surface - Monitor for any further deterioration and repair as required

Finding: There is some minor damage to the surface

Action: Monitor for any further deterioration and repair as required

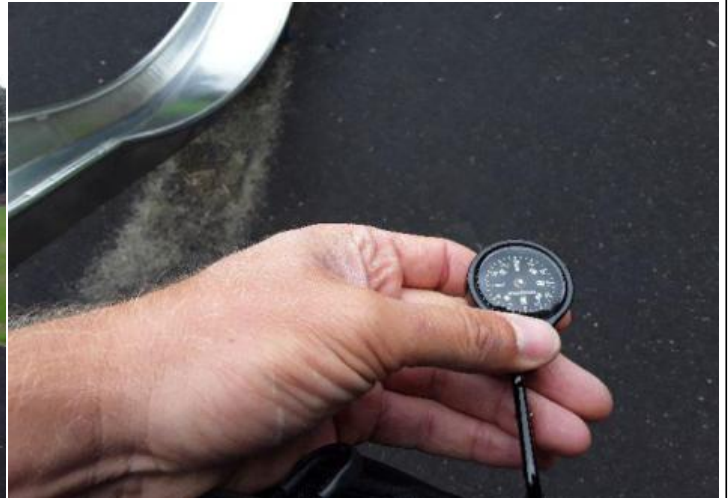
The slide is predominately south facing and will catch the majority of the sun's heat during the day. Slide surfaces can become very warm during periods of sustained sunny weather - Monitor - No remedial work recommended

Finding: The slide is predominately south facing and will catch the majority of the sun's heat during the day. Slide surfaces can become very warm during periods of sustained sunny weather

Action: Monitor - No remedial work recommended

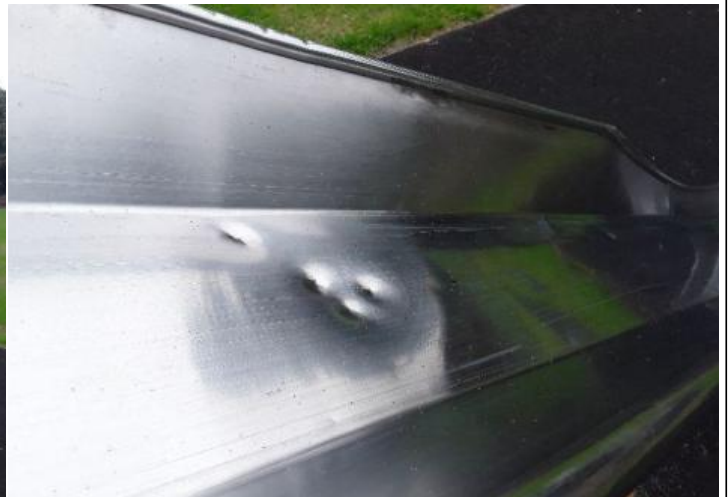
There are a number of dents in the slide surface - Monitor for any further deterioration and repair as required

Finding: There are a number of dents in the slide surface

Action: Monitor for any further deterioration and repair as required

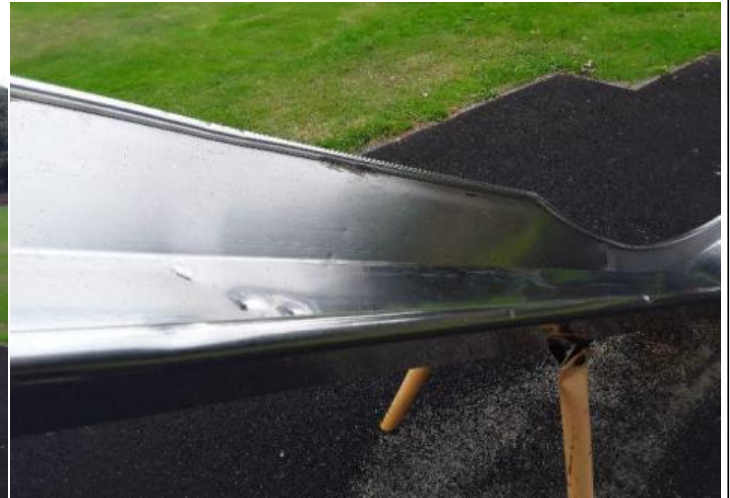
The side of the slide is damaged - Monitor for any further deterioration and repair as required

Finding: The side of the slide is damaged

Action: Monitor for any further deterioration and repair as required

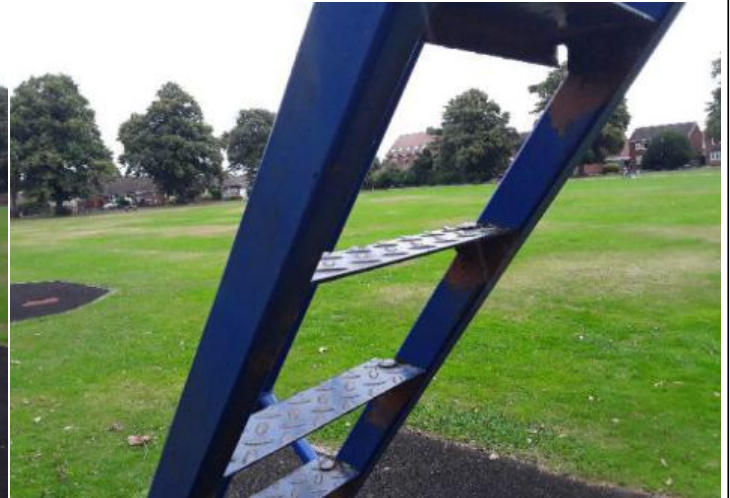
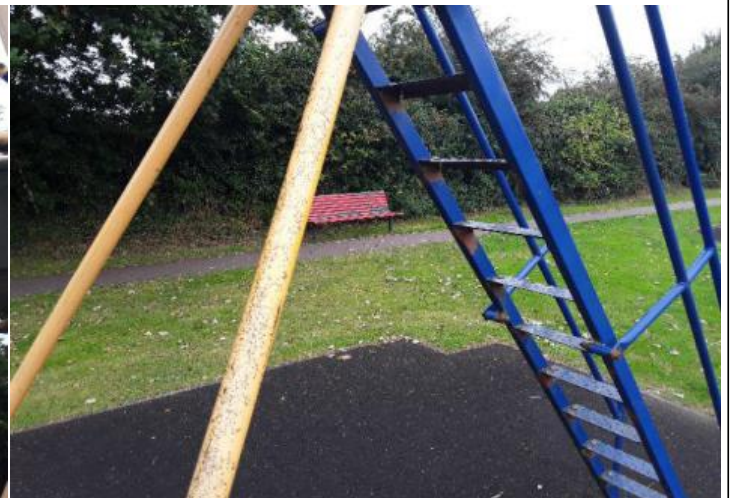
The paintwork on this item has been damaged or worn exposing the metal underneath which is rusting / corroding - Treat affected areas and repaint

Finding: The paintwork on this item has been damaged or worn exposing the metal underneath which is rusting / corroding

Action: Treat affected areas and repaint

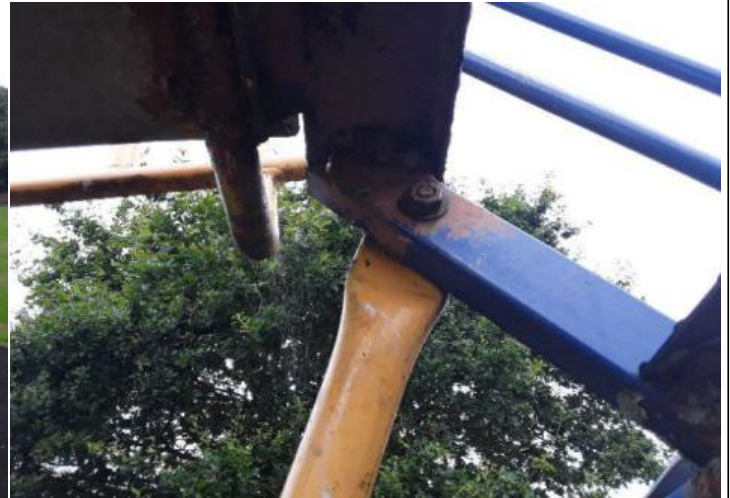
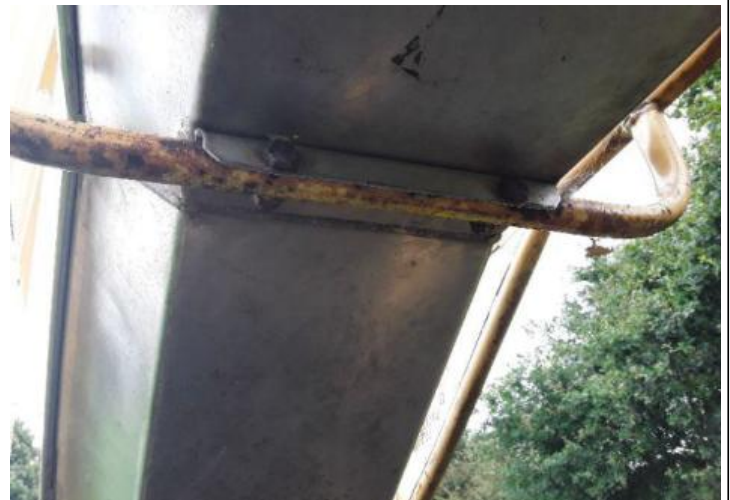
The fixings have corroded excessively - Replace all corroded fixings

Finding: The fixings have corroded excessively

Action: Replace all corroded fixings

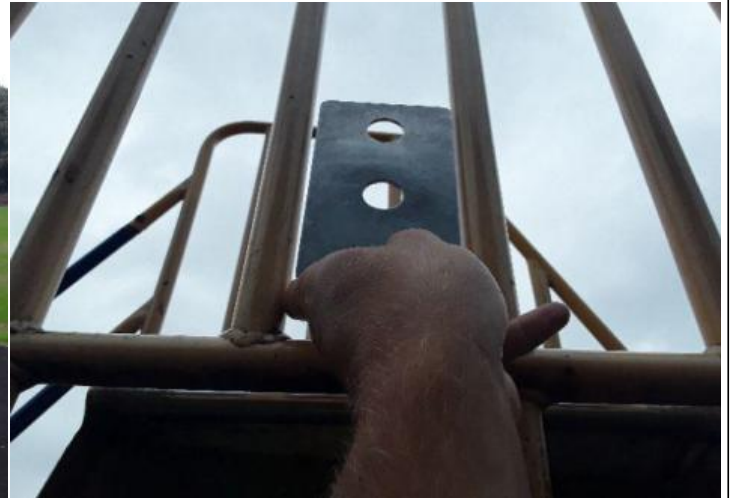
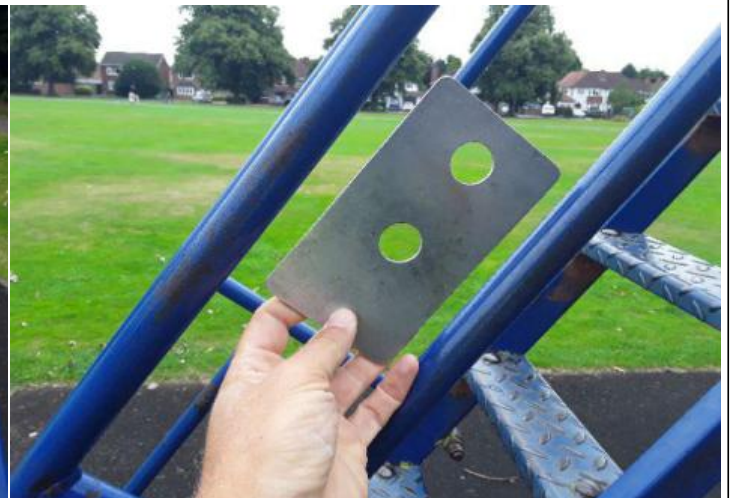
The item fails to meet the requirements of BS EN 1176 Part 1 4.2.7.2 head and neck entrapment in the barriers and/or steps - Monitor - No remedial work recommended

Finding: The item fails to meet the requirements of BS EN 1176 Part 1 4.2.7.2 head and neck entrapment in the barriers and/or steps

Action: Monitor - No remedial work recommended

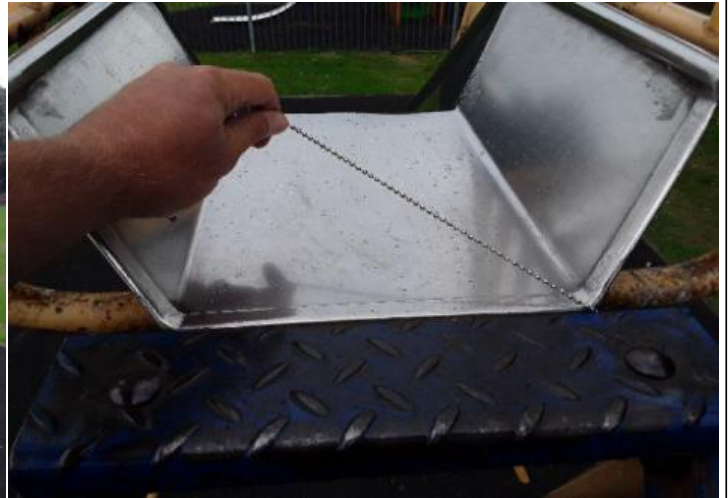
There is / are toggle entrapment/s present in contravention of the recommendations set out in BS EN 1176 Part 1 - Monitor - no remedial work recommended

Finding: There is / are toggle entrapment/s present in contravention of the recommendations set out in BS EN 1176 Part 1

Action: Monitor - no remedial work recommended

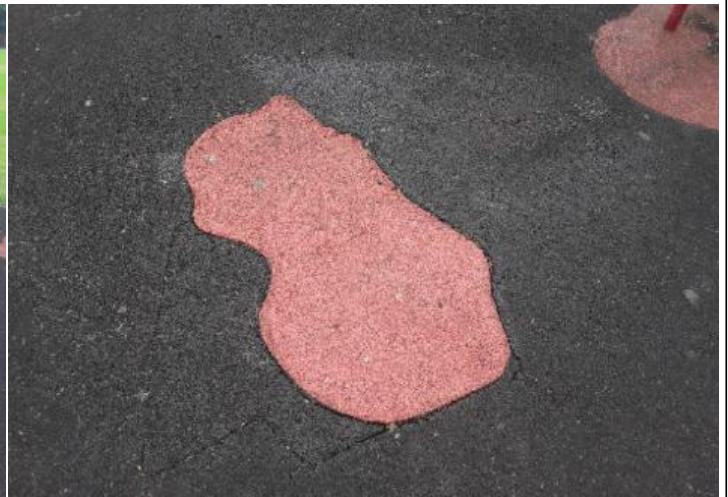
There are gaps opening between the surfacing and the edging surround or between the joints in the surfacing - Monitor for any further deterioration and repair as required

Finding: There are gaps opening between the surfacing and the edging surround or between the joints in the surfacing
Action: Monitor for any further deterioration and repair as required

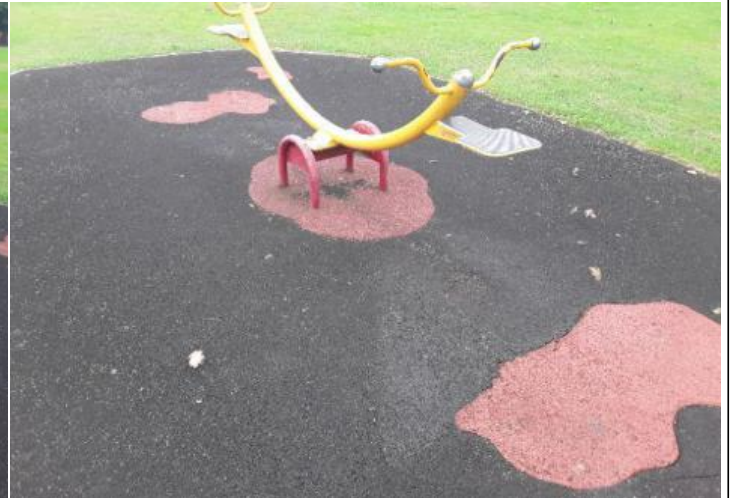
The safety surface around the area is beginning to wear - Monitor for any further deterioration and repair as required

Finding: The safety surface around the area is beginning to wear

Action: Monitor for any further deterioration and repair as required

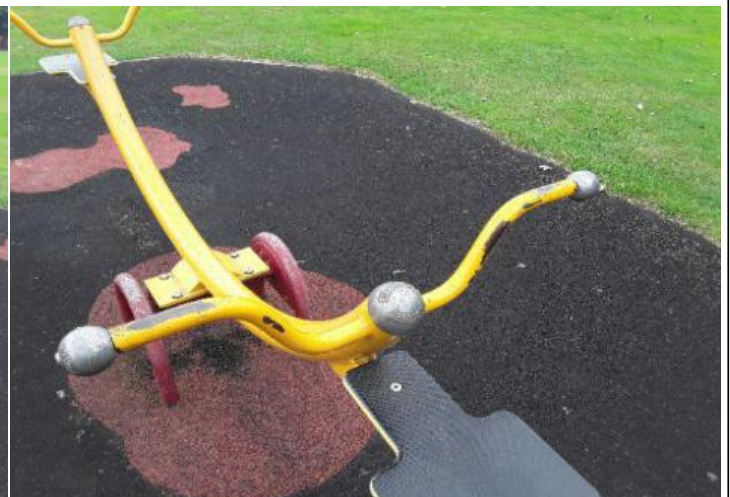
The paintwork on this item has been damaged or worn exposing the metal underneath which is rusting / corroding - Treat affected areas and repaint

Finding: The paintwork on this item has been damaged or worn exposing the metal underneath which is rusting / corroding

Action: Treat affected areas and repaint

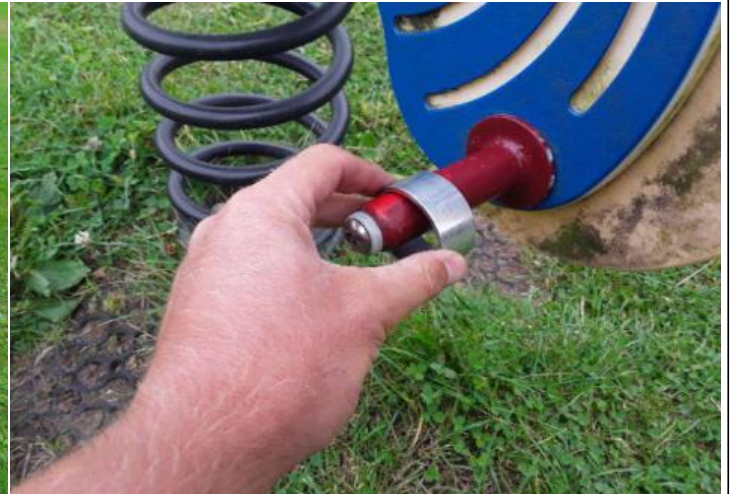
The end of handgrips and/or footrests have a cross section of less than 15cm2 and fail to meet the requirements of BS EN 1176 Part 6 - Monitor - No remedial work recommended

Finding: The end of handgrips and/or footrests have a cross section of less than 15cm² and fail to meet the requirements of BS EN 1176 Part 6

Action: Monitor - No remedial work recommended

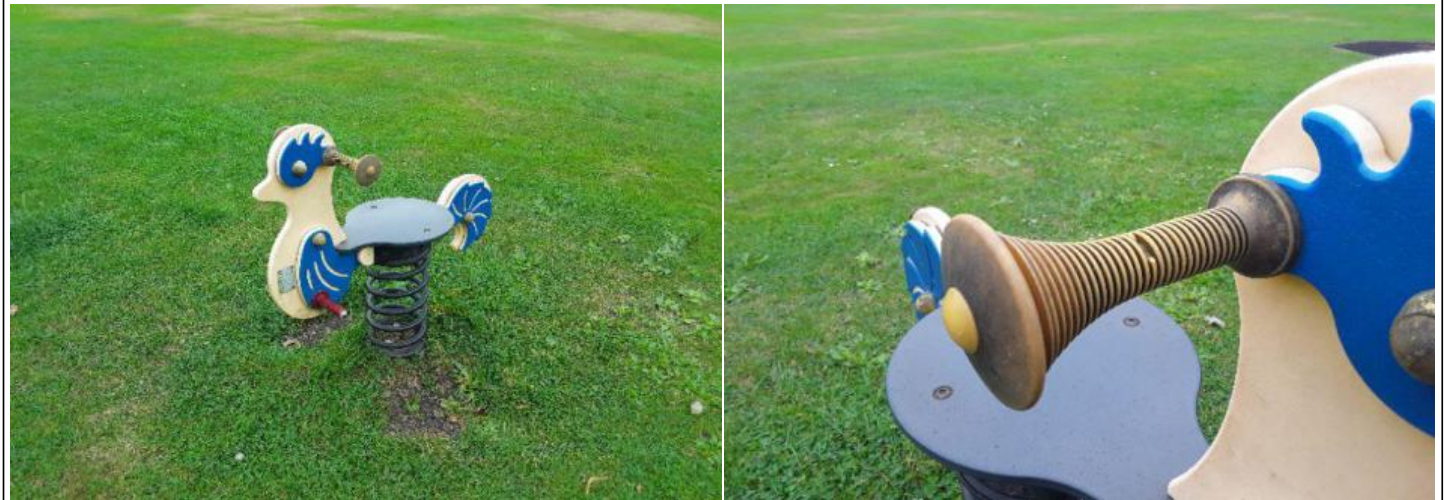
The item has been damaged - Monitor for any further deterioration and replace as required

Finding: The item has been damaged
Action: Monitor for any further deterioration and replace as required

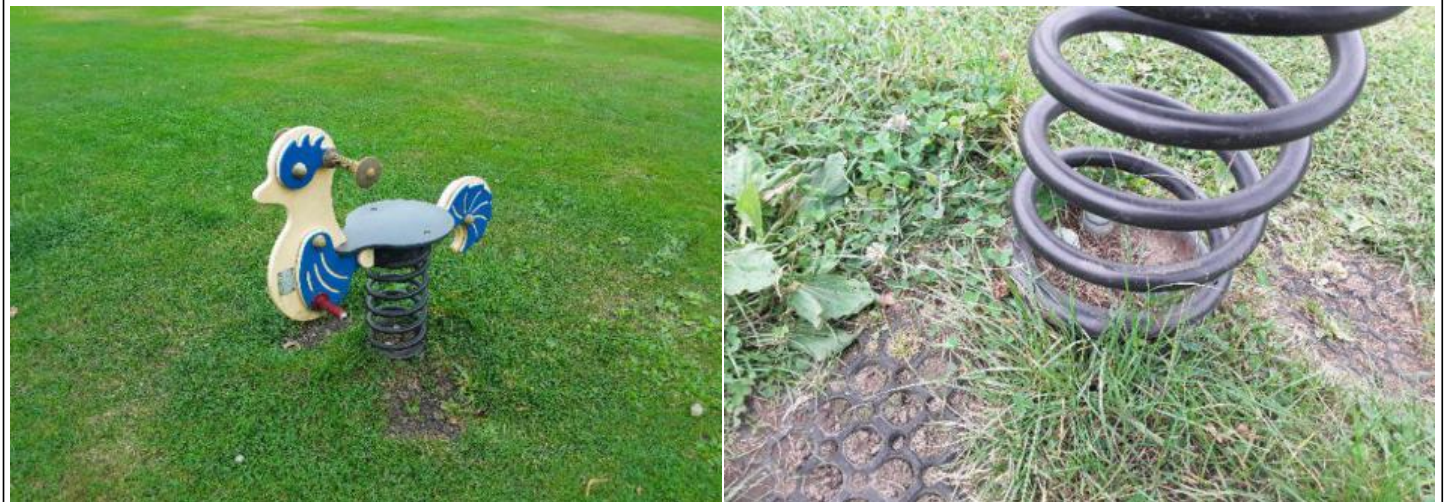
The paintwork on the spring has been damaged or worn exposing the metal underneath which is rusting - Treat any rusting components and repaint

Finding: The paintwork on the spring has been damaged or worn exposing the metal underneath which is rusting
Action: Treat any rusting components and repaint

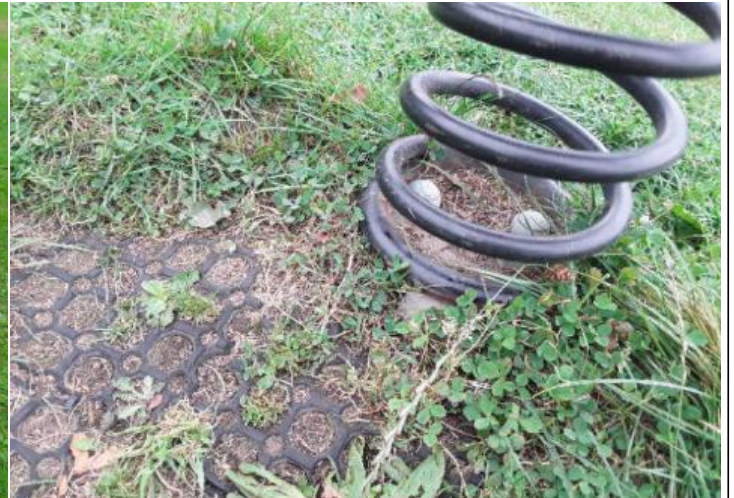
A number of fixing(s) have worked loose - Secure all loose fixings

Finding: A number of fixing(s) have worked loose

Action: Secure all loose fixings

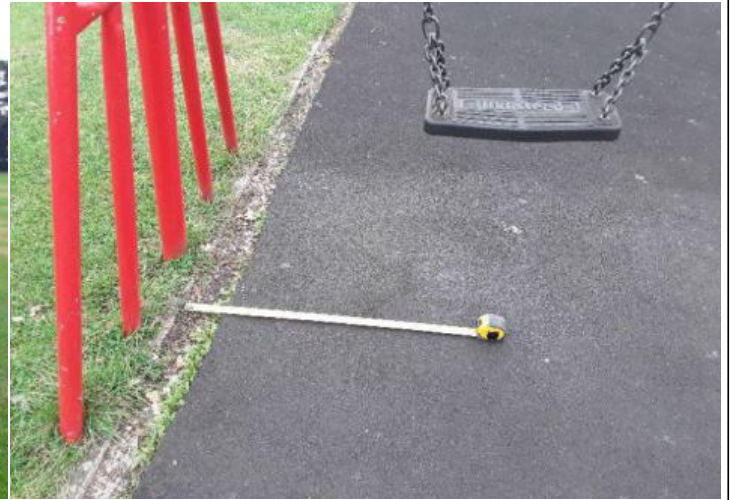
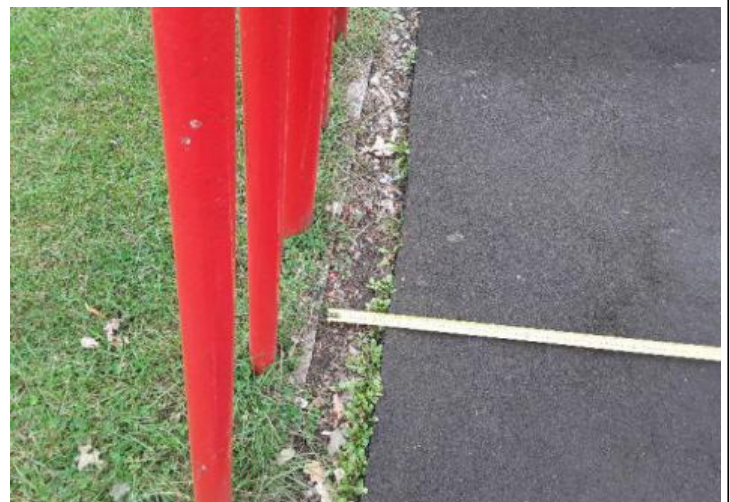
The surfacing width under the seat/s is / are less than 875mm when measured from the centre of the seat outwards due to damaged surfacing, and fails the requirements of BS EN 1176 Part 2 - Repair damaged surfacing

Finding: The surfacing width under the seat/s is / are less than 875mm when measured from the centre of the seat outwards due to damaged surfacing, and fails the requirements of BS EN 1176 Part 2

Action: Repair damaged surfacing

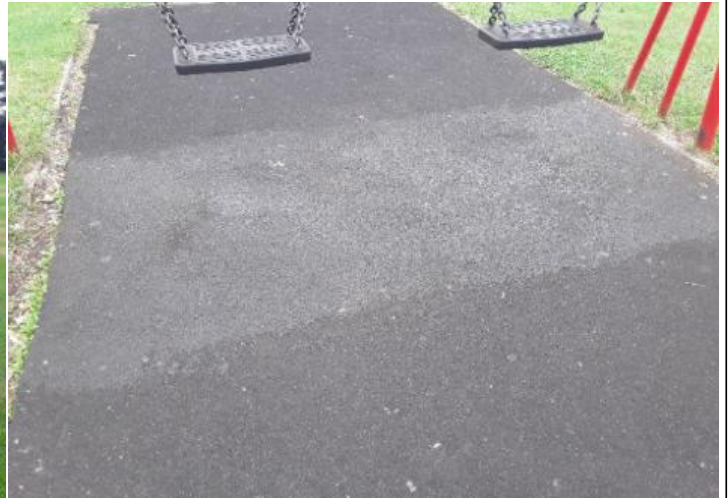
The safety surface around the area is beginning to wear - Monitor for any further deterioration and repair as required

Finding: The safety surface around the area is beginning to wear

Action: Monitor for any further deterioration and repair as required

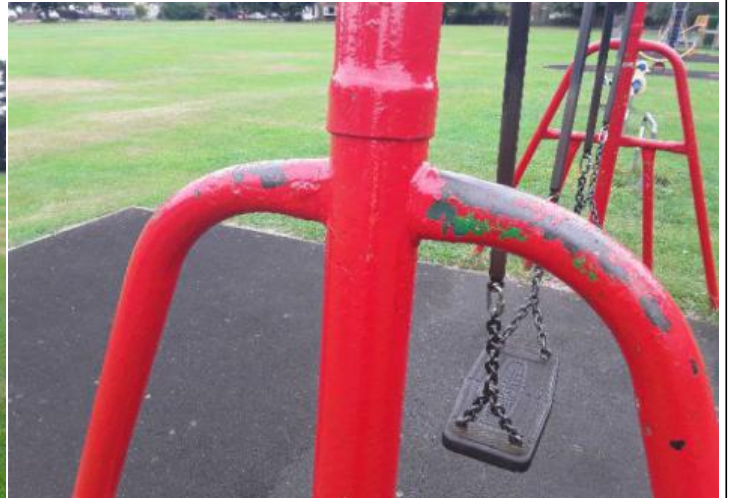
The paintwork on this item has been damaged or worn exposing the metal underneath which is rusting / corroding - Treat affected areas and repaint

Finding: The paintwork on this item has been damaged or worn exposing the metal underneath which is rusting / corroding

Action: Treat affected areas and repaint

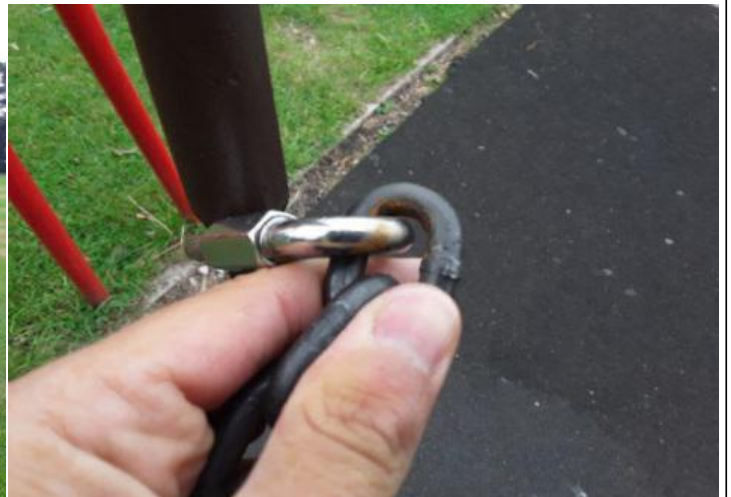
There is some notable evidence of chain wear - Monitor for any further deterioration and replace when 40% worn

Finding: There is some notable evidence of chain wear

Action: Monitor for any further deterioration and replace when 40% worn

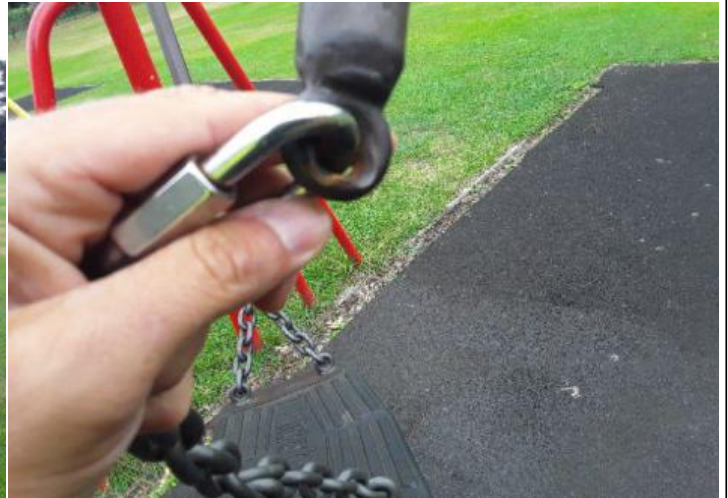
The connecting lugs are showing signs of wear - Monitor for any further deterioration and repair as required

Finding: The connecting lugs are showing signs of wear

Action: Monitor for any further deterioration and repair as required

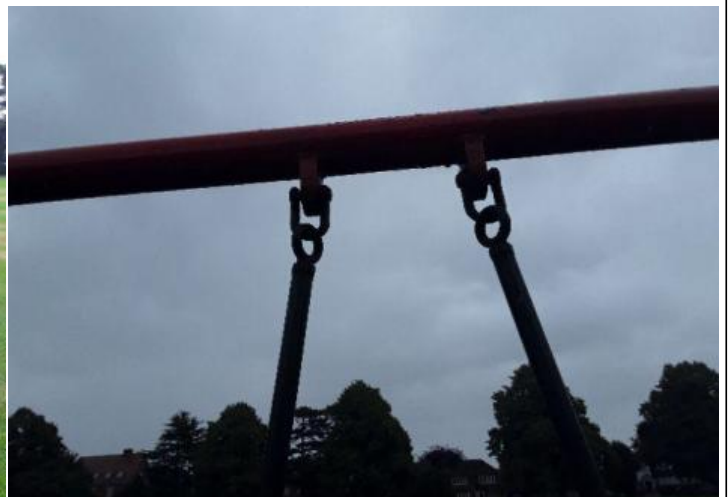
There is some wear to the shackles - Monitor for any further deterioration and replace when 40% worn

Finding: There is some wear to the shackles

Action: Monitor for any further deterioration and replace when 40% worn

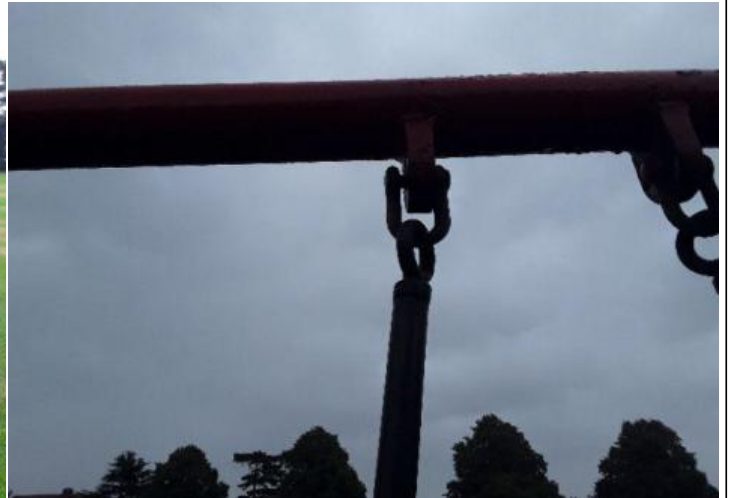
The bushes are worn or missing - Replace worn or missing bushes

Finding: The bushes are worn or missing

Action: Replace worn or missing bushes

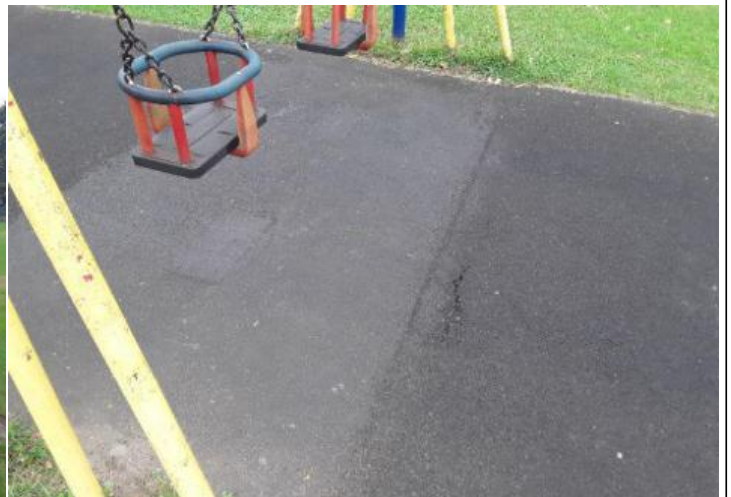
There is some minor damage to the surface - Monitor for any further deterioration and repair as required

Finding: There is some minor damage to the surface

Action: Monitor for any further deterioration and repair as required

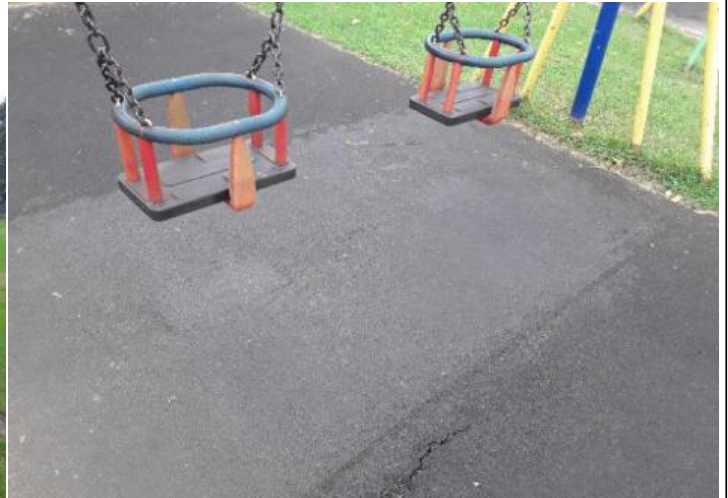
The safety surface around the area is beginning to wear - Monitor for any further deterioration and repair as required

Finding: The safety surface around the area is beginning to wear

Action: Monitor for any further deterioration and repair as required
