the **play inspection** company

Annual Inspection

North Warwickshire Borough Council

Vicarage Lane

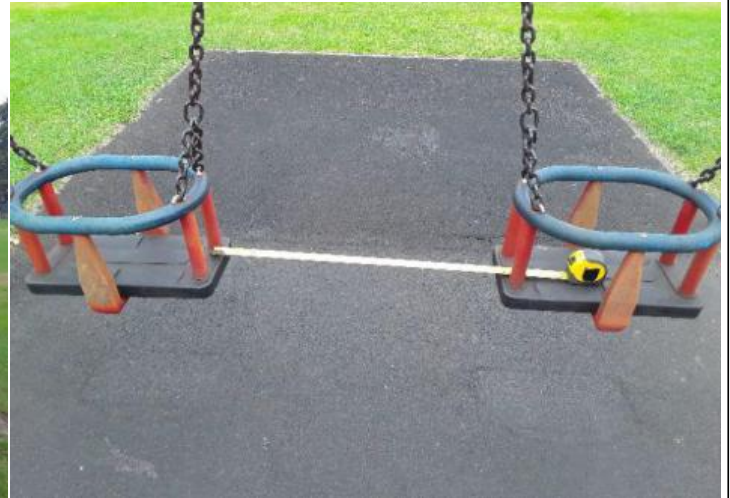
Finding: The seats are too close to each other as defined in BS EN 1176 Part 2; this is a low risk failure and no remedial action is required
Action: Monitor - No remedial work recommended

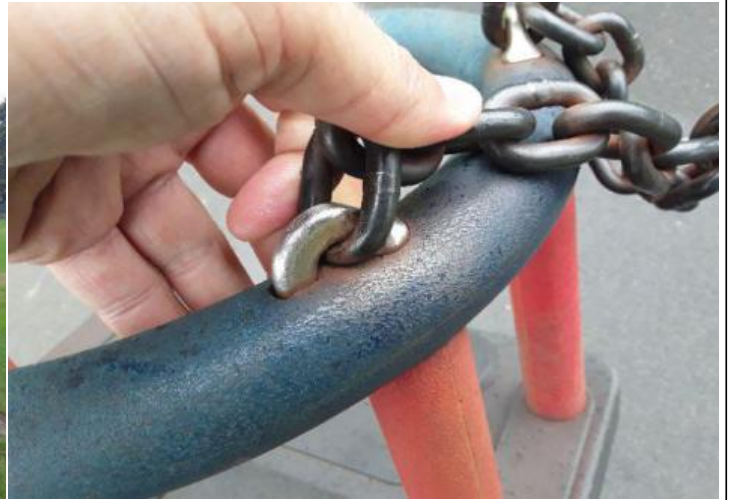
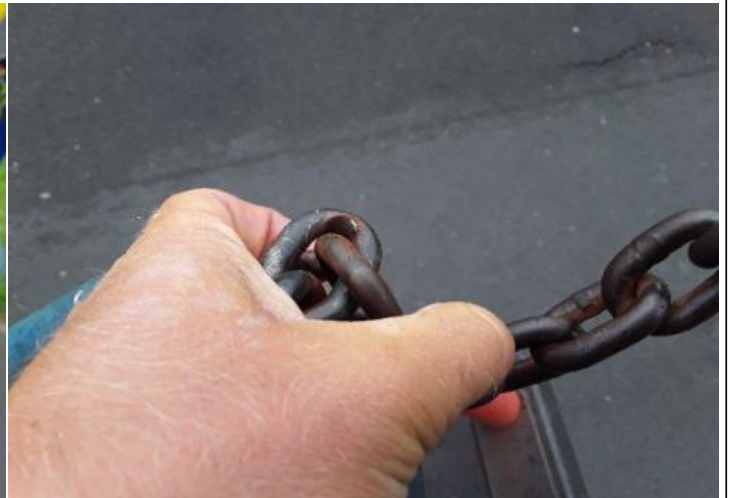
The chain links are worn excessively and require renewing - Replace worn chains

Finding: The chain links are worn excessively and require renewing

Action: Replace worn chains

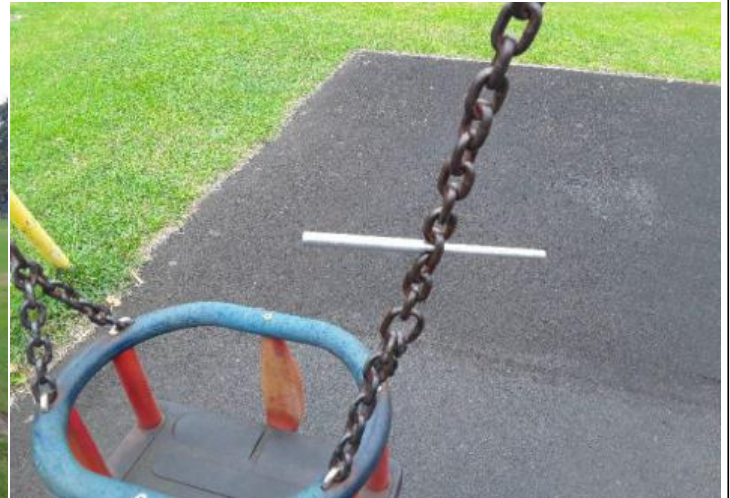
Finding: The chain openings are in excess of 8.6mm and do not meet the recommendations of BS EN 1176 Part 1

Action: Monitor - No remedial work recommended

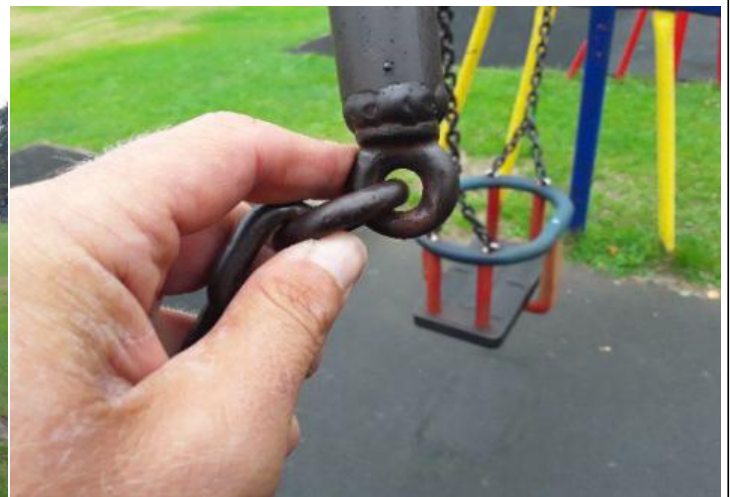
The connecting lugs are showing signs of wear - Monitor for any further deterioration and repair as required

Finding: The connecting lugs are showing signs of wear

Action: Monitor for any further deterioration and repair as required

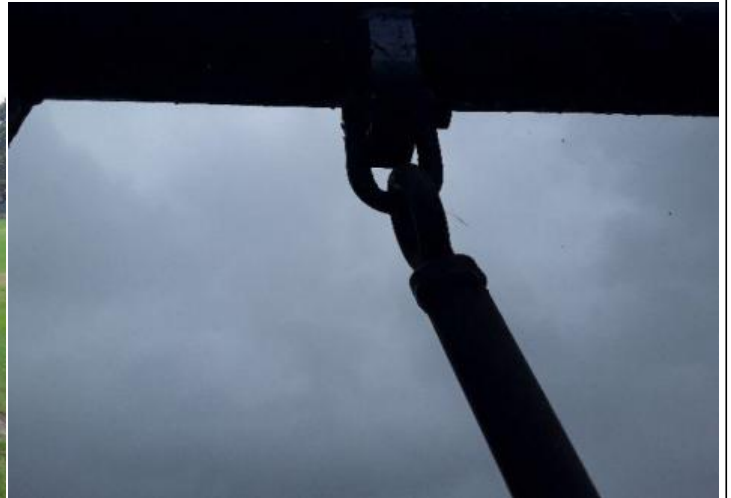
Finding: There is some wear to the shackles

Action: Monitor for any further deterioration and replace when 40% worn

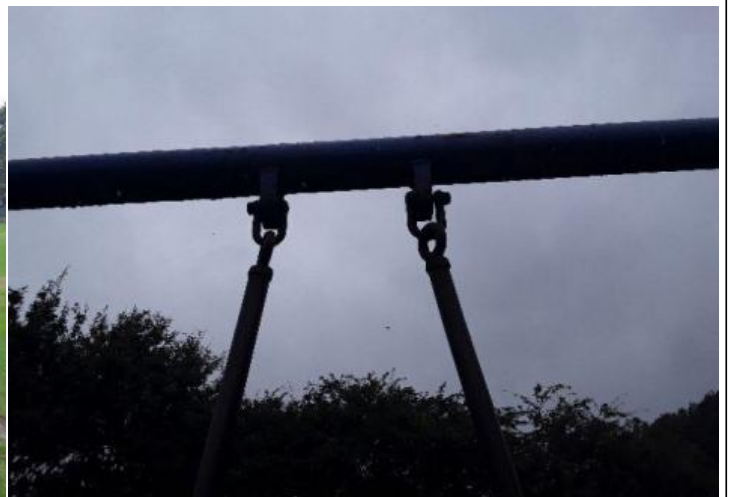
The bushes are worn or missing - Replace worn or missing bushes

Finding: The bushes are worn or missing

Action: Replace worn or missing bushes

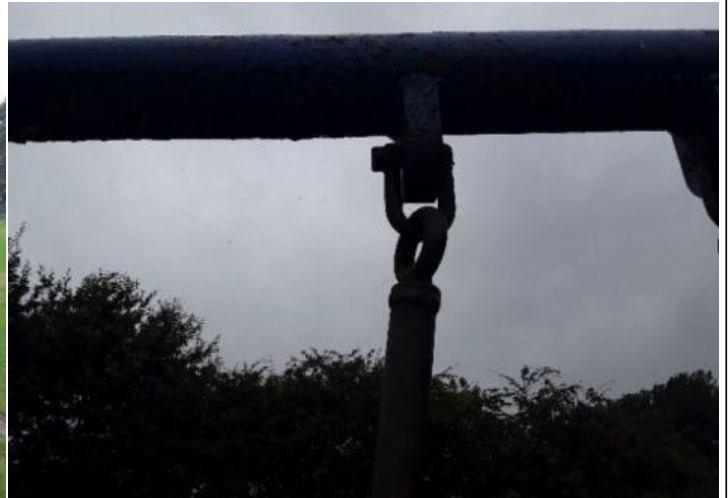
Finding: The split pins are missing from the shackles

Action: Insert split pins to secure the shackles

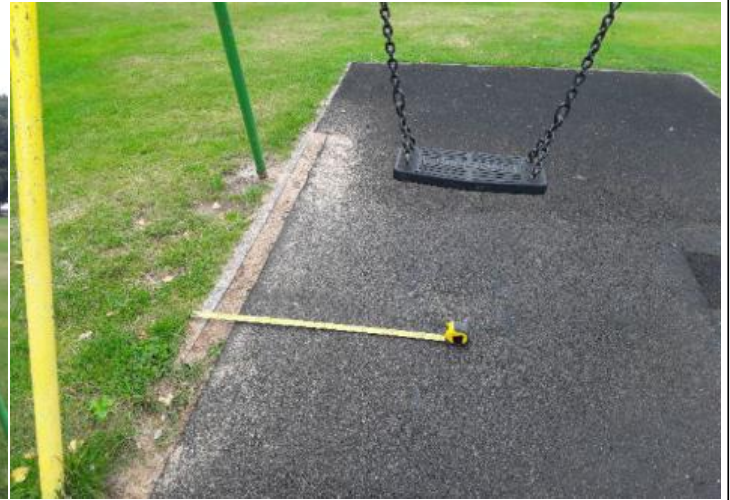
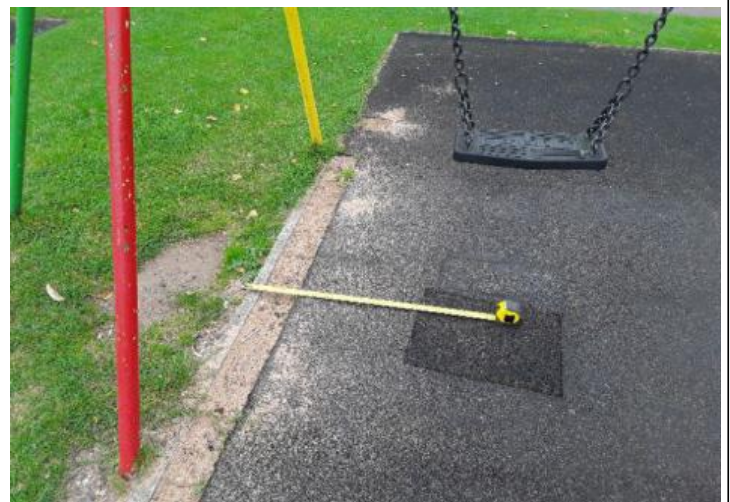
Finding: The surfacing width under the seat/s is / are less than 875mm when measured from the centre of the seat outwards due to damaged surfacing, and fails the requirements of BS EN 1176 Part 2

Action: Repair damaged surfacing

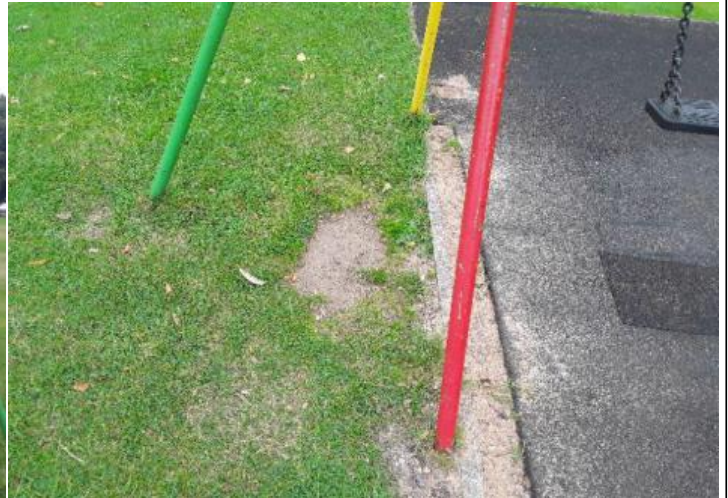
Finding: The surface has eroded in some areas and may be slippery in wet conditions
Action: Reinstate the surface

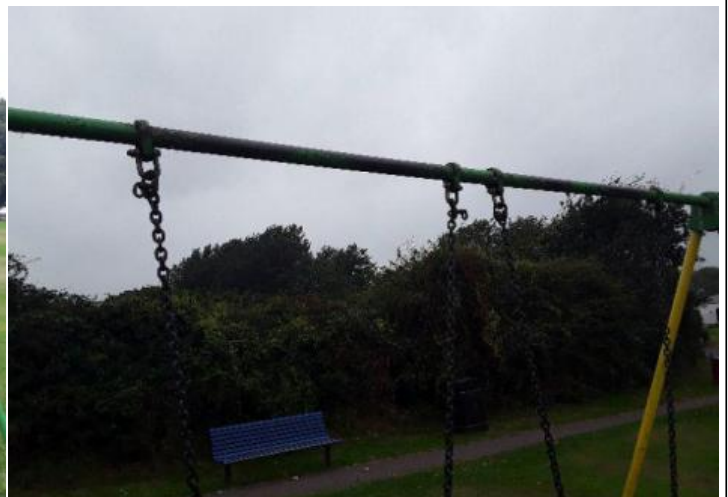
Finding: The paintwork on this item has been damaged or worn exposing the metal underneath which is rusting / corroding
Action: Treat affected areas and repaint

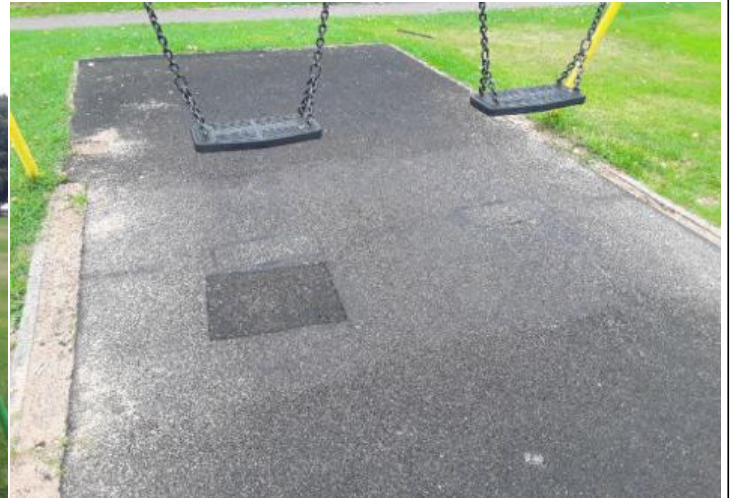
Finding: The safety surface around the area is beginning to wear

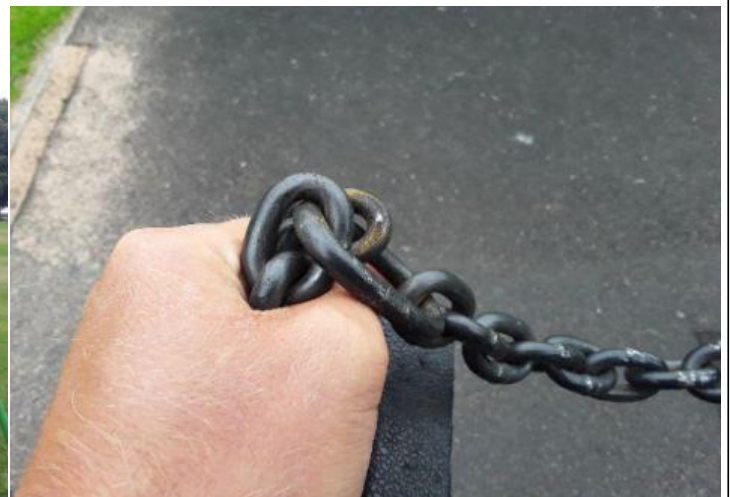
Finding: There is some notable evidence of chain wear

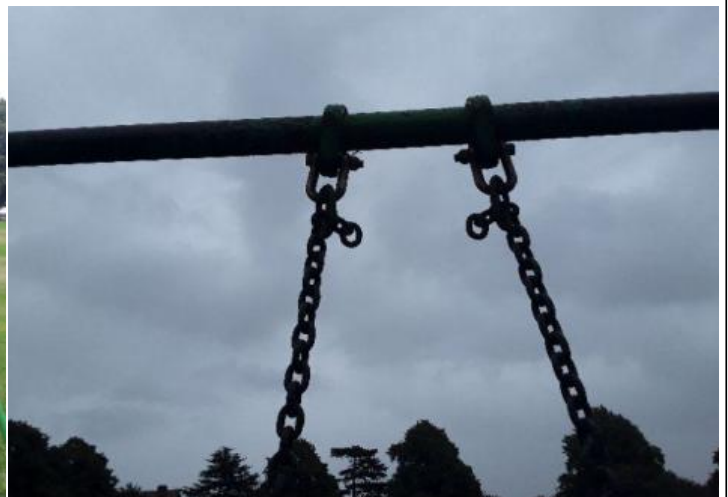
Finding: There is some wear to the shackles

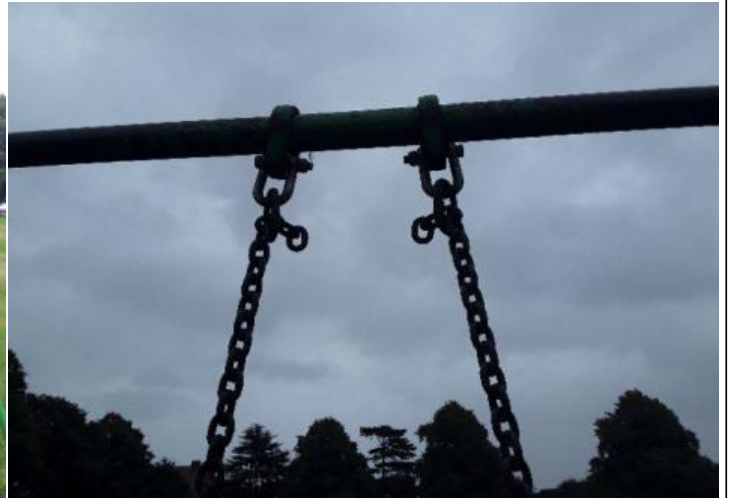
Finding: The bushes are showing signs of wear

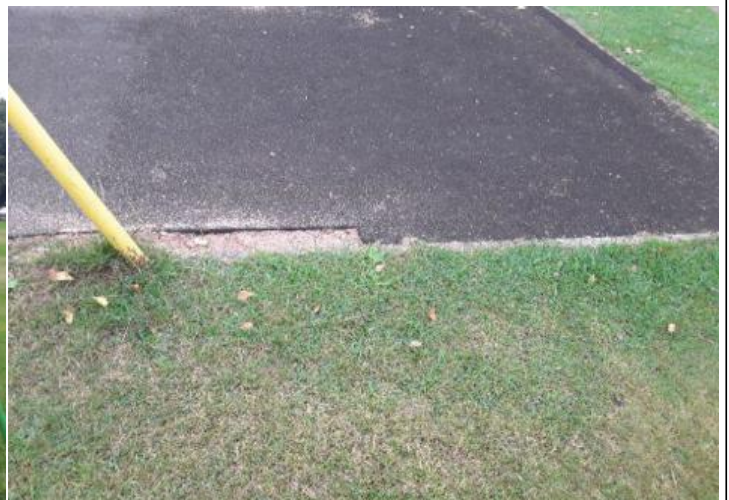
Finding: The surface is lifting at the edges and creating trip points
