Annual Inspection

North Warwickshire Borough Council

Openfield Croft

Water Orton, North Warwickshire, B46 1RE

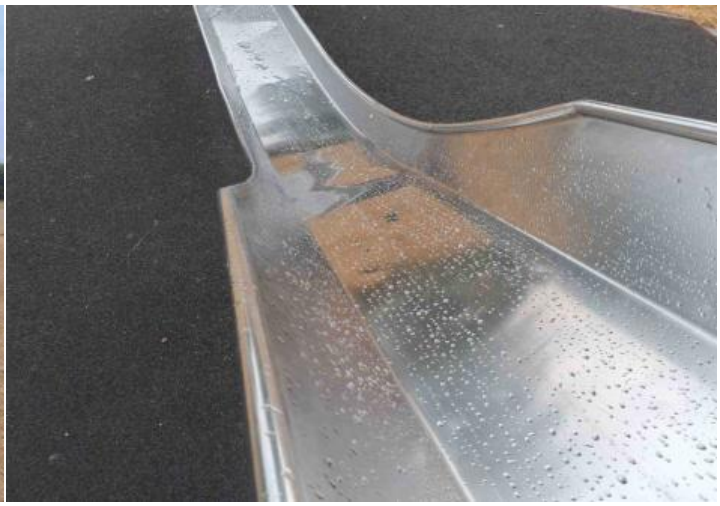
8 - Low Risk (Finding 2)

Finding 2
There is algae, silt or moss growth on the surface resulting in slippery conditions - Clean and treat appropriately

Item: Other - Free Standing Slide
Manufacturer: Wicksteed Playgrounds
Risk Level: L - Low Risk
Surface: Wet Pour

Finding: There is algae, silt or moss growth on the surface resulting in slippery conditions

Action: Clean and treat appropriately

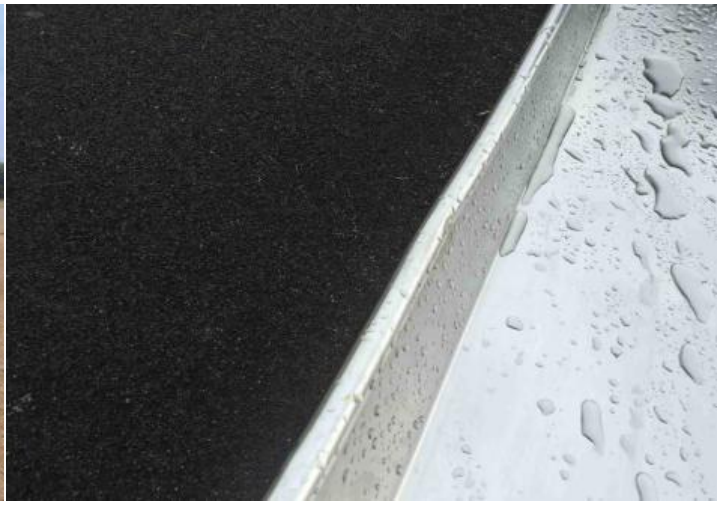
4 - Very Low Risk (Finding 4)

Finding 4
The side of the slide is damaged - Monitor for any further deterioration and repair as required

Item:	Other - Free Standing Slide	**Risk Level:**	V - Very Low Risk
Manufacturer:	Wicksteed Playgrounds	**Surface:**	Wet Pour

Finding: The side of the slide is damaged

Action: Monitor for any further deterioration and repair as required
