the play inspection company

Annual Inspection

North Warwickshire Borough Council

Vicarage Lane

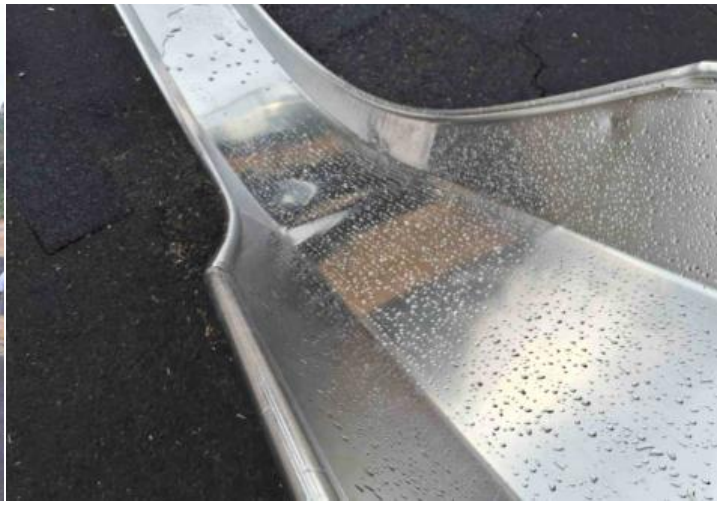
6 - Low Risk (Finding 5)

Item: Activity Equipment - Multi Play (Junior)
Manufacturer: Wicksteed Playgrounds
Risk Level: L - Low Risk
Surface: Wet Pour

Finding: There are gaps opening between the surfacing and the edging surround or between the joints in the surfacing

Action: Monitor for any further deterioration and repair as required

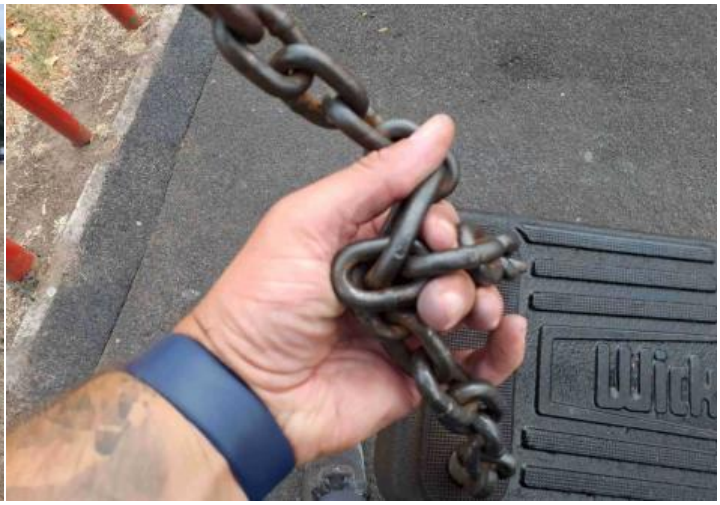
8 - Low Risk (Finding 5)

Item: Swings - 1 Bay 2 Seat (Flat)
Manufacturer: Wicksteed Playgrounds
Risk Level: L - Low Risk
Surface: Wet Pour

Finding: The swing bar connecting lugs are worn

Action: Replace lugs or all affected components
