Annual Inspection

North Warwickshire Borough Council

Openfield Croft

Inspection Ref: 1715258

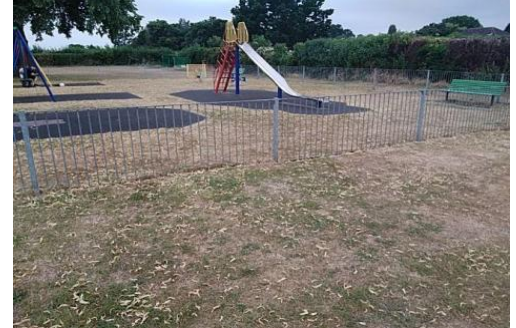
Item: Fencing - Flat Top
Manufacturer: Not Identified
Surface Type: Grass
Item Quantity: 1
Equipment Compliance: N/A
Surface Area Compliance: N/A

There is some damage to the fence sections - Monitor for any further deterioration and repair as required

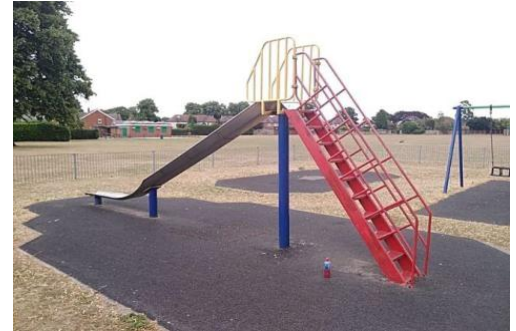
Item: Free Standing Slide
Manufacturer: Wicksteed Playgrounds
Surface Type: Wet Pour
Item Quantity: 1
Equipment Compliance: No
Surface Area Compliance: Yes

There are a number of dents in the slide surface - Monitor for any further deterioration and repair as required

The item fails to meet the requirements of BS EN 1176 Part 1 4.2.7.2 head and neck entrapment in the barriers and/or steps - Monitor - No remedial work recommended

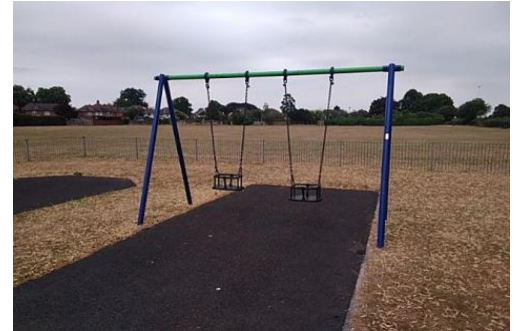
Item: 1 Bay 2 Seat (Cradle)
Manufacturer: Wicksteed Playgrounds
Surface Type: Wet Pour
Item Quantity: 1
Equipment Compliance: Yes
Surface Area Compliance: Yes

There is some minor damage to the surface - Monitor for any further deterioration and repair as required

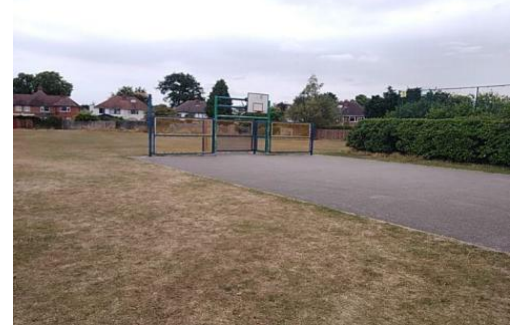
Item: Goal End
Manufacturer: Wicksteed Playgrounds
Surface Type: Bitmac
Item Quantity: 1
Equipment Compliance: Yes
Surface Area Compliance: N/A

A clearly visible facility sign should be provided in a prominent position with the wording as detailed BS EN 15312- the equipment is not intended for children less than 3 years old- the warning - Do not climb on the framework or nets- the warning - Do not hang on the ring (if provided)- the warning - Do not wear rings or other jewellery- name and telephone number of the administrator- number to call in case of accident - Provide signage to BS EN 15312

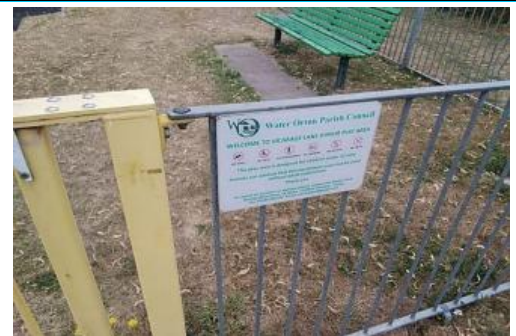
Item: Sign
Manufacturer: Owner/Operator
Surface Type: N/A
Item Quantity: 1
Equipment Compliance: N/A
Surface Area Compliance: N/A

This item is satisfactory - no work required -
