the **play inspection** company

Annual Inspection

North Warwickshire Borough Council

Openfield Croft

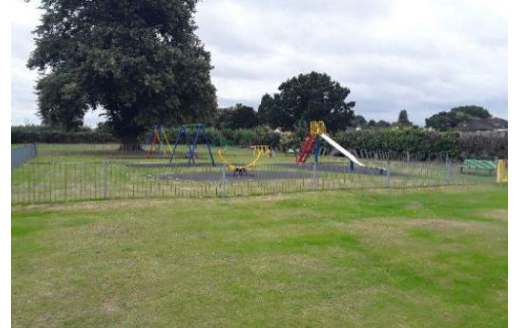
Item: Site General
Manufacturer: Owner/Operator
Surface Type: N/A
Item Quantity: 1
Equipment Compliance: N/A
Surface Area Compliance: N/A

There are trip hazards at the edges of the surface - Remove trip hazard

There is algae, silt or moss growth on the surface resulting in slippery conditions - Clean and treat appropriately

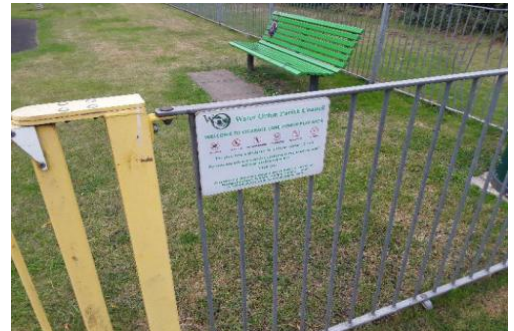
Item: Sign
Manufacturer: Not Identified
Surface Type: N/A
Item Quantity: 1
Equipment Compliance: N/A
Surface Area Compliance: N/A

There are projecting bolt thread(s) present - Remove excess thread length and deburr or provide cap

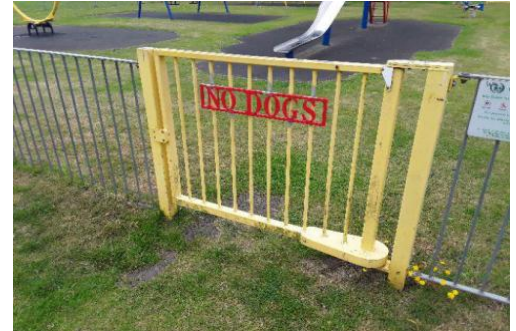
Item: Gate - Self Closing
Manufacturer: I.A.E. Fencing
Surface Type: Grass
Item Quantity: 2
Equipment Compliance: N/A
Surface Area Compliance: N/A

The area under the gate has eroded leaving uneven areas, or the concrete foundations exposed, resulting in trip hazards at the entrance/exit to the playground - Reinstate to level with surrounding surfaces

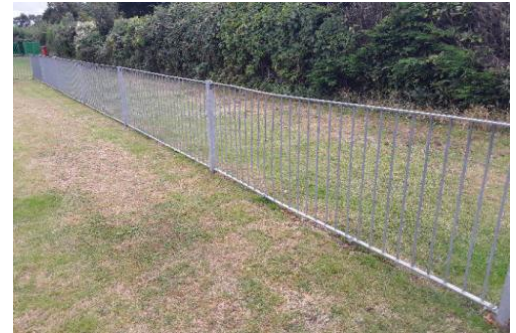
Item: Fencing - Flat Top
Manufacturer: Not Identified
Surface Type: Grass
Item Quantity: 1
Equipment Compliance: N/A
Surface Area Compliance: N/A

There is some damage to the fence sections - Monitor for any further deterioration and repair as required

A number of fixings have worked loose around the fencing - Secure all loose fixings

There are a number of fixings missing from the fence - Replace missing fixings

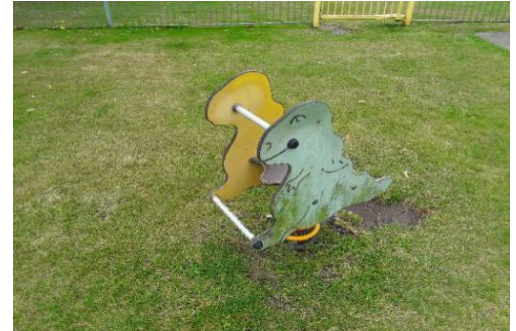
Item: Spring Dino
Manufacturer: Hags
Surface Type: Grass Matrix Tiles
Item Quantity: 1
Equipment Compliance: Yes
Surface Area Compliance: Yes

The grass has eroded within the impact area of the equipment and may not provide the necessary impact attenuating properties for the equipment fall height; the surface may also be slippery in wet weather - Reinstate the grass or provide an all weather surface

The paintwork on the spring has been damaged or worn exposing the metal underneath which is rusting - Treat any rusting components and repaint

The item is slightly loose in its foundations - Monitor for any further deterioration and repair as required

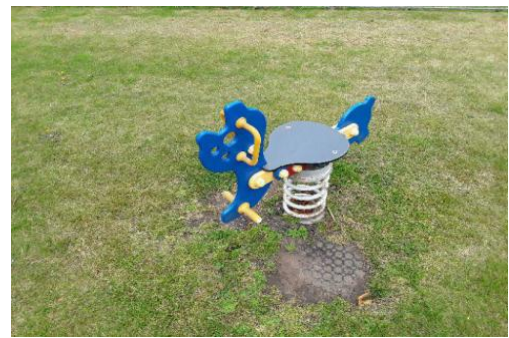
Item: Spring Dog
Manufacturer: Wicksteed Playgrounds
Surface Type: Grass Matrix Tiles
Item Quantity: 1
Equipment Compliance: No
Surface Area Compliance: Yes

There is moderate damage to the surface - Repair the damaged areas of surfacing

The end of handgrips and/or footrests have a cross section of less than 15cm² and fail to meet the requirements of BS EN 1176 Part 6 - Monitor - No remedial work recommended

The item is slightly loose in its foundations - Monitor for any further deterioration and repair as required

The paintwork on the spring has been damaged or worn exposing the metal underneath which is rusting - Treat any rusting components and repaint

The item has been damaged - Monitor for any further deterioration and replace as required

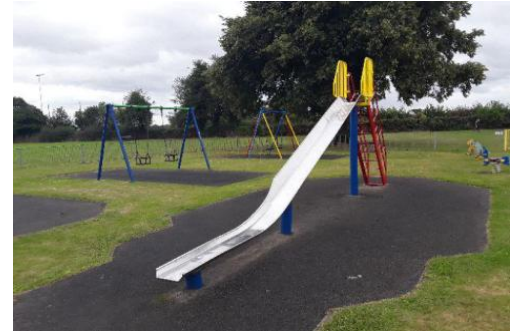
Item: Free Standing Slide
Manufacturer: Wicksteed Playgrounds
Surface Type: Wet Pour
Item Quantity: 1
Equipment Compliance: No
Surface Area Compliance: Yes

There are a number of dents in the slide surface - Monitor for any further deterioration and repair as required

The side of the slide is damaged - Monitor for any further deterioration and repair as required

The item fails to meet the requirements of BS EN 1176 Part 1 4.2.7.2 head and neck entrapment in the barriers and/or steps - Monitor - No remedial work recommended

There is / are toggle entrapment/s present in contravention of the recommendations set out in BS EN 1176 Part 1 - Monitor - no remedial work recommended

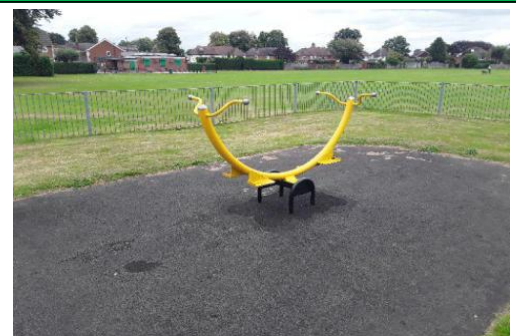
Item: Stand up SeeSaw
Manufacturer: Wicksteed Playgrounds
Surface Type: Wet Pour
Item Quantity: 1
Equipment Compliance: Yes
Surface Area Compliance: Yes

There is some minor damage to the surface - Monitor for any further deterioration and repair as required

There is some evidence of fire damage to the surfacing - Repair as required

The paintwork on this item has been damaged or worn exposing the metal underneath which is rusting / corroding - Treat affected areas and repaint

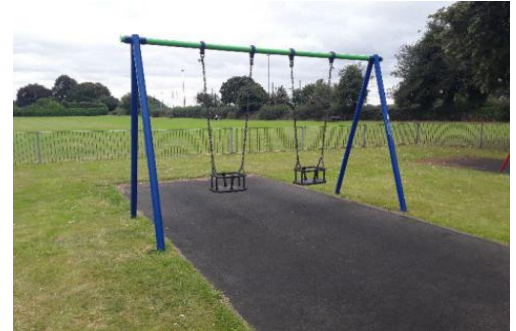
Item: 1 Bay 2 Seat (Cradle)
Manufacturer: Wicksteed Playgrounds
Surface Type: Wet Pour
Item Quantity: 1
Equipment Compliance: Yes
Surface Area Compliance: Yes

There is some minor damage to the surface - Monitor for any further deterioration and repair as required

There is some notable evidence of chain wear - Monitor for any further deterioration and replace when 40% worn

The seat has minor damage or wear - Monitor for any further deterioration and replace as required

There is some wear to the shackles - Monitor for any further deterioration and replace when 40% worn

The bushes are showing signs of wear - Monitor for any further deterioration and replace as required

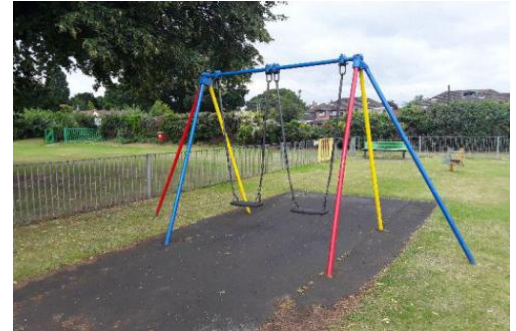
Item: 1 Bay 2 Seat (Flat)
Manufacturer: Wicksteed Playgrounds
Surface Type: Wet Pour
Item Quantity: 1
Equipment Compliance: No
Surface Area Compliance: Yes

There is some tree debris on the surfacing - Remove and maintain

There is some minor damage to the surface - Monitor for any further deterioration and repair as required

The seats are too close to each other as defined in BS EN 1176 Part 2; this is a low risk failure and no remedial action is required - Monitor - No remedial work recommended

The paintwork on this item has been damaged or worn exposing the metal underneath which is rusting / corroding - Treat affected areas and repaint

The chain openings are in excess of 8.6mm and do not meet the recommendations of BS EN 1176 Part 1 - Monitor - No remedial work recommended

The connecting lugs are showing signs of wear - Monitor for any further deterioration and repair as required

The bushes are worn or missing - Replace worn or missing bushes

The safety surface around the area is beginning to wear - Monitor for any further deterioration and repair as required

The seats are too close to the frame as defined in BS EN 1176 Part 2; this is a low risk failure and no remedial action is required - Monitor - No remedial work recommended

The swing seat connectors are loose - Tighten to secure

The seat has minor damage or wear - Monitor for any further deterioration and replace as required

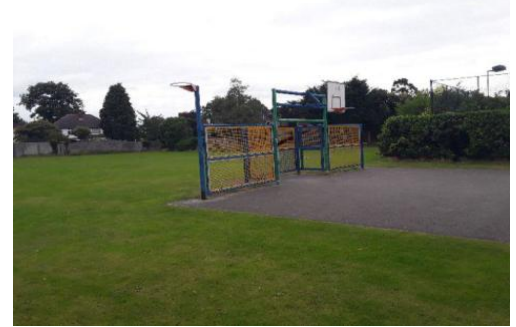
Item: Goal End
Manufacturer: Wicksteed Playgrounds
Surface Type: Bitmac
Item Quantity: 1
Equipment Compliance: Yes
Surface Area Compliance: N/A

A clearly visible facility sign should be provided in a prominent position with the wording as detailed BS EN 15312- the equipment is not intended for children less than 3 years old- the warning - Do not climb on the framework or nets- the warning - Do not hang on the ring (if provided)- the warning - Do not wear rings or other jewellery- name and telephone number of the administrator- number to call in case of accident - Provide signage to BS EN 15312

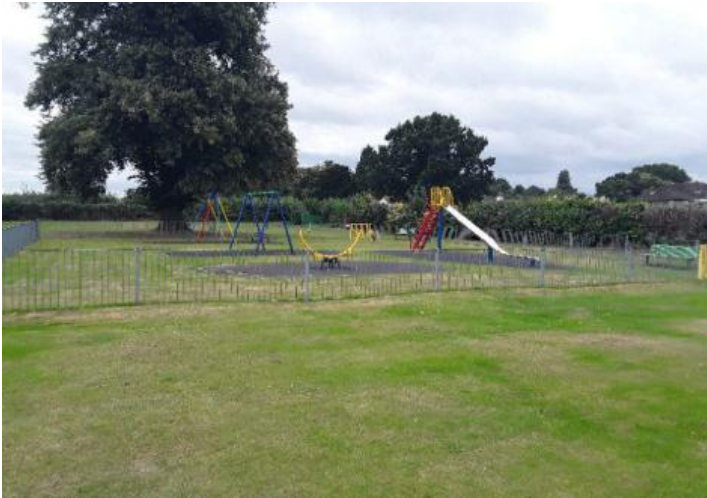
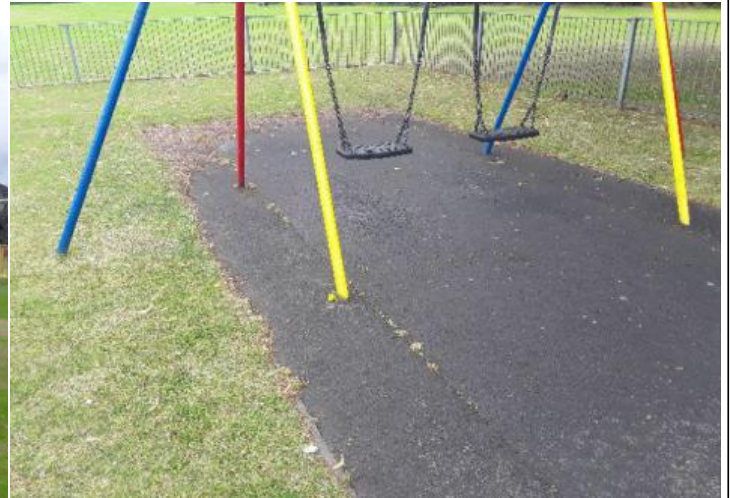
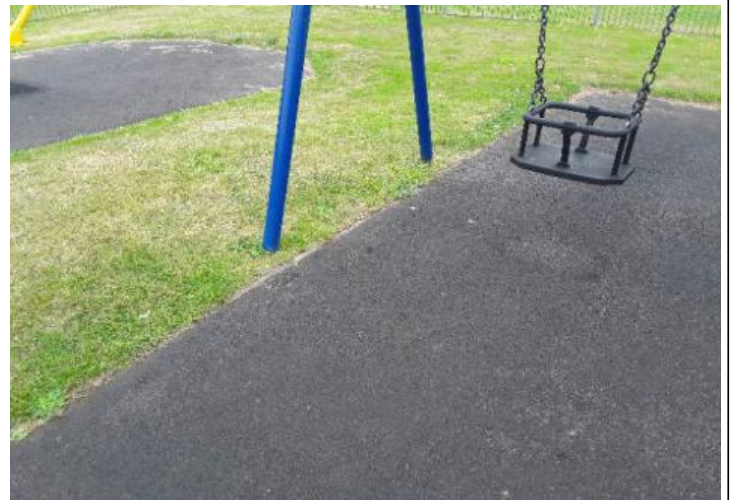
Item: Ancillary Items - Site General
Manufacturer: Owner/Operator

Finding: There is weed / vegetation growth within the surface

Action: Remove weed / vegetation growth

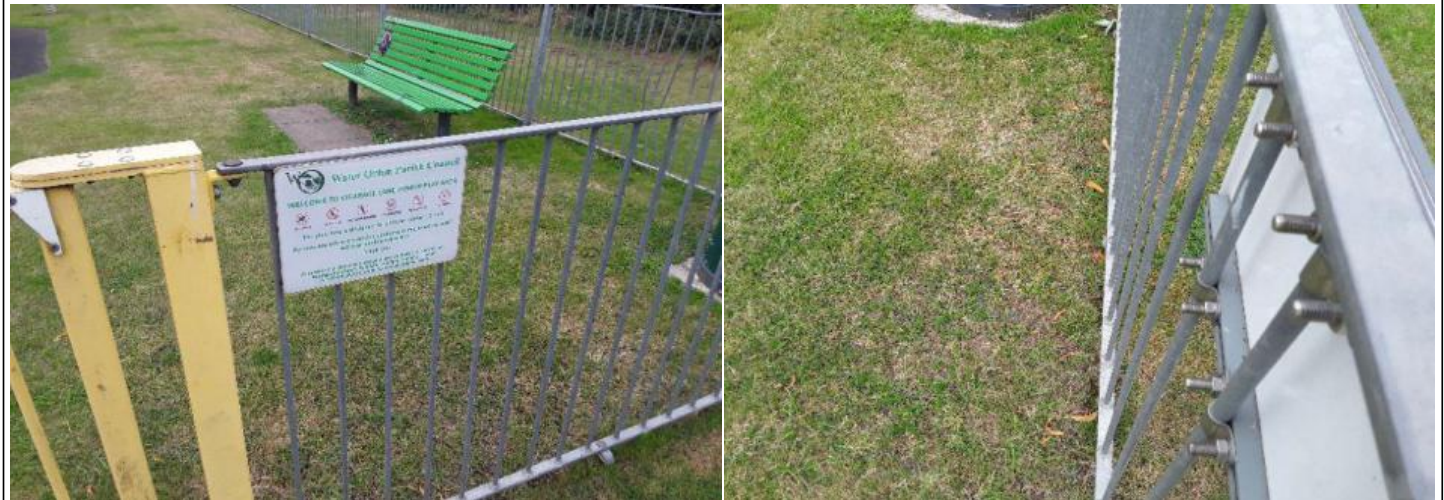
Item: Ancillary Items - Sign
Manufacturer: Not Identified
Risk Level: L - Low Risk
Surface: N/A

Finding: There are projecting bolt thread(s) present
Action: Remove excess thread length and deburr or provide cap

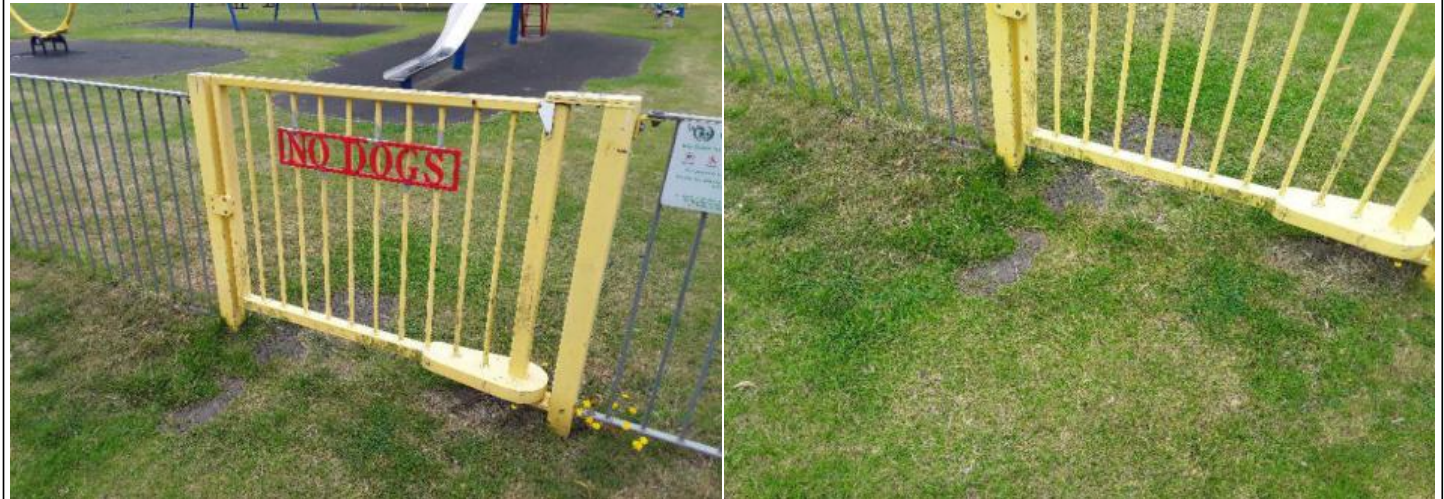
Item: Gates - Gate - Self Closing
Manufacturer: I.A.E. Fencing
Risk Level: L - Low Risk
Surface: Grass

Finding: The grass mats are silted up, the soil is compacted and the area will become very slippery when the soil is wet.
Action: Reinstate as required

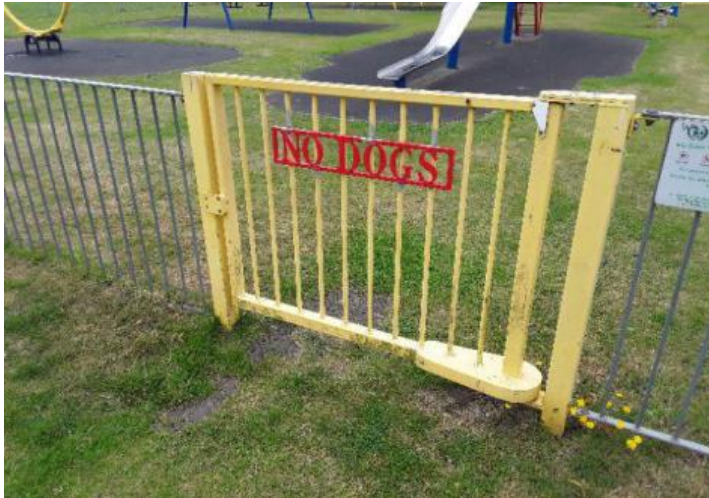
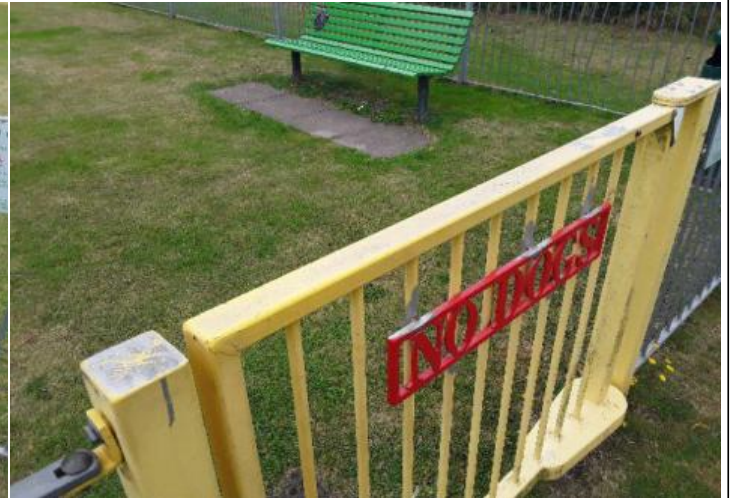
Item: Gates - Gate - Self Closing
Manufacturer: I.A.E. Fencing

Finding: There is some graffiti present

Action: Remove the graffiti

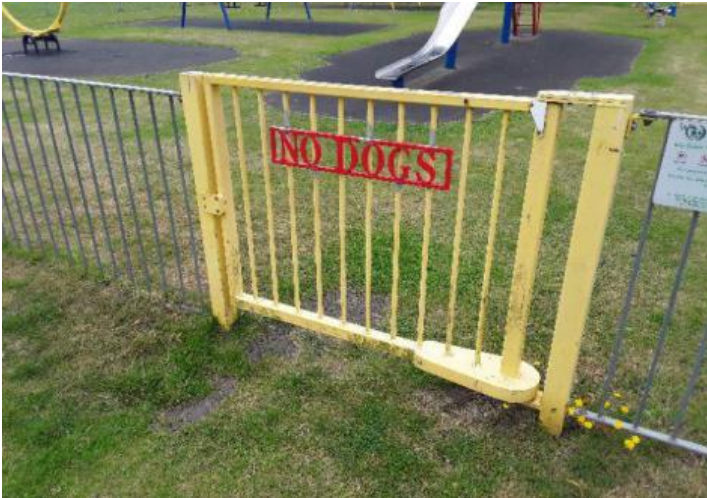
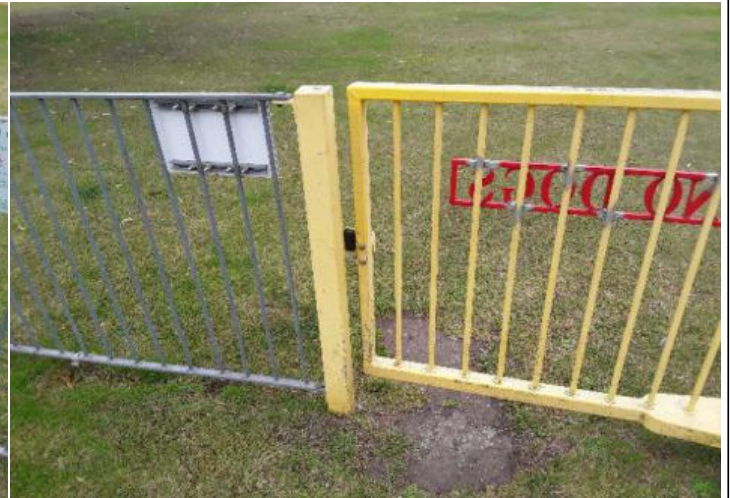
Item: Gates - Gate - Self Closing
Manufacturer: I.A.E. Fencing

Finding: The gate is not operating correctly

Action: Take effective action to ensure the gate closes between 4 and 8 seconds

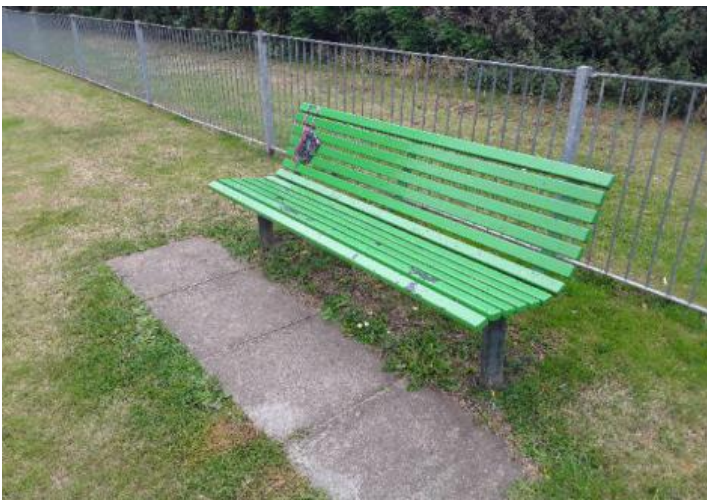
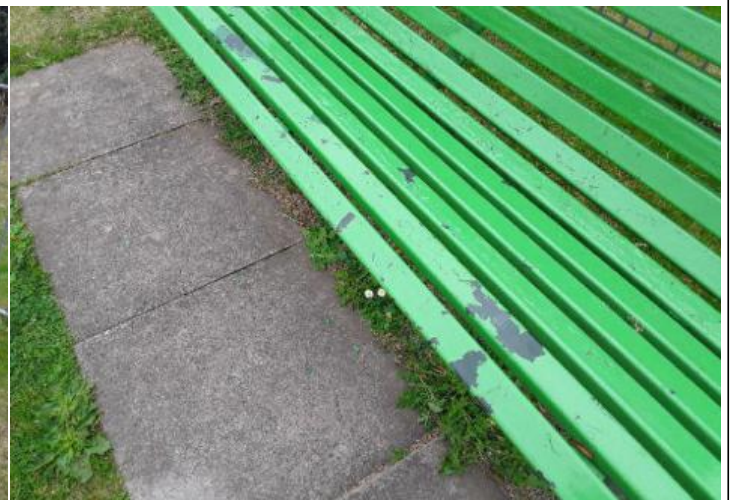
Item: Ancillary Items - Bench
Manufacturer: Not Identified

Finding: The paint is flaking off the metalwork

Action: Rub down and re-paint

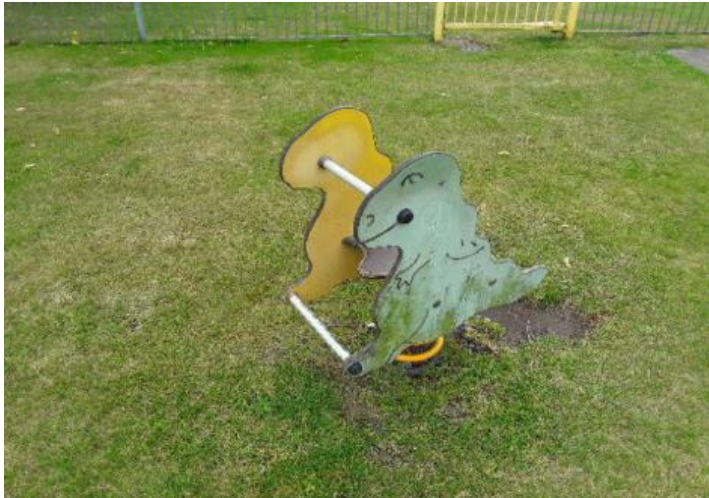
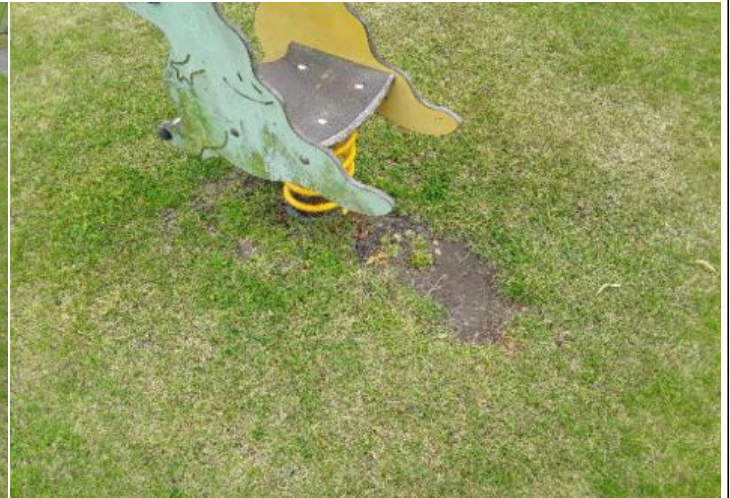
Item: Rocking Equipment - Spring Dino
Manufacturer: Hags

Finding: The grass has eroded within the impact area of the equipment and may not provide the necessary impact attenuating properties for the equipment fall height; the surface may also be slippery in wet weather
Action: Reinststate the grass or provide an all weather surface

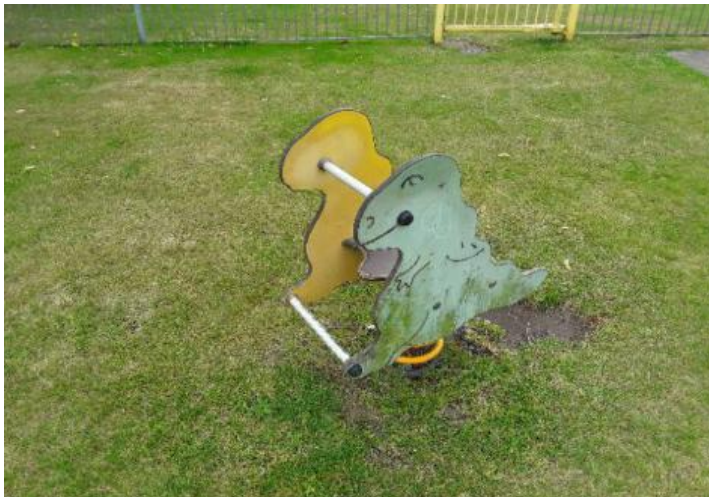
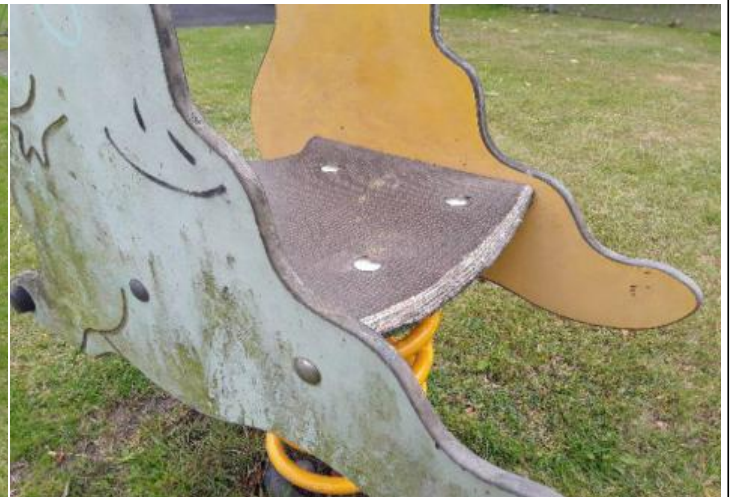
Item: Rocking Equipment - Spring Dino
Manufacturer: Hags

Finding: Parts of the timber are rough or splintered
Action: Remove all rough or sharp edges

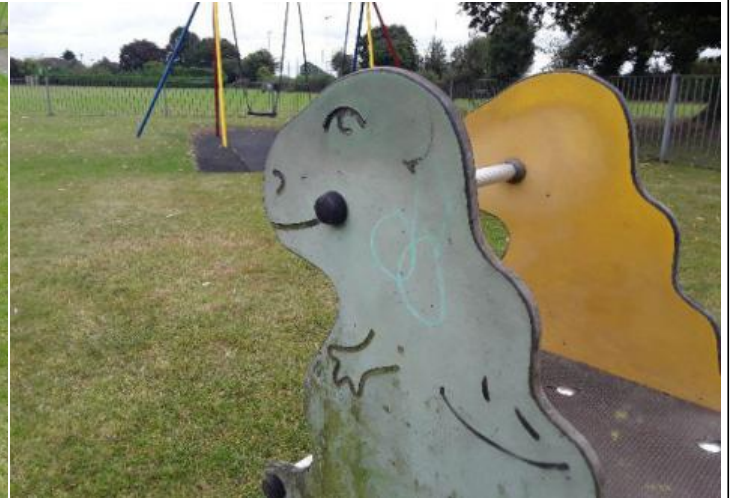
Item: Rocking Equipment - Spring Dino
Manufacturer: Hags

Finding: There is offensive graffiti present

Action: Remove as soon as practicable

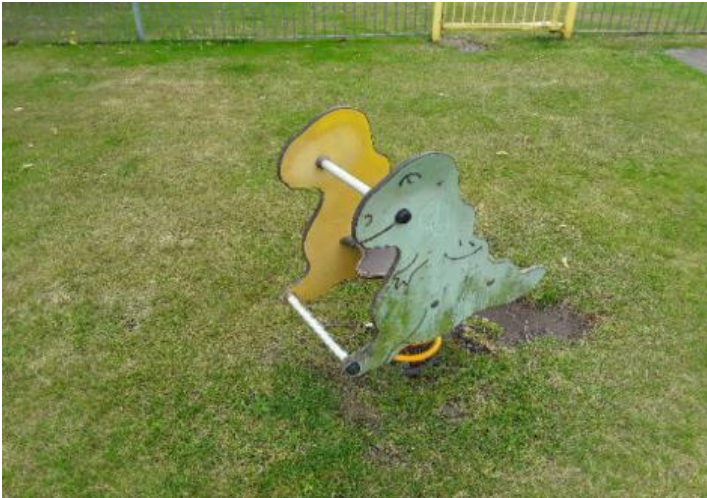
Item: Rocking Equipment - Spring Dino
Manufacturer: Hags

Finding: The item is slightly loose in its foundations

Action: Monitor for any further deterioration and repair as required

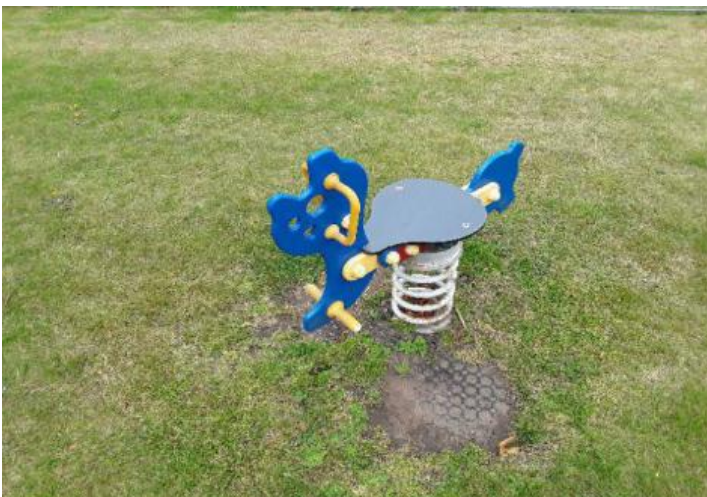
Item: Rocking Equipment - Spring Dog
Manufacturer: Wicksteed Playgrounds

Finding: There is moderate damage to the surface

Action: Repair the damaged areas of surfacing

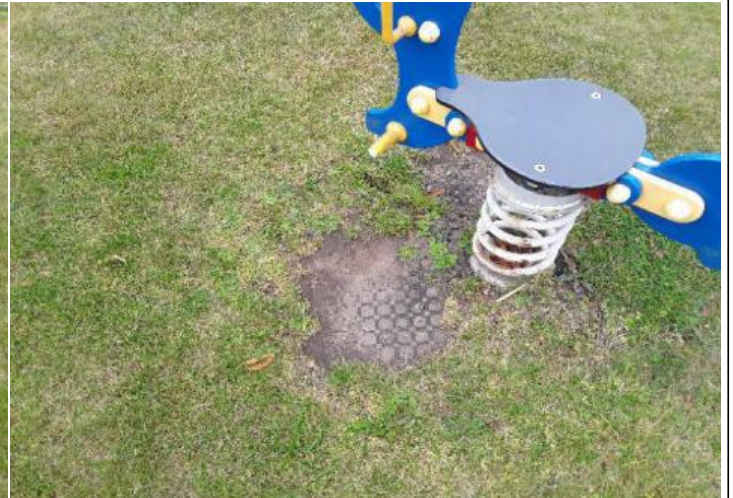
Item: Rocking Equipment - Spring Dog
Manufacturer: Wicksteed Playgrounds

Finding: The grass mats are silted up, the soil is compacted and the area will become very slippery when the soil is wet. **Action:** Reinstate as required

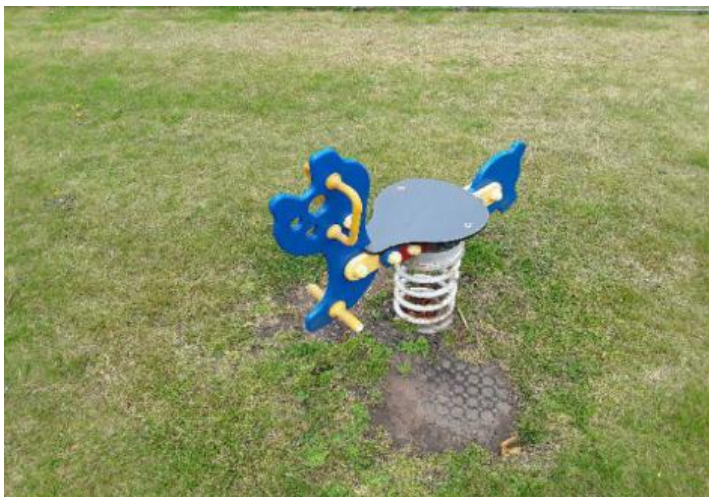
Item: Rocking Equipment - Spring Dog
Manufacturer: Wicksteed Playgrounds

Finding: The end of handgrips and/or footrests have a cross section of less than 15cm² and fail to meet the requirements of BS EN 1176 Part 6 **Action:** Monitor - No remedial work recommended

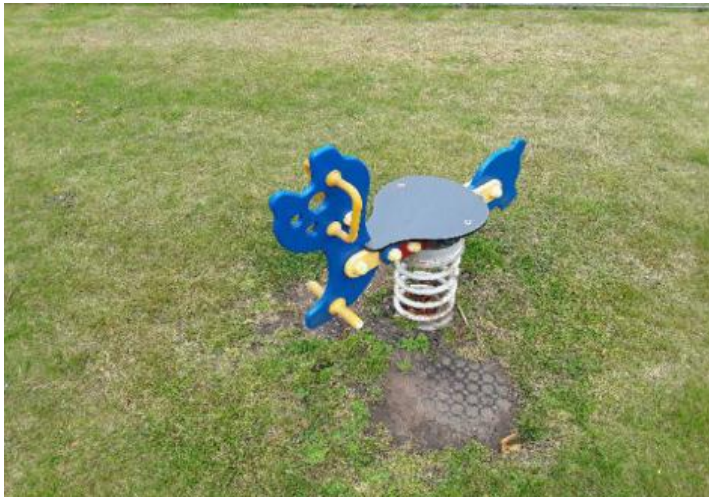
Item: Rocking Equipment - Spring Dog
Manufacturer: Wicksteed Playgrounds

Finding: The item is slightly loose in its foundations
Action: Monitor for any further deterioration and repair as required

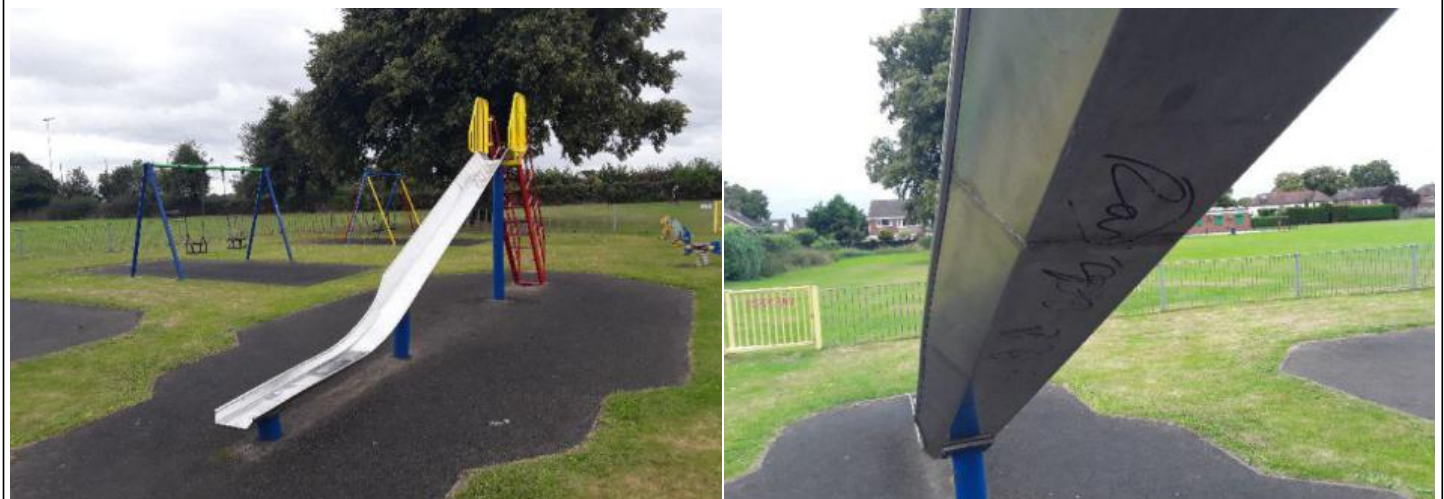
Item:	Other - Free Standing Slide	Risk Level:	N - Risk Assessment not Undertaken
Manufacturer:	Wicksteed Playgrounds	Surface:	Wet Pour

Finding:	There is some graffiti present	Action:	Remove the graffiti
-----------------	--------------------------------	----------------	---------------------

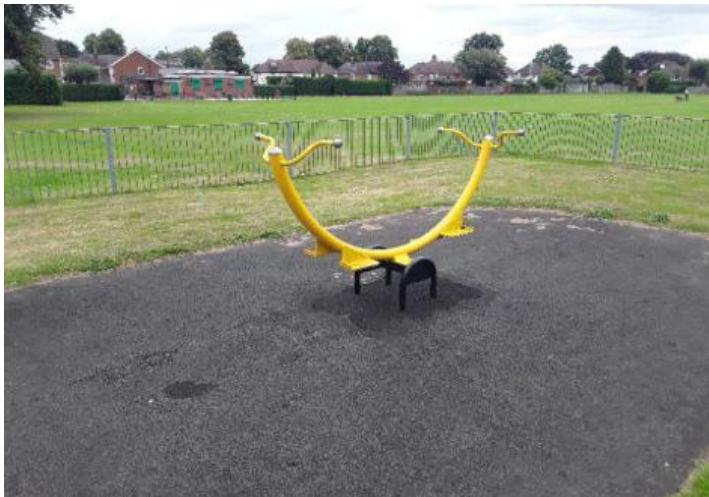
Item: Rocking Equipment - Stand up SeeSaw
Manufacturer: Wicksteed Playgrounds

Finding: There is some minor damage to the surface

Action: Monitor for any further deterioration and repair as required

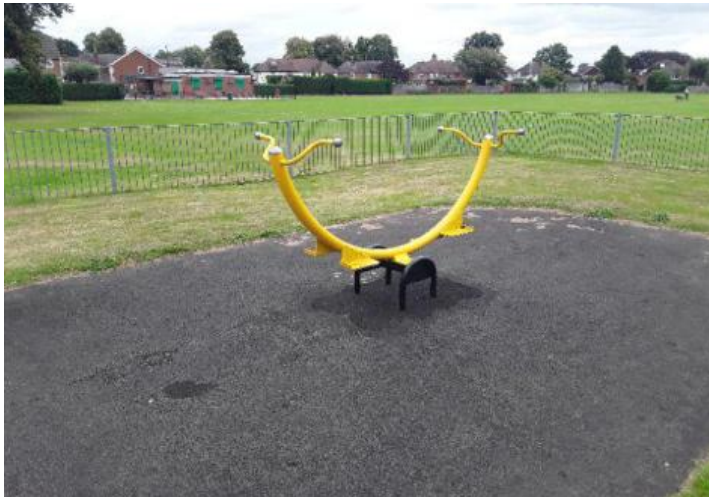
Item: Rocking Equipment - Stand up SeeSaw
Manufacturer: Wicksteed Playgrounds

Finding: The paintwork on this item has been damaged or worn exposing the metal underneath which is rusting / corroding

Action: Treat affected areas and repaint

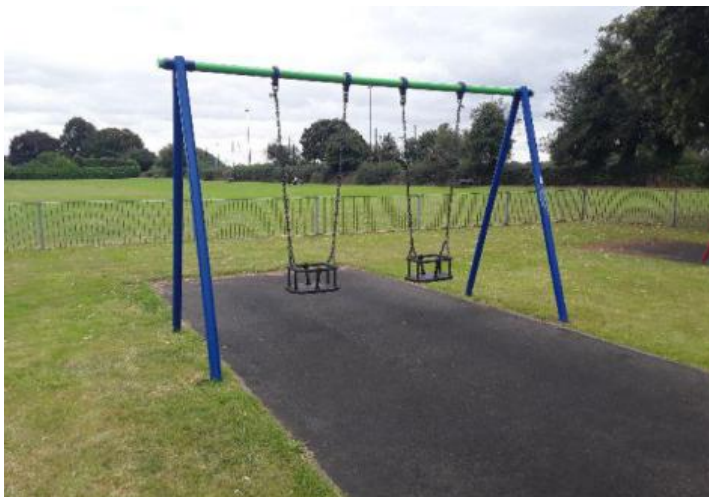
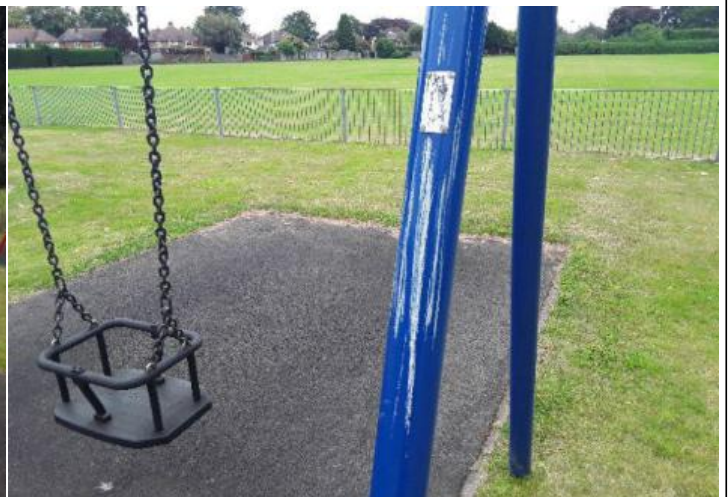
Item: Swings - 1 Bay 2 Seat (Cradle)
Manufacturer: Wicksteed Playgrounds

Risk Level: N - Risk Assessment not Undertaken
Surface: Wet Pour

Finding: There is some graffiti present

Action: Remove the graffiti

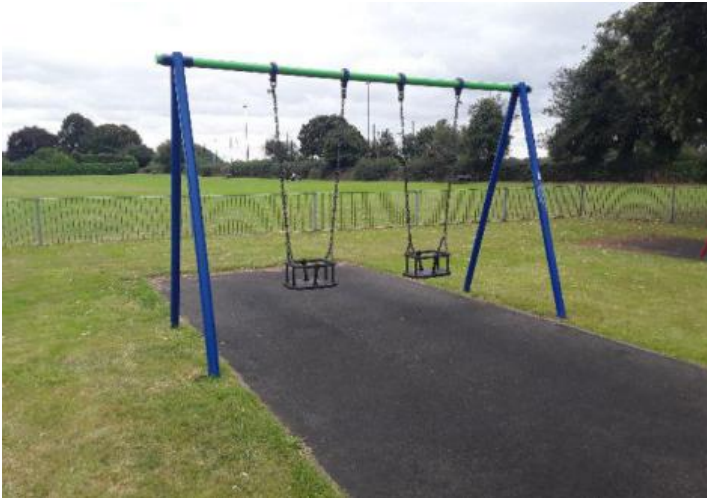
Item: Swings - 1 Bay 2 Seat (Cradle)
Manufacturer: Wicksteed Playgrounds

Risk Level: L - Low Risk
Surface: Wet Pour

Finding: There is some notable evidence of chain wear

Action: Monitor for any further deterioration and replace when 40% worn

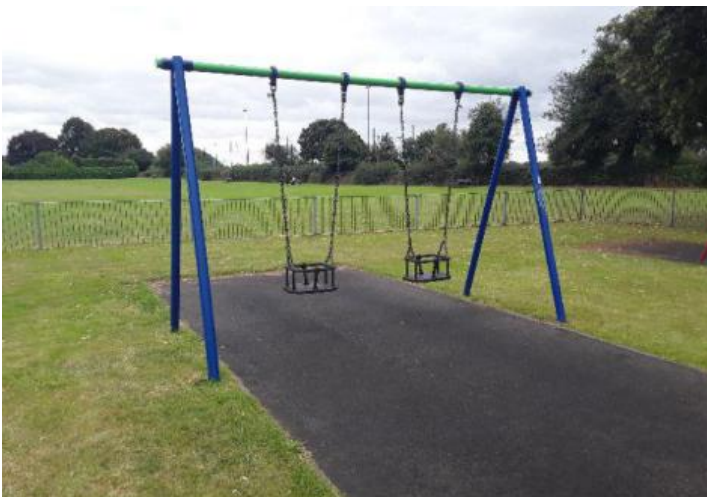
Item: Swings - 1 Bay 2 Seat (Cradle)
Manufacturer: Wicksteed Playgrounds

Risk Level: L - Low Risk
Surface: Wet Pour

Finding: The seat has minor damage or wear

Action: Monitor for any further deterioration and replace as required

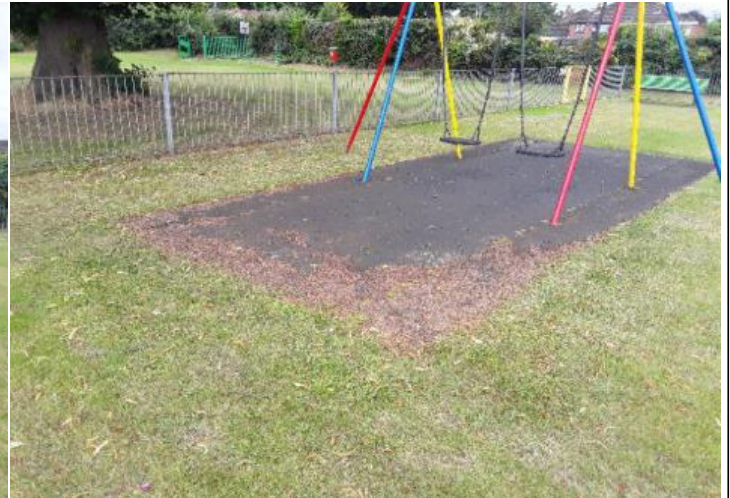
Item: Swings - 1 Bay 2 Seat (Flat)
Manufacturer: Wicksteed Playgrounds

Risk Level: L - Low Risk
Surface: Wet Pour

Finding: There is some tree debris on the surfacing

Action: Remove and maintain

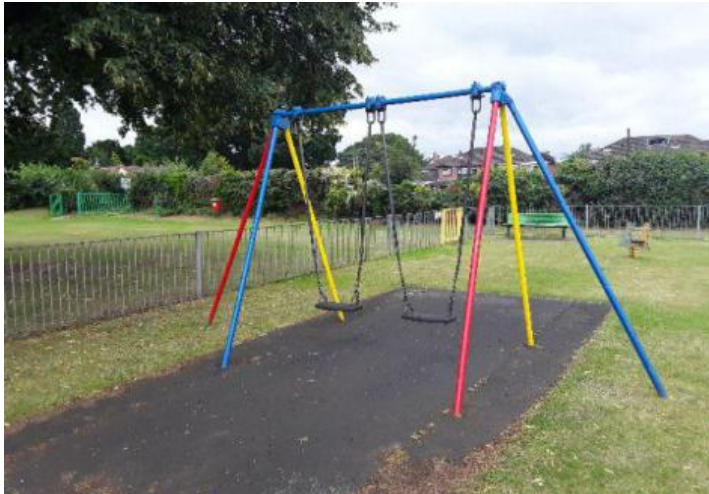
Item: Swings - 1 Bay 2 Seat (Flat)
Manufacturer: Wicksteed Playgrounds

Risk Level: L - Low Risk
Surface: Wet Pour

Finding: The safety surface around the area is beginning to wear

Action: Monitor for any further deterioration and repair as required

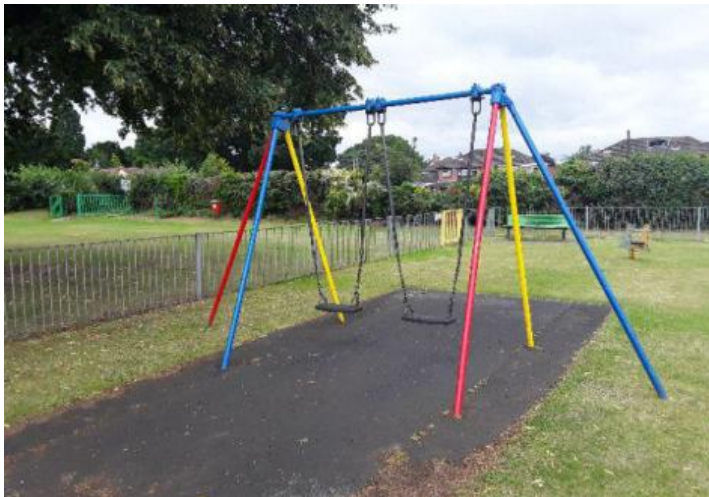
Item: Swings - 1 Bay 2 Seat (Flat)
Manufacturer: Wicksteed Playgrounds

Risk Level: L - Low Risk
Surface: Wet Pour

Finding: The swing seat connectors are loose
Action: Tighten to secure

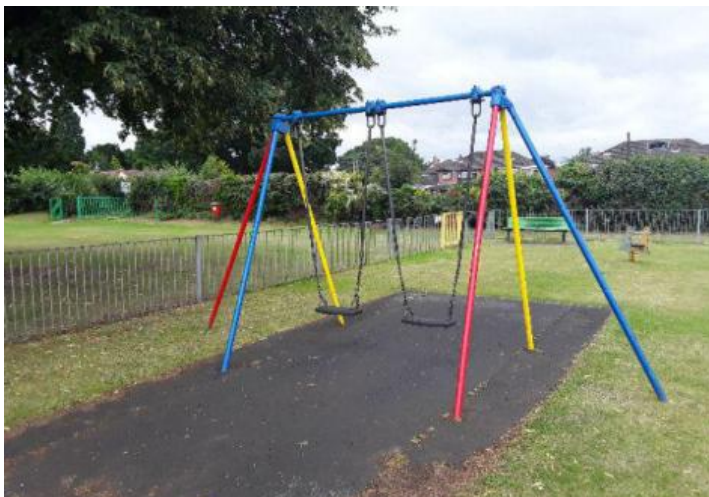
Item: Swings - 1 Bay 2 Seat (Flat)
Manufacturer: Wicksteed Playgrounds

Risk Level: L - Low Risk
Surface: Wet Pour

Finding: There is some notable evidence of chain wear

Action: Monitor for any further deterioration and replace when 40% worn

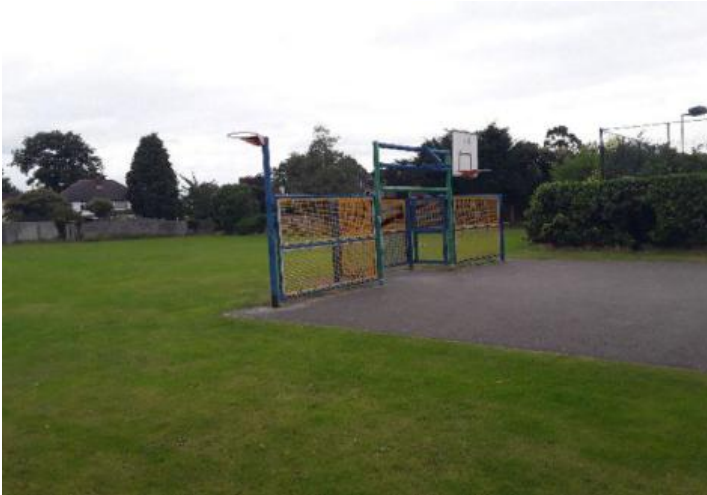
Item: Multi Use Games Area - Goal End
Manufacturer: Wicksteed Playgrounds

Risk Level: M - Moderate Risk
Surface: Bitmac

Finding: Parts of the steel on this item have corroded excessively and the metal has perforated in places

Action: Ensure all affected areas are treated and repaired

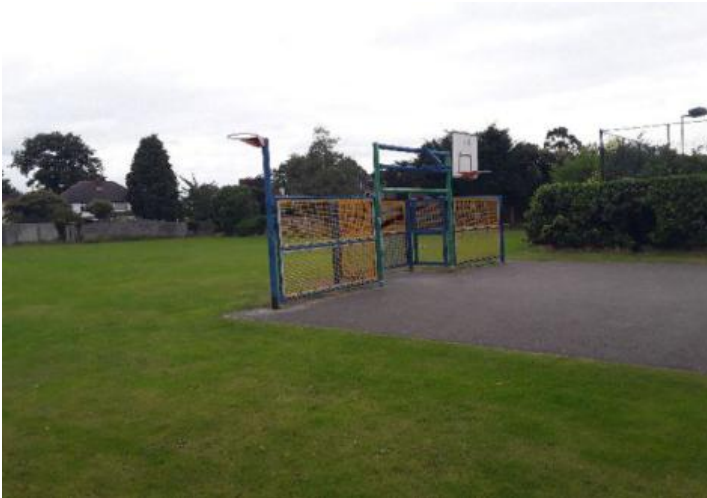
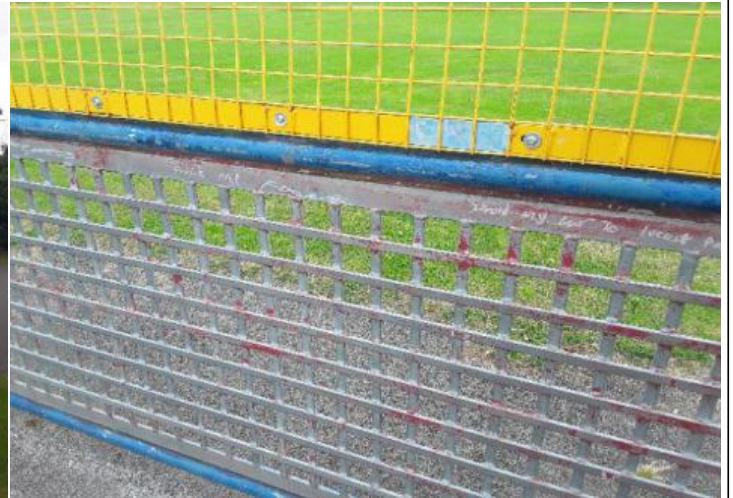
Item: Multi Use Games Area - Goal End
Manufacturer: Wicksteed Playgrounds

Risk Level: N - Risk Assessment not Undertaken
Surface: Bitmac

Finding: There is offensive graffiti present

Action: Remove as soon as practicable

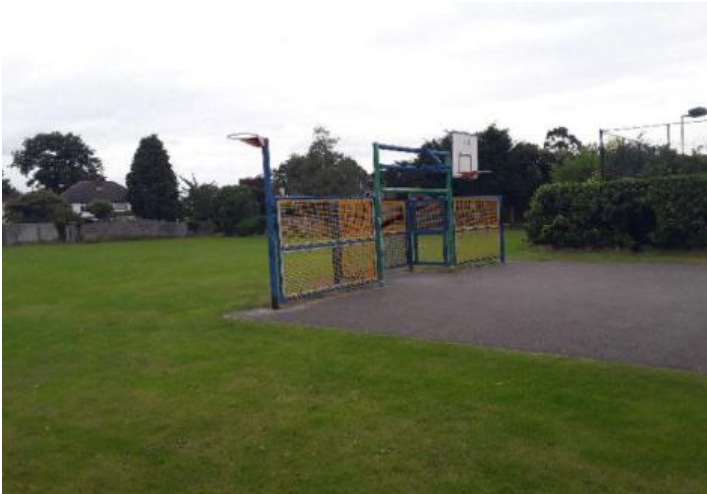
Item: Multi Use Games Area - Goal End
Manufacturer: Wicksteed Playgrounds

Risk Level: L - Low Risk
Surface: Bitmac

Finding: The paintwork on this item has been damaged or worn exposing the metal underneath which is rusting / corroding

Action: Treat affected areas and repaint
