the **play inspection** company

Annual Inspection

North Warwickshire Borough Council

Vicarage Lane

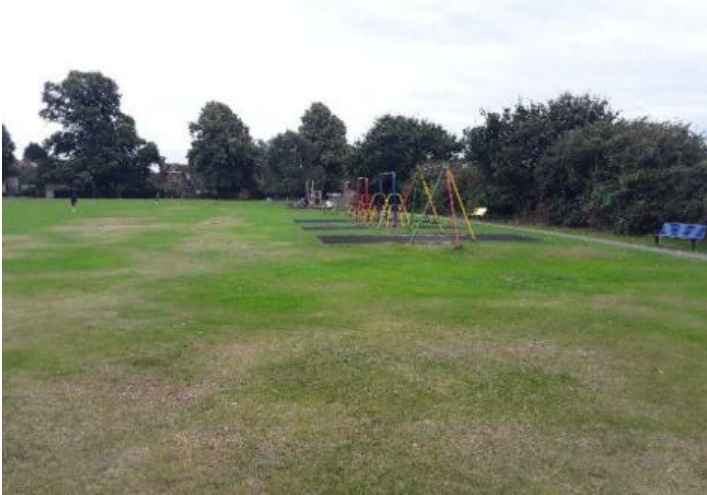
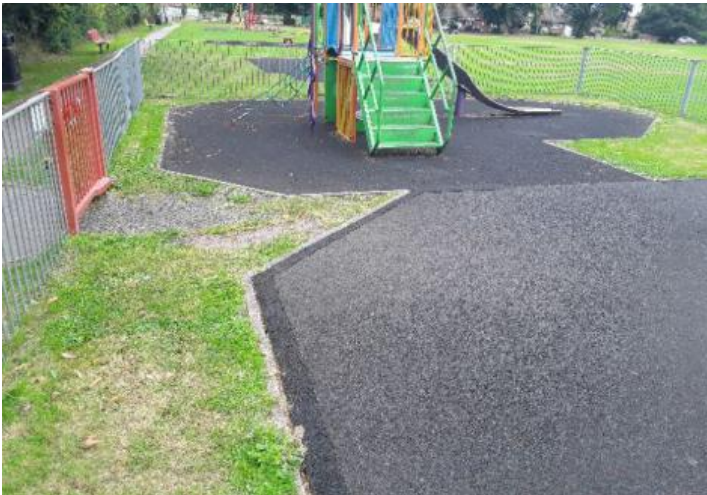
Finding: There are trip hazards at the edges of the surface **Action:** Remove trip hazard

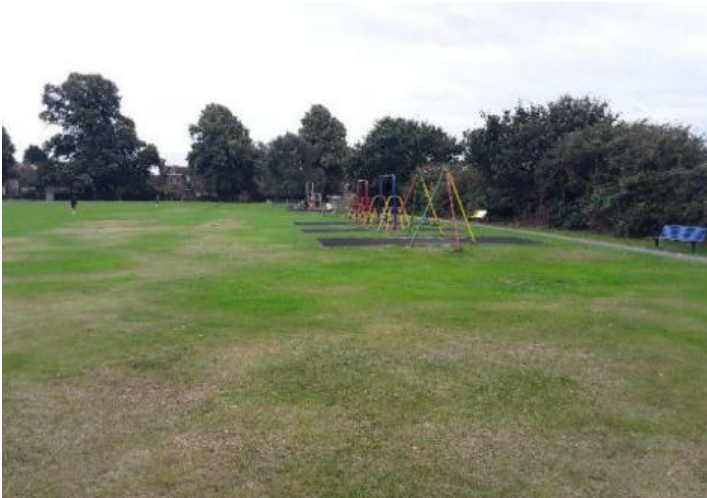
Finding: There are significant gaps (over 30mm) between the surface and the edging or between the joints in the surface; these are large enough for a small foot to enter

Action: Repair surfacing

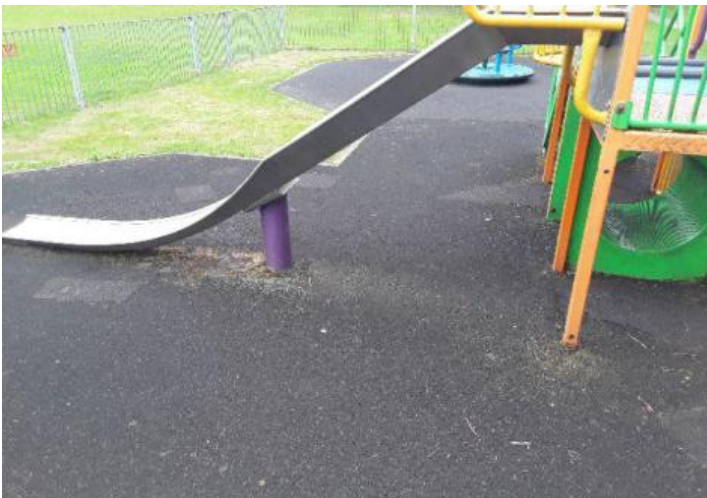
Finding: There is algae, silt or moss growth on the surface resulting in slippery conditions

Action: Clean and treat appropriately

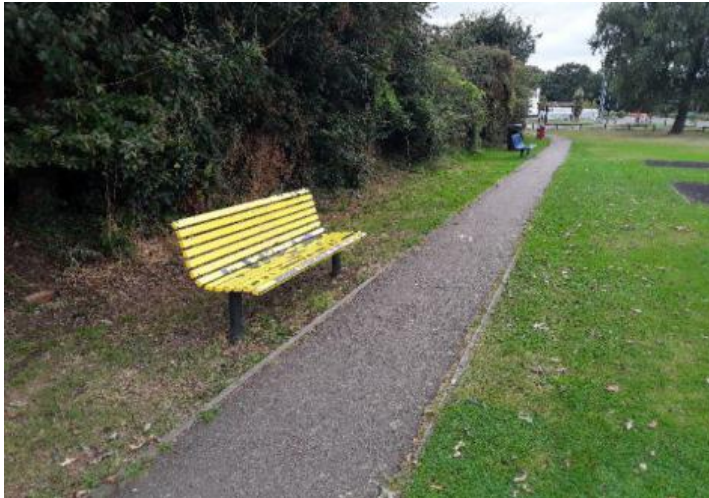
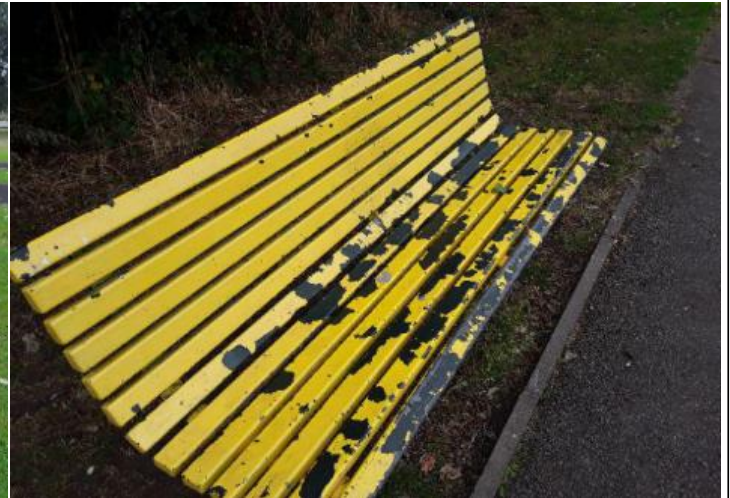
Finding: The paint is flaking off the metalwork

Action: Rub down and re-paint

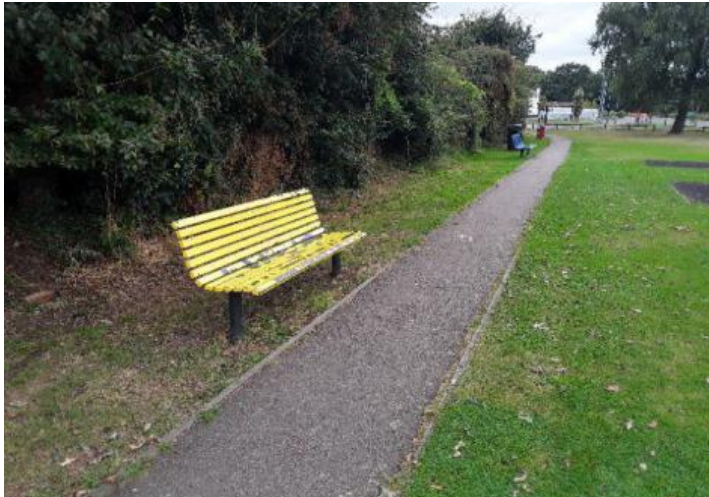
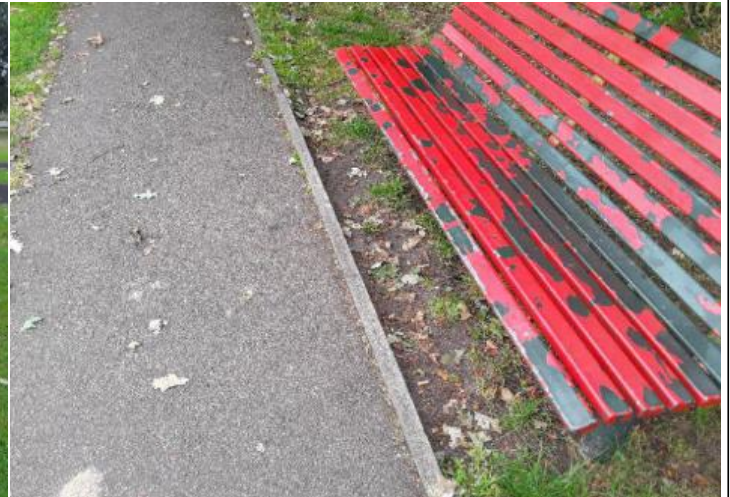
Finding: The area around the item has eroded and may become slippery

Action: Reinstate eroded area

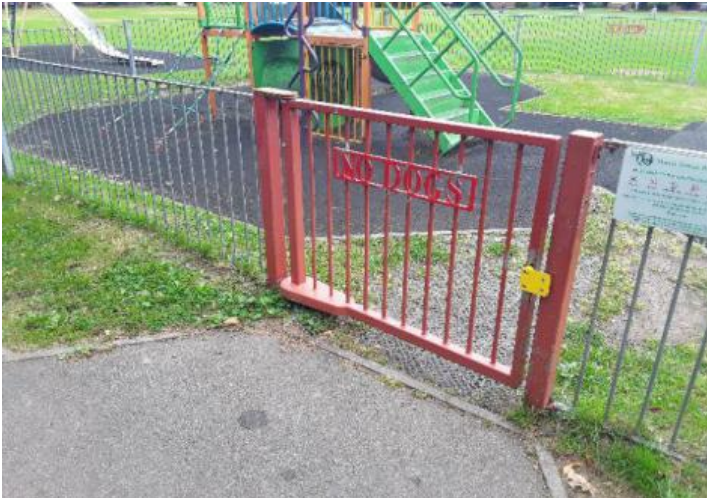
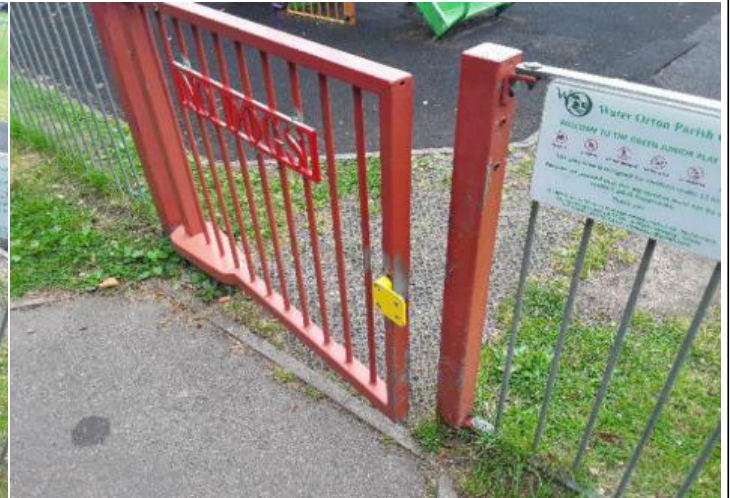
Finding: The gate is not operating correctly

Action: Take effective action to ensure the gate closes between 4 and 8 seconds

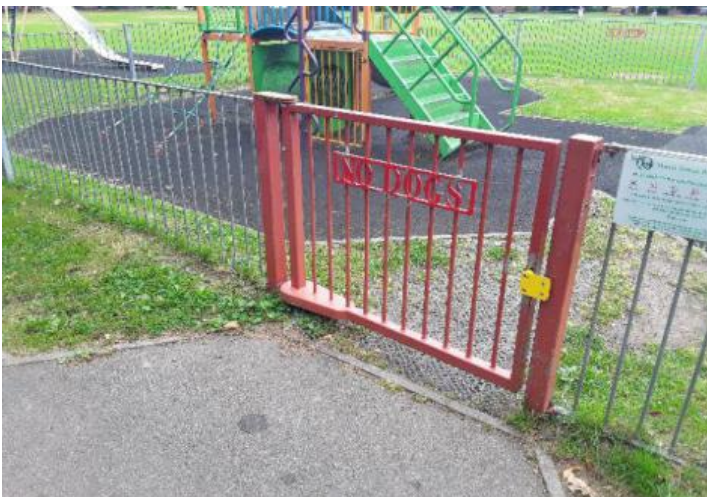
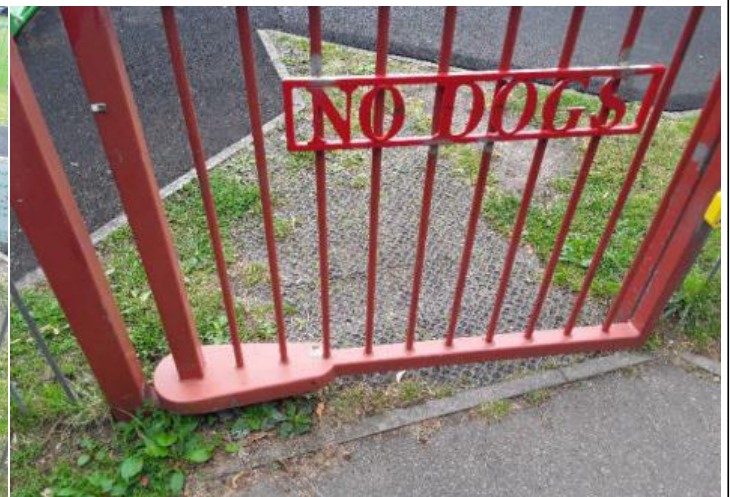
Finding: The grass mats are silted up, the soil is compacted and the area will become very slippery when the soil is wet.

Action: Reinstate as required

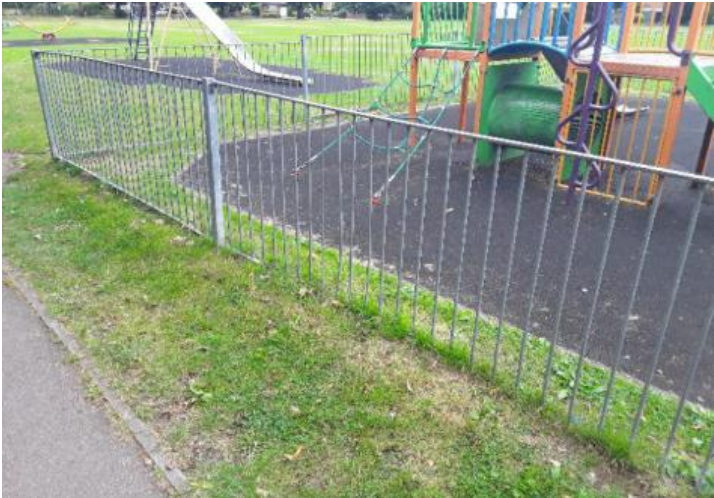
Finding: There are a number of loose posts around the fence

Action: Monitor for any further deterioration and reset as required

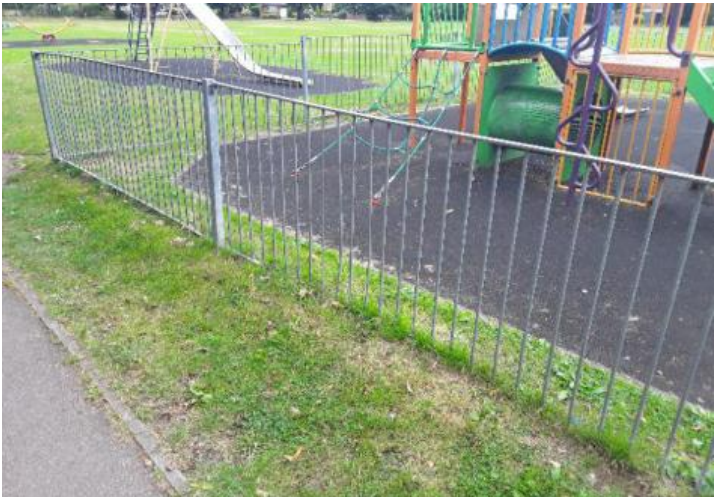
Finding: There is some damage to the fence sections

Action: Monitor for any further deterioration and repair as required

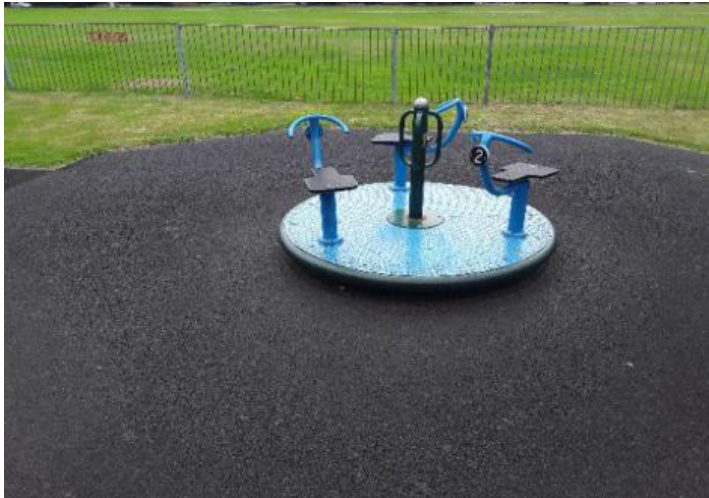
Finding: The surface is lifting at the edges and creating trip points
Action: Repair perimeter of surfacing to remove trip points

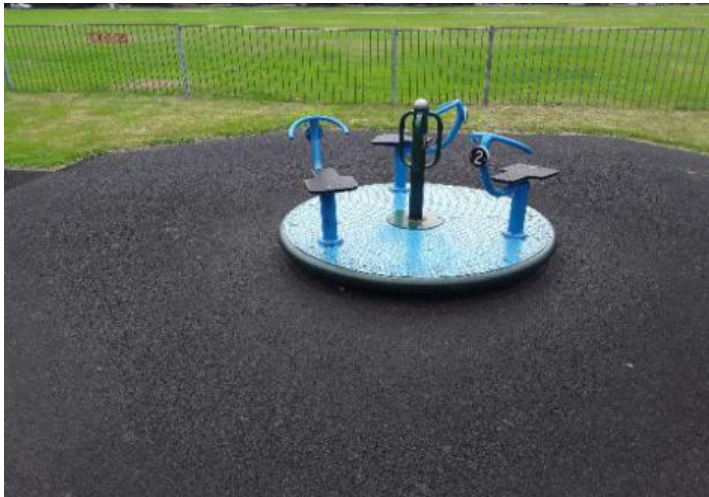
Finding: The safety surface around the area is beginning to wear
Action: Monitor for any further deterioration and repair as required

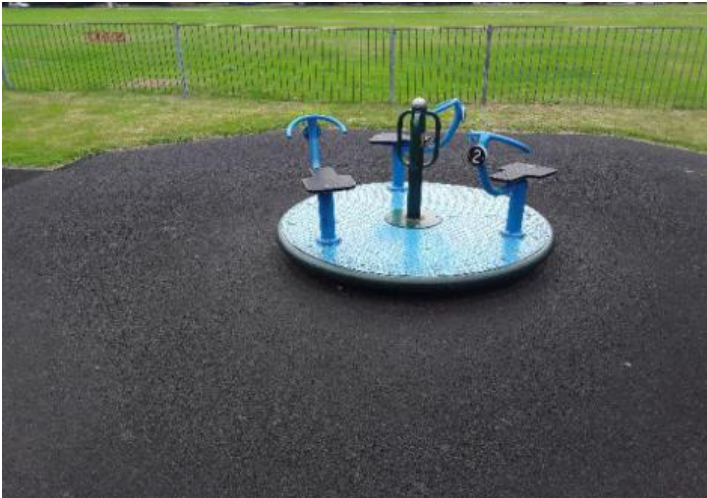
Finding: The ground clearance is not maintained under the roundabout for 300mm without deviations as required by BS EN 1176 Part 5 Clause 5.2.3
Action: Monitor - No remedial work recommended

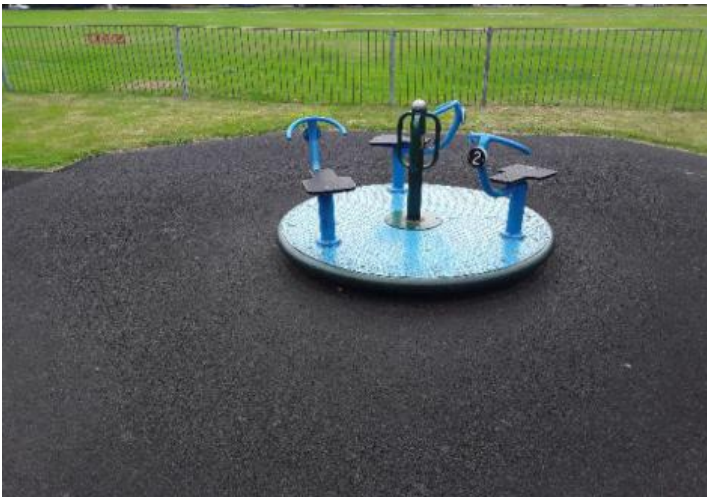
Finding: The paintwork on this item has been damaged or worn exposing the metal underneath which is rusting / corroding
Action: Treat affected areas and repaint

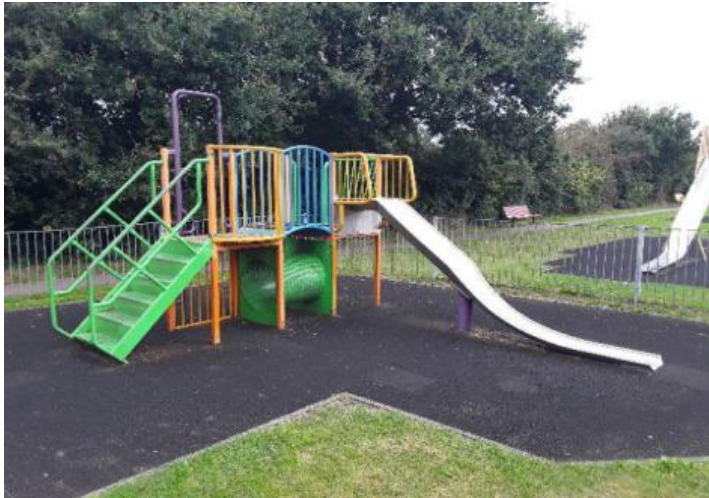
Finding: There is some minor damage to the surface

Action: Monitor for any further deterioration and repair as required

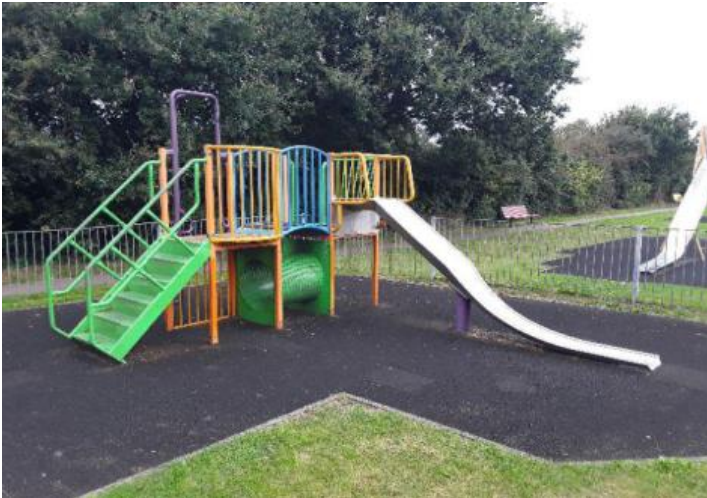
Finding: The ropes/nets are worn/damaged in places

Action: Monitor for any further deterioration and repair or replace as required

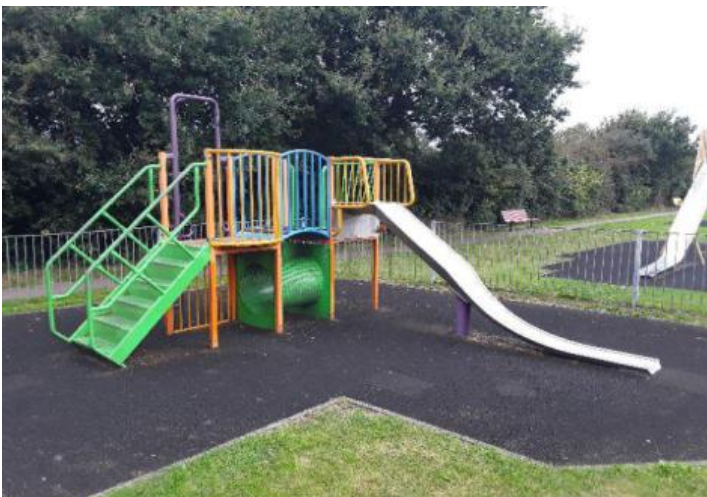
Finding: The side of the slide is damaged

Action: Monitor for any further deterioration and repair as required

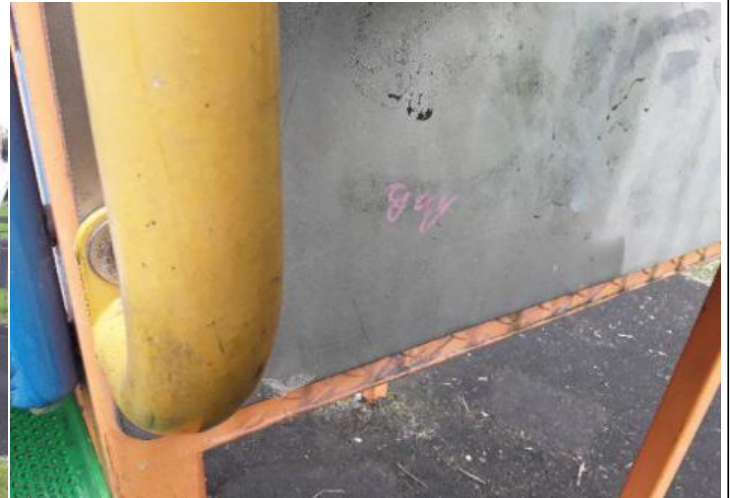
Finding: There is offensive graffiti present

Action: Remove as soon as practicable

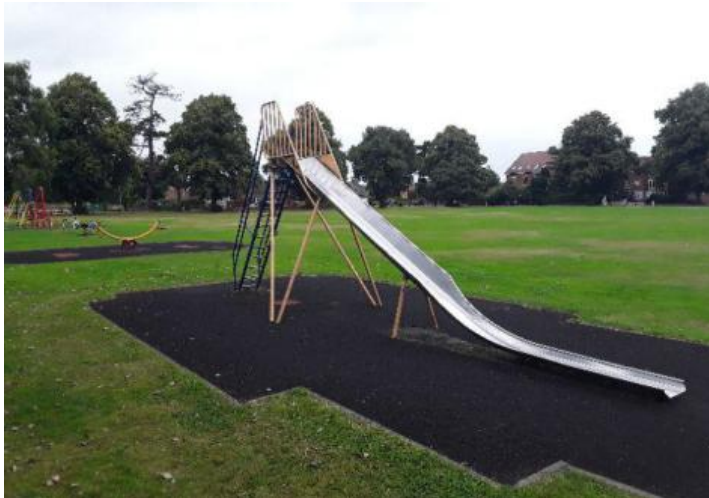
Finding: There is some minor damage to the surface

Action: Monitor for any further deterioration and repair as required

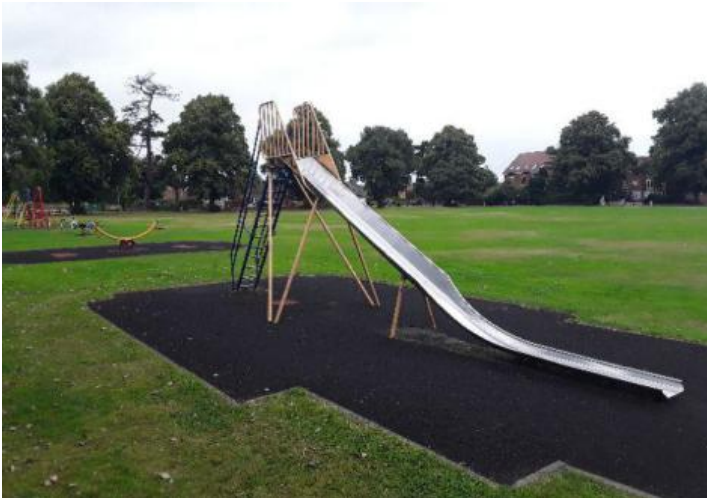
Finding: The slide is predominately south facing and will catch the majority of the sun's heat during the day. Slide surfaces can become very warm during periods of sustained sunny weather

Action: Monitor - No remedial work recommended

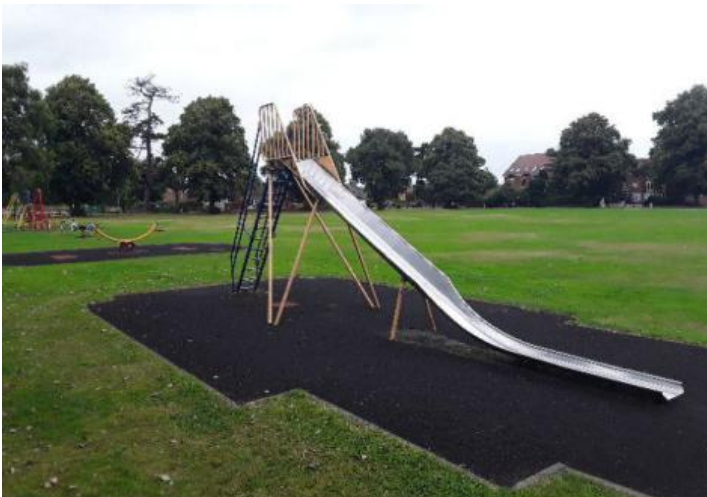
Finding: There are a number of dents in the slide surface

Action: Monitor for any further deterioration and repair as required

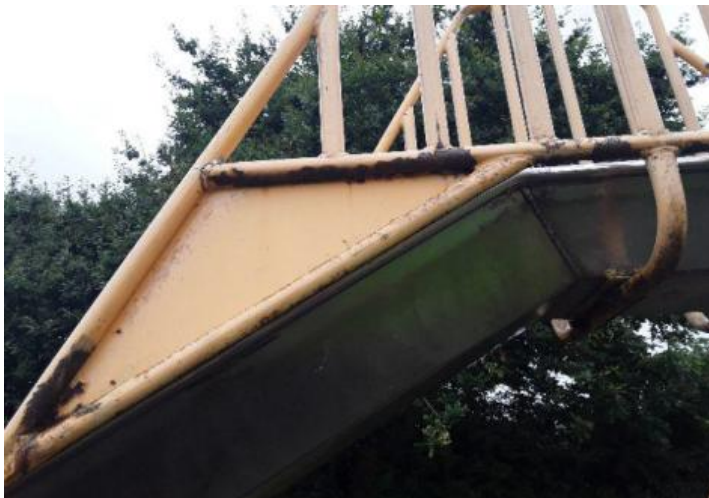
Finding: The paintwork on this item has been damaged or worn exposing the metal underneath which is rusting / corroding

Action: Treat affected areas and repaint

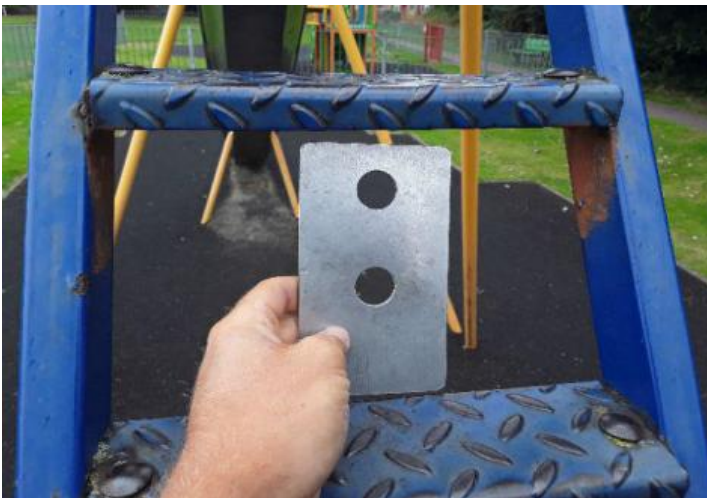
Finding: The item fails to meet the requirements of BS EN 1176 Part 1 4.2.7.2 head and neck entrapment in the barriers and/or steps

Action: Monitor - No remedial work recommended

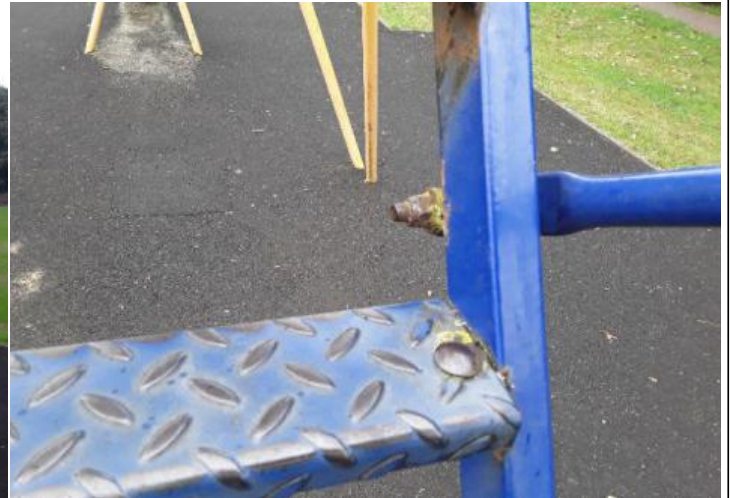
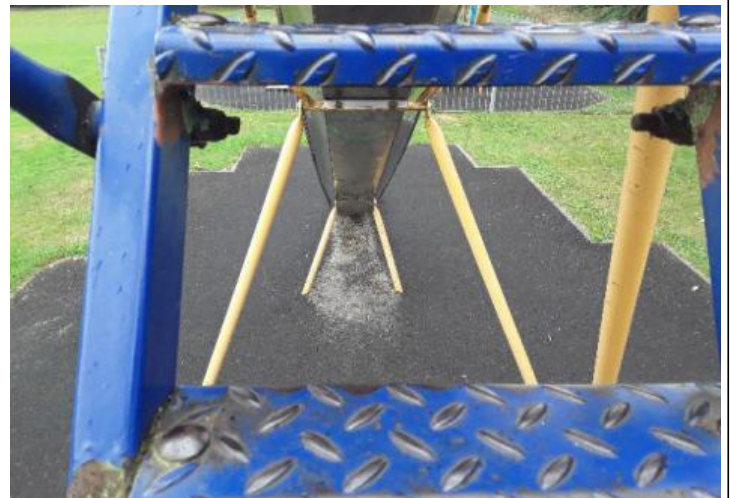
Finding: There are projecting bolt thread(s) present

Action: Remove excess thread length and deburr or provide cap

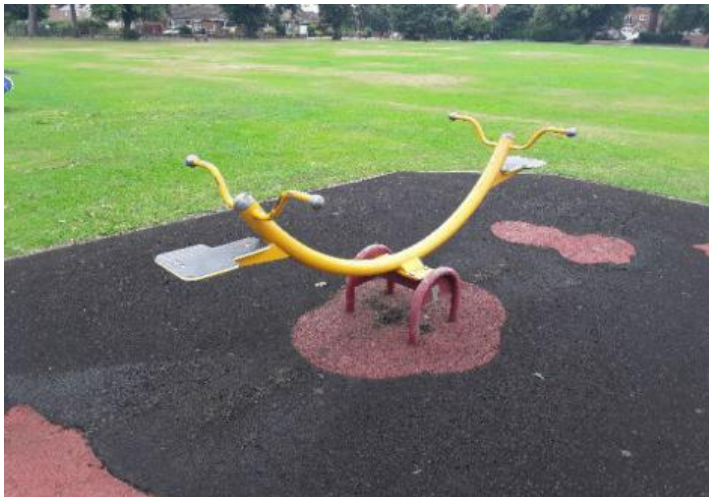
Finding: There are gaps opening between the surfacing and the edging surround or between the joints in the surfacing
Action: Monitor for any further deterioration and repair as required

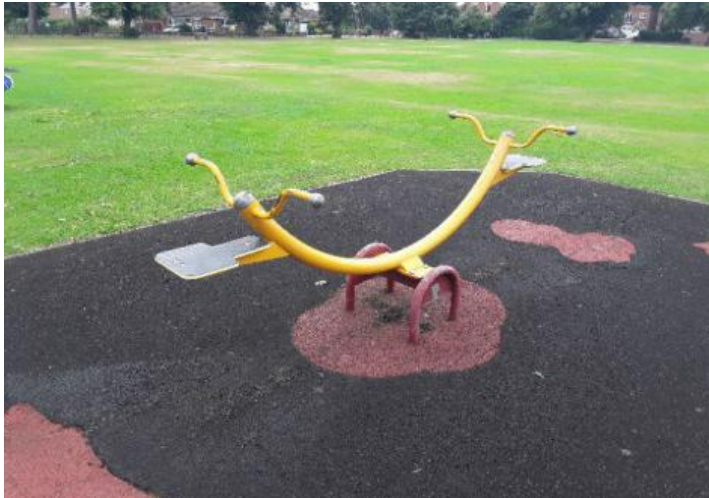
Finding: The safety surface around the area is beginning to wear

Action: Monitor for any further deterioration and repair as required

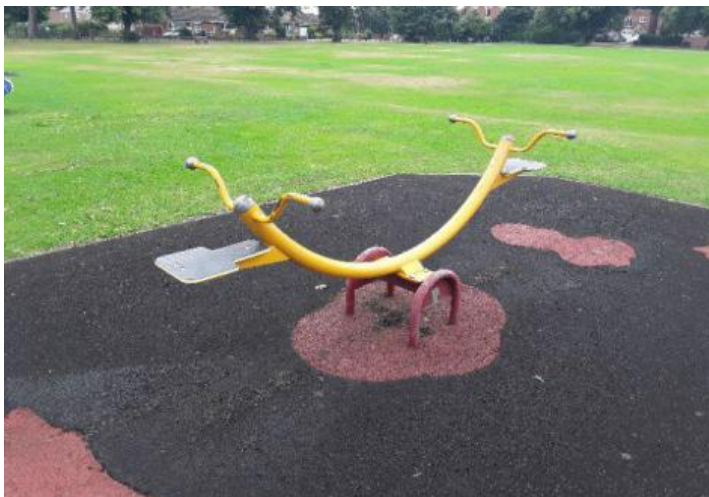
Finding: The paintwork on this item has been damaged or worn exposing the metal underneath which is rusting / corroding

Action: Treat affected areas and repaint

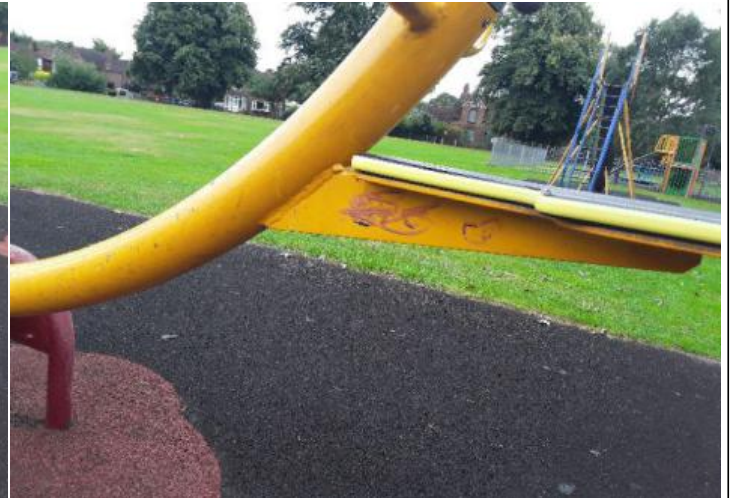
Finding: There is some graffiti present

Action: Remove the graffiti

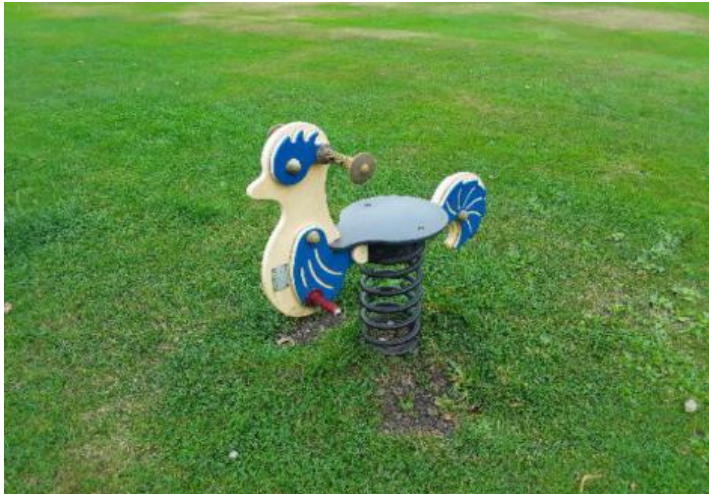
Finding: The end of handgrips and/or footrests have a cross section of less than 15cm² and fail to meet the requirements of BS EN 1176 Part 6

Action: Monitor - No remedial work recommended

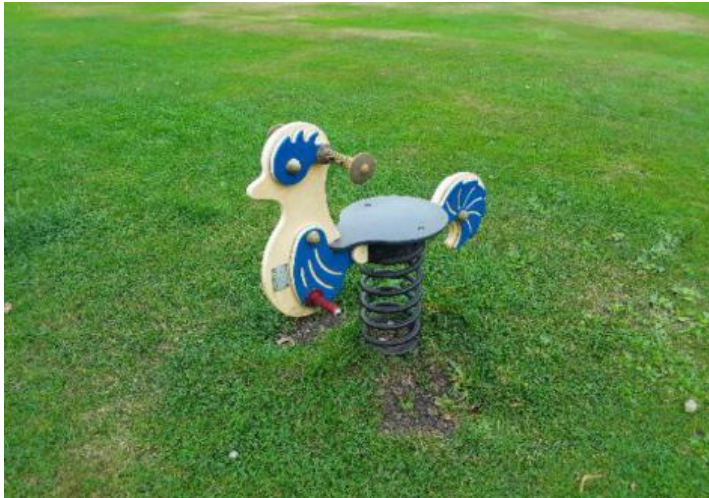
Finding: A number of fixing(s) have worked loose

Action: Secure all loose fixings

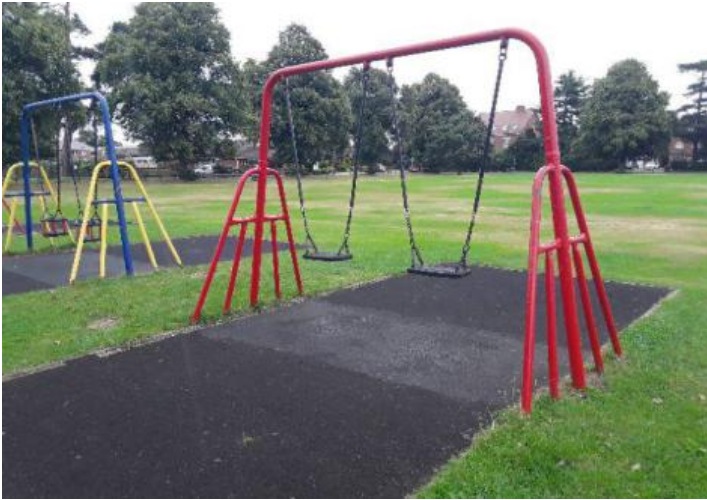
Finding: The surfacing width under the seat/s is / are less than 875mm when measured from the centre of the seat outwards due to damaged surfacing, and fails the requirements of BS EN 1176 Part 2

Action: Repair damaged surfacing

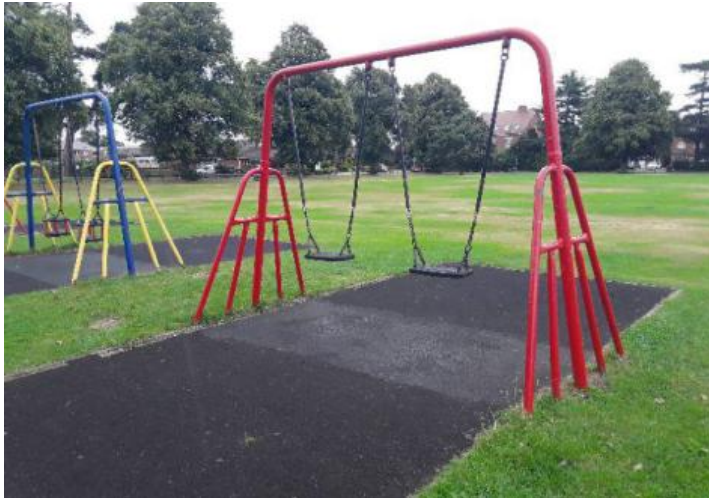
Finding: The safety surface around the area is beginning to wear

Action: Monitor for any further deterioration and repair as required

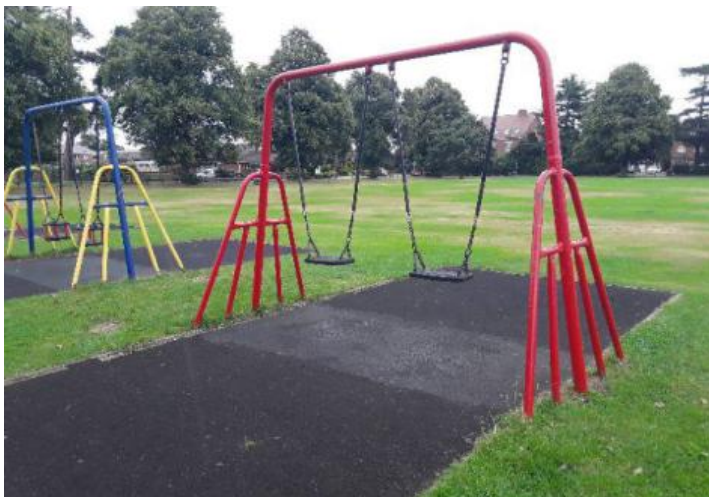
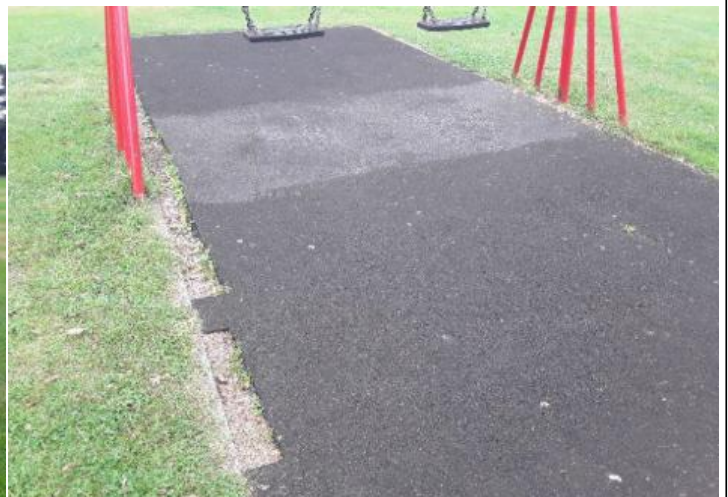
Finding: There is weed / vegetation growth within the surface

Action: Remove weed / vegetation growth

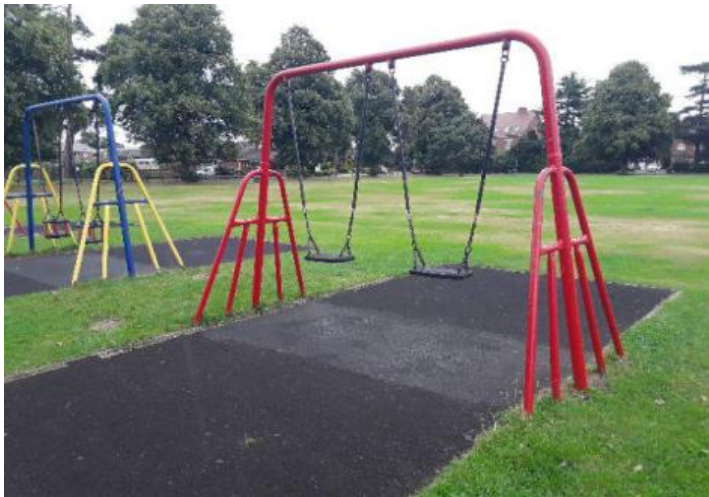
Finding: There is some notable evidence of chain wear

Action: Monitor for any further deterioration and replace when 40% worn

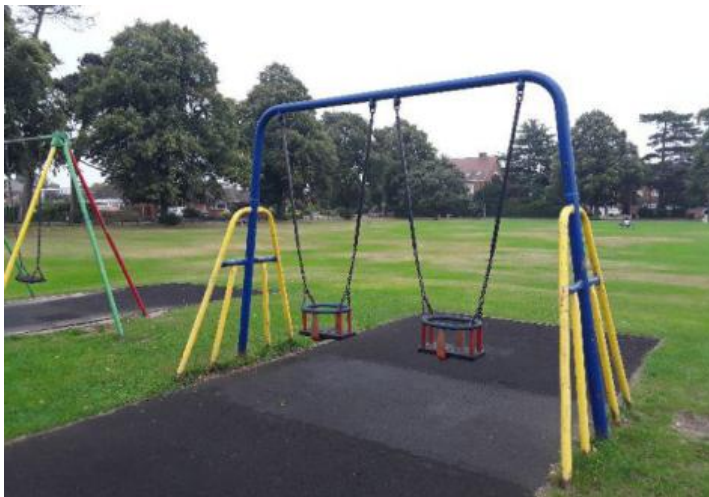
Finding: There is some minor damage to the surface

Action: Monitor for any further deterioration and repair as required

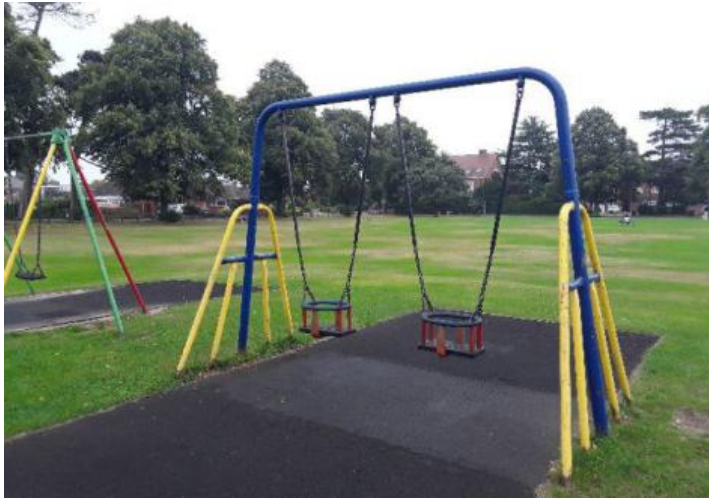
Finding: The safety surface around the area is beginning to wear

Action: Monitor for any further deterioration and repair as required

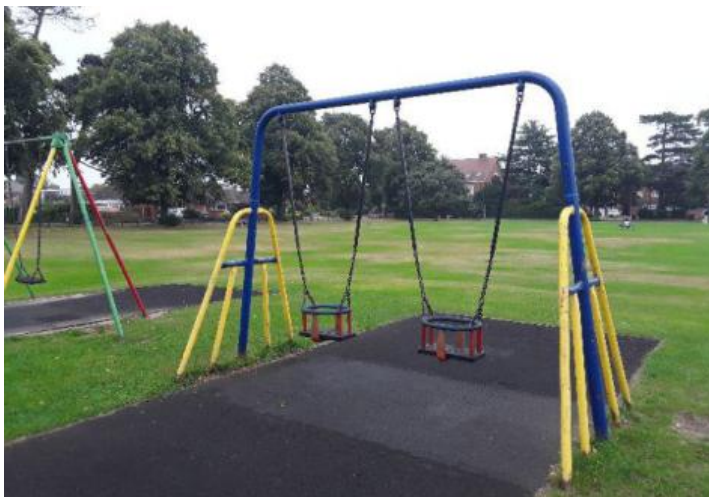
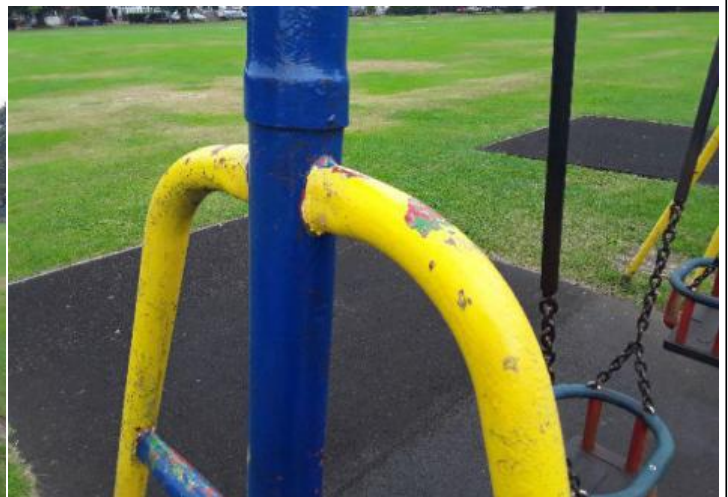
Finding: The paint is flaking off the metalwork

Action: Rub down and re-paint

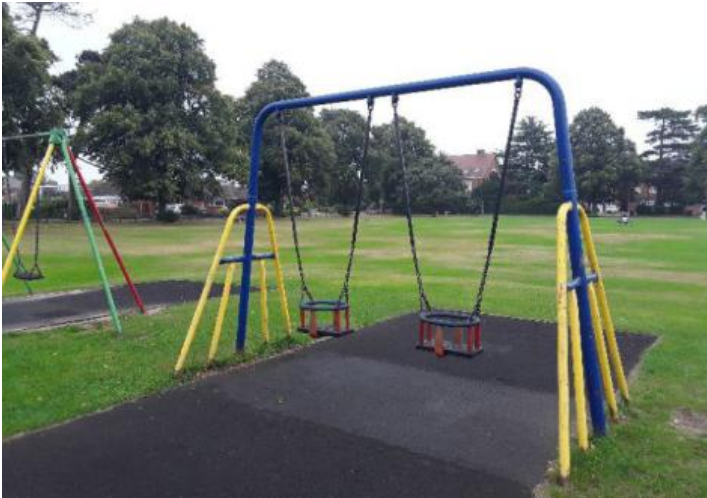
Finding: The seats are too close to each other as defined in BS EN 1176 Part 2; this is a low risk failure and no remedial action is required
Action: Monitor - No remedial work recommended

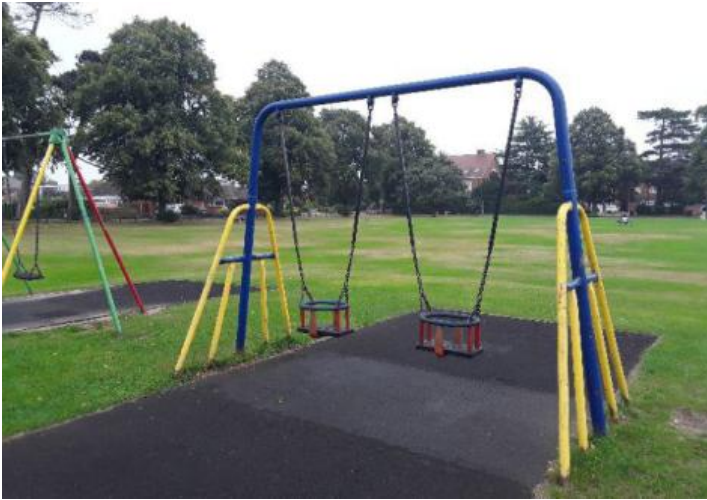
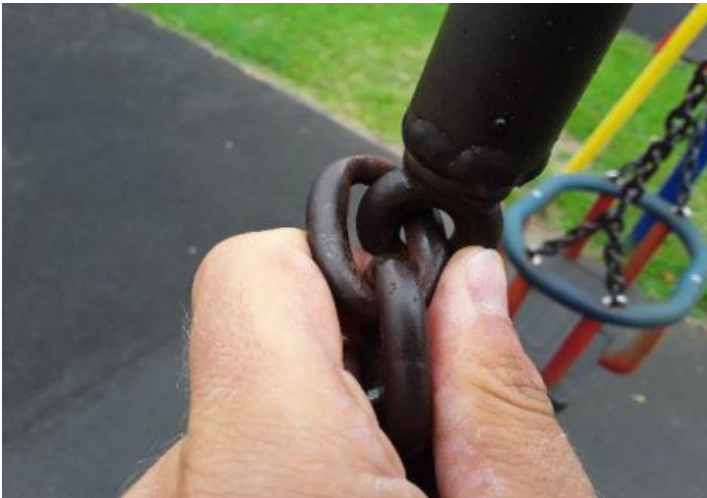
Finding: The chain links are worn excessively and require renewing

Action: Replace worn chains

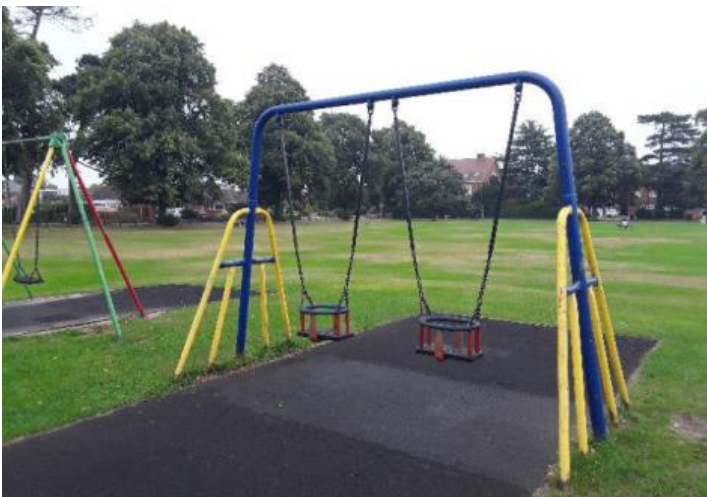
Finding: The bushes are worn or missing

Action: Replace worn or missing bushes

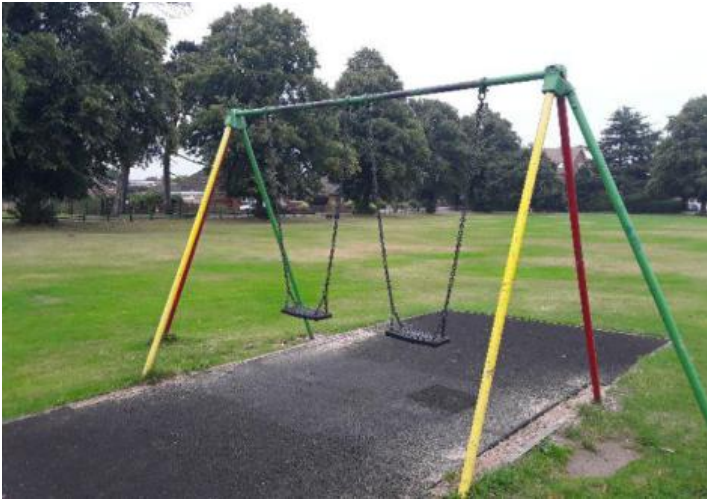
Finding: The surfacing width under the seat/s is / are less than 875mm when measured from the centre of the seat outwards due to damaged surfacing, and fails the requirements of BS EN 1176 Part 2

Action: Repair damaged surfacing

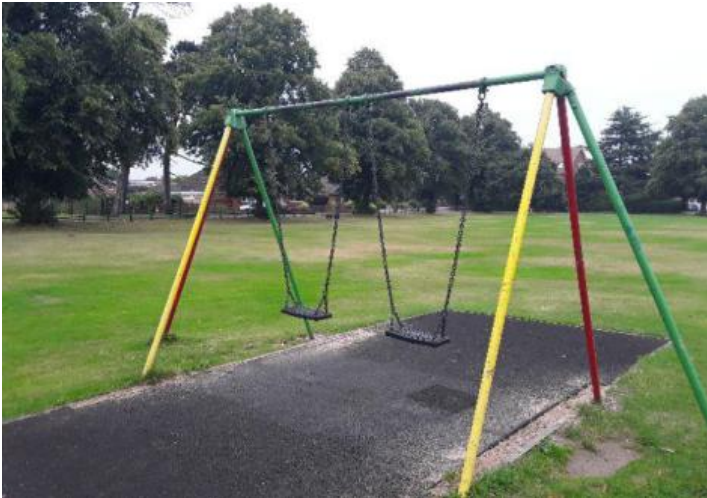
Finding: The surface has eroded in some areas and may be slippery in wet conditions
Action: Reinstate the surface

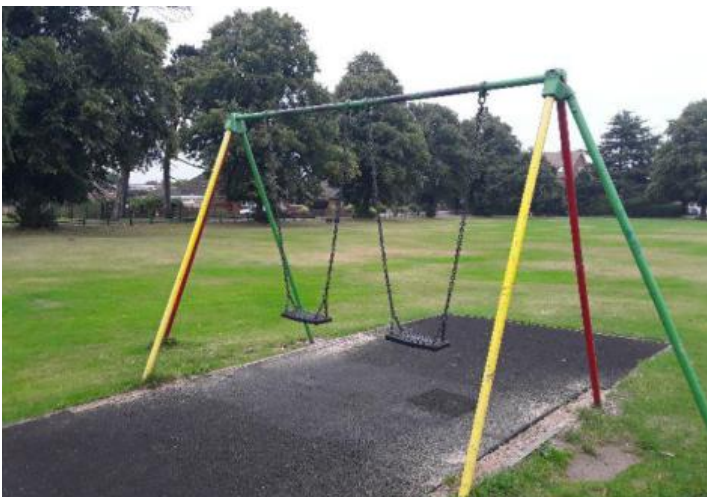
Finding: The paintwork on this item has been damaged or worn exposing the metal underneath which is rusting / corroding
Action: Treat affected areas and repaint

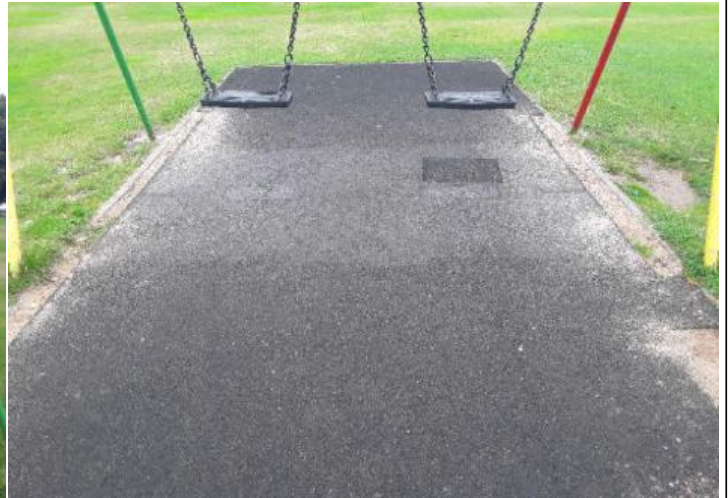
Finding: There is weed / vegetation growth within the surface

Action: Remove weed / vegetation growth

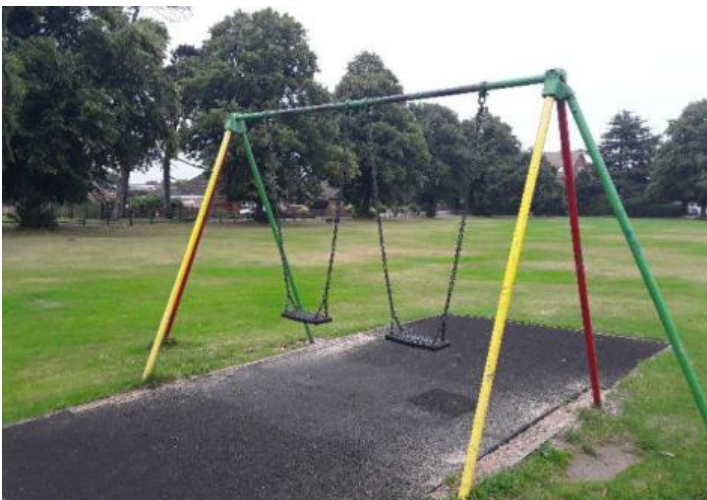
Finding: The surface is lifting at the edges and creating trip points

Action: Repair perimeter of surfacing to remove trip points
